ATB 51971-01889 Version 8

## Recall: Driver's Airbag Inflator May Produce Excessive Pressure After Long-Term Exposure to High Absolute Humidity

Supersedes 14-045, dated April 14, 2015, to revise the information highlighted in **yellow**

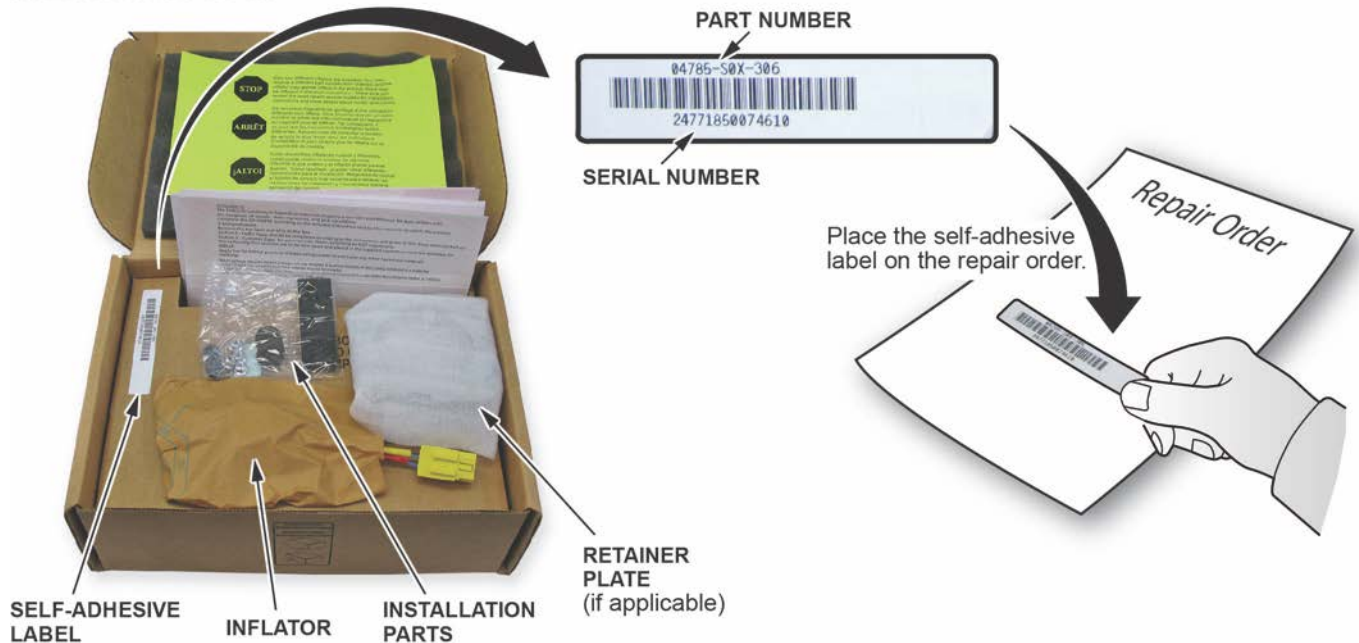
### INFLATOR PARTS BOX

- The replacement part number is printed on the top part of the label and the serial number is printed on the bottom. **Make sure you attach the label to the R.O. and give it to the warranty clerk.**
- There may also be a colored sticker located in the kit, ignore it because it is not used.
- Not all inflator kits have a label included. In those cases, write the serial number and part number from the side of the inflator box on the R.O. The part number always starts with 047.

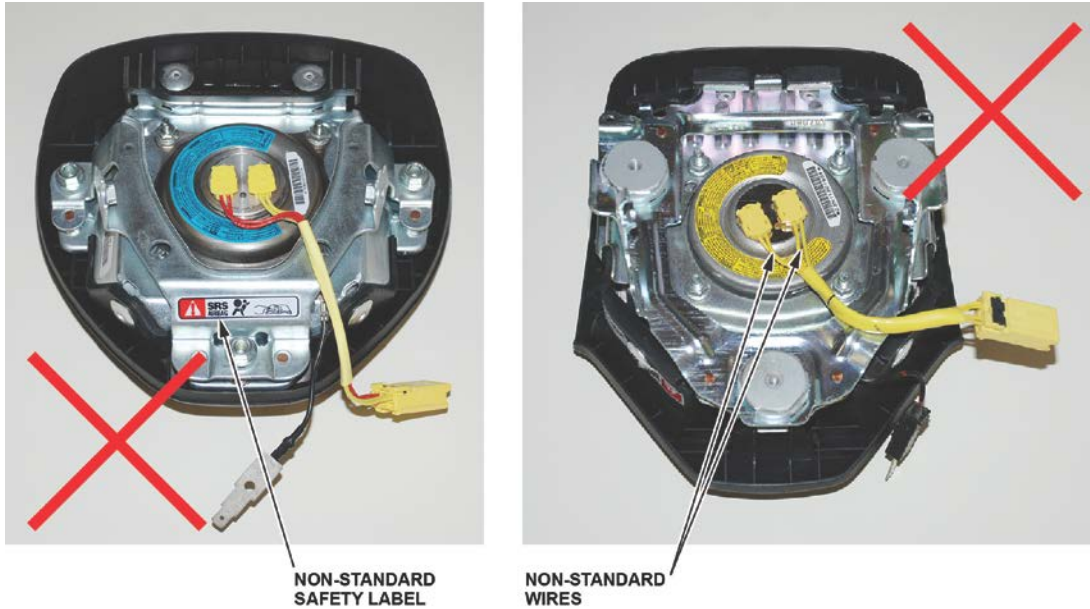
4. Visually inspect the airbag and the inflator for any unusual writing or markings.
  - If there is nothing unusual about the airbag or the inflator, go to step 5.
  - If there are any unusual markings, like an incorrect label or a model year written in marker, the airbag and inflator may not be the correct airbag and/or inflator for the vehicle or it may be a counterfeit part. For more information about counterfeit airbags, you can refer to [safercar.gov](http://safercar.gov), enter keywords **MANAGING COUNTERFEIT**, and select **Recommended Dealer Guidance for Managing Counterfeit Air Bags** from the list. **If you suspect that the airbag or inflator is counterfeit, do not continue this procedure.** Contact your DPSM for assistance.

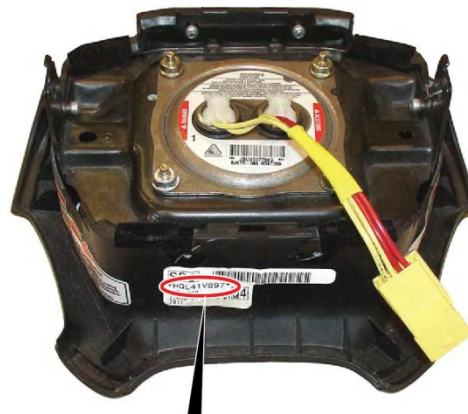
TAKATA

NOTE: The Autoliv serial number label is different from the Takata label; the Autoliv has 11 characters, the Takata has 9.

Locate serial number here.

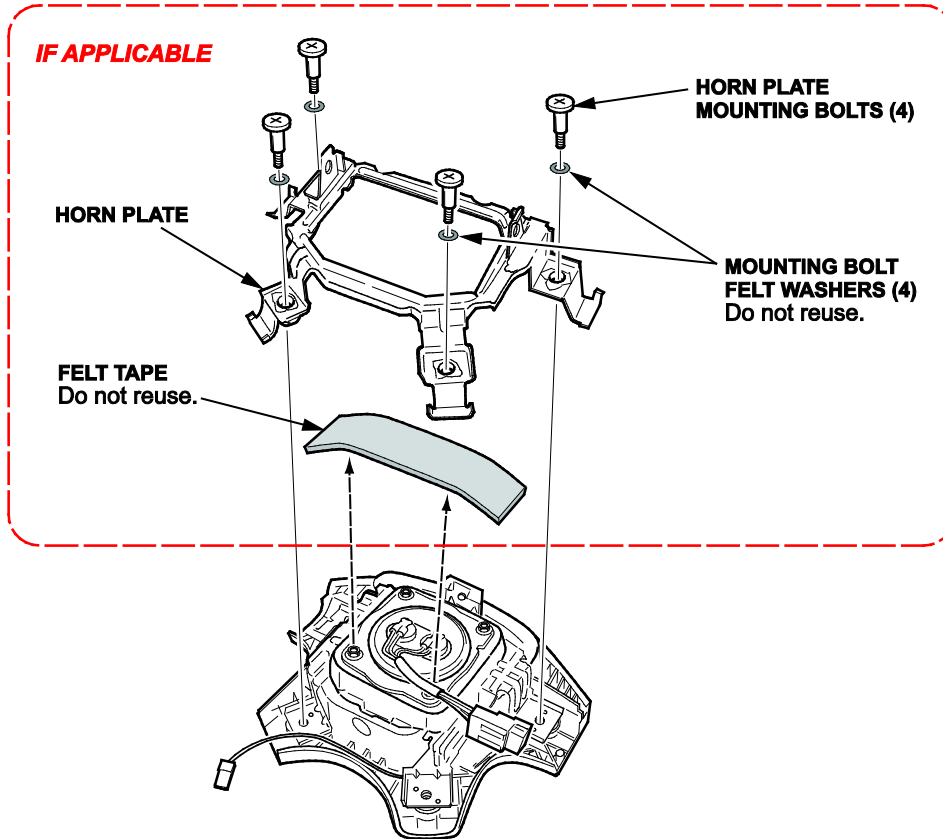
6. If there is no horn plate installed, go to step 7. If there is a horn plate installed, remove the four horn plate mounting bolts, the mounting bolt felt washers, the horn plate, and remove the felt tape covering the lower two inflator locknuts. The felt washers and felt tape will not be reused.

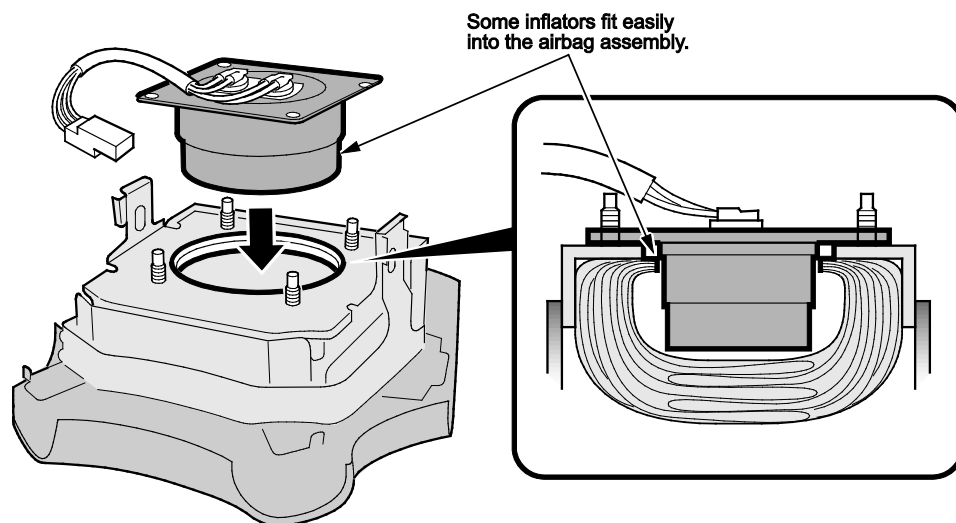
- Insert the inflator into the opening.

**NOTE:** Make sure the inflator wires are positioned toward the bottom of the airbag. If you install the inflator incorrectly, you may not be able to reconnect the SRS airbag harness.

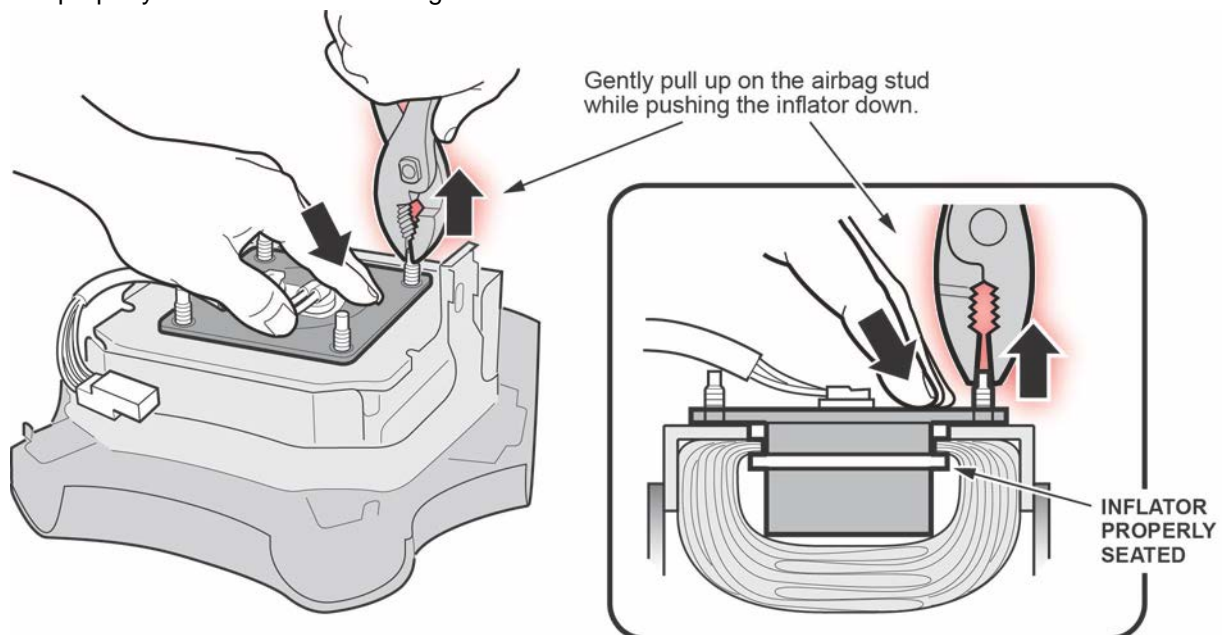
- Using a pair of pliers, gently pull up on each stud up while pushing the inflator module down until the airbag is properly seated within the airbag module.

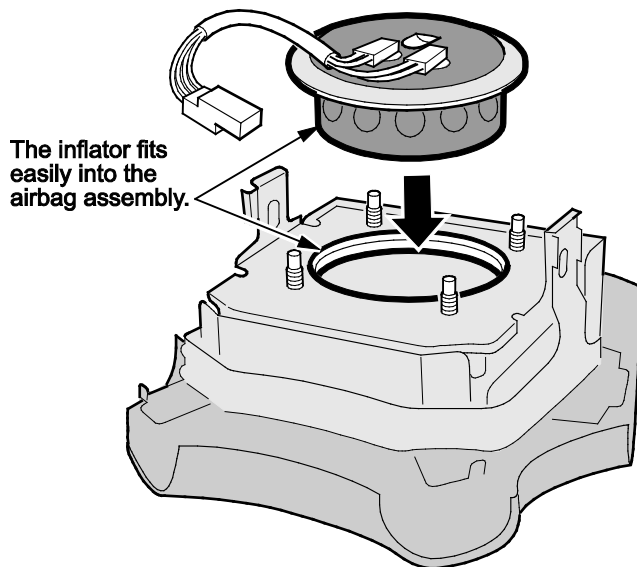
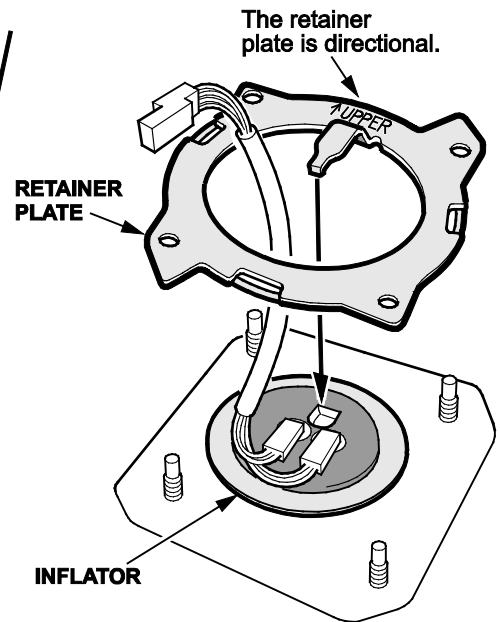
- Place the inflator into the opening with the inflator harness toward the bottom of the airbag.

- Install the bracket onto the studs. Make sure the locator tab fits into the locator hole as shown.

**NOTE:** Make sure the harness comes out through the center opening. Do not install the bracket over the harness wires.

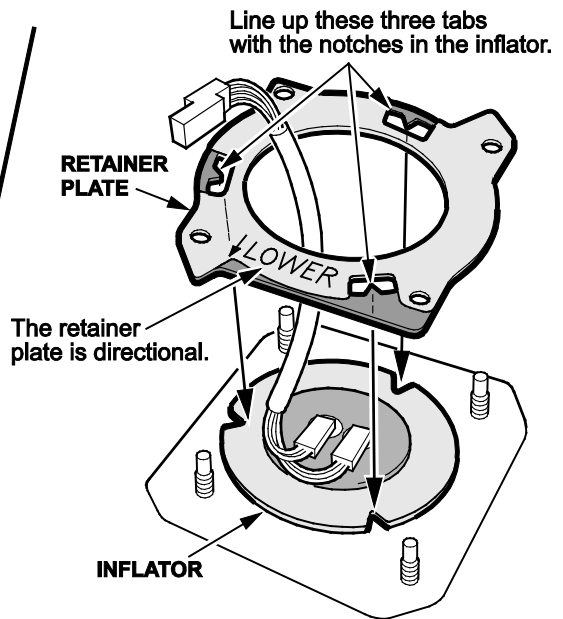
- Place the inflator into the opening with the inflator harness toward the bottom of the airbag.

- Install the bracket onto the studs with the stamp **LOWER** at the bottom of the airbag.
- Make sure the three tabs and notches are properly aligned.

- The tabs and notches are designed to align in one direction only. If the tabs and notches are not aligned, the inflator and bracket are not installed correctly.
- Make sure the harness comes out through the center opening. Do not install the bracket over the harness wires.
