# Service Bulletin

*14-046*

# Recall: Front Passenger's Airbag Inflator May Produce Excessive Pressure After Long-Term Exposure To High Absolute Humidity

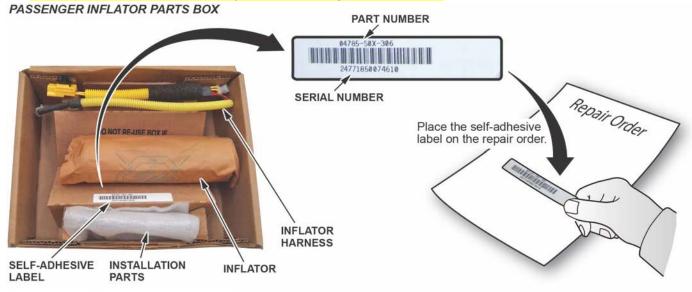
- The replacement part number is printed on the top part of the label and the serial number is printed on the bottom. Make sure you attach the label to the R.O. and give it to the warranty clerk.
- There may also be a colored sticker located in the kit, ignore it because it is not used.
- Not all inflator kits have a label included. In those cases, write the serial number and part number from the side
  of the inflator box on the R.O. The part number always starts with 047.

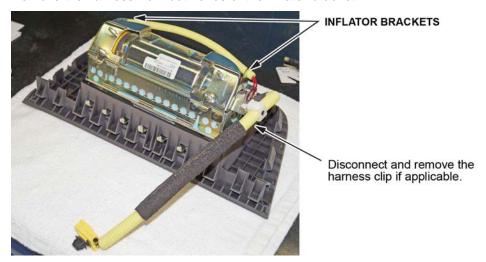
5. Remove the harness from both ends of the inflator bracket.

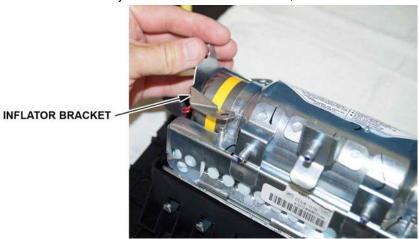
# 9. Remove the inflator bracket.

NOTE: You can only remove one of the brackets, as the other is welded to the airbag housing.

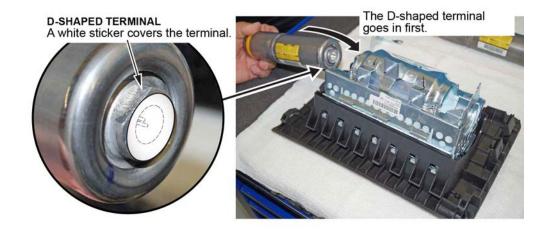
• One connector looks like a "D" whereas the other connector is a circle. Make sure you insert the "D" shaped terminal into the airbag first.

NOTE: There is a yellow band marking on the circle side.

• Slide the inflator in until the "D" aligns with the tab on the inflator bracket. There should be no space or gap between the inflator and bracket.

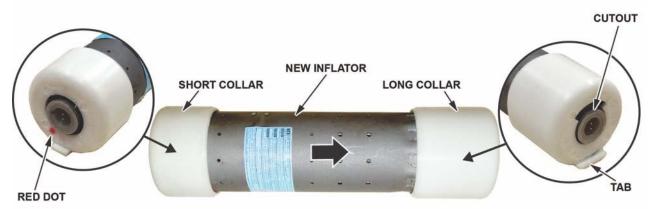
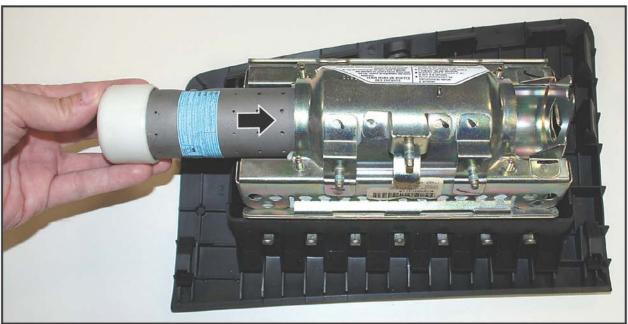
• One side of the inflator has a longer collar, a longer tab, a plastic cutout, and a small flat spot on the connector. The other side of the inflator has a shorter collar, a shorter tab, and a red dot. Make sure you insert the end with the longer collar into the airbag first.

Slide the inflator in until the plastic cutout and the small flat spot align with the tab on the bracket. There should be no space or gap between the inflator and bracket.

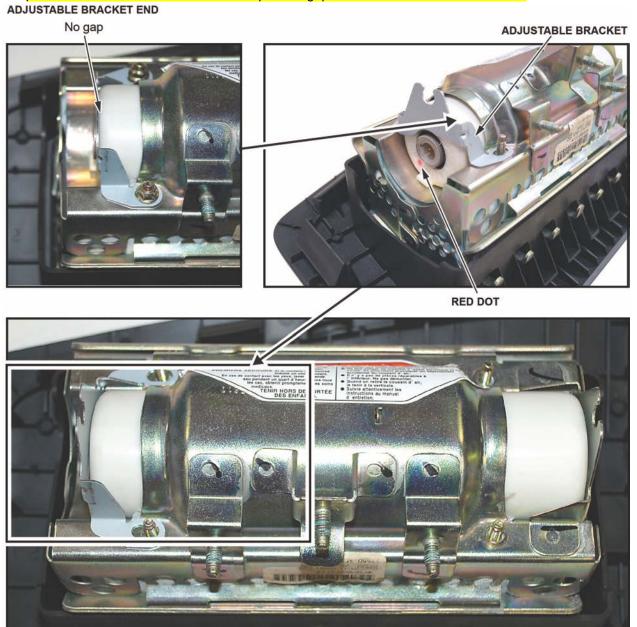
Install the bracket included in the kit onto the airbag module. There should be a red dot visible on the end of the
plastic connector. There should be no space or gap between the inflator and bracket.
 ADJUSTABLE BRACKET END

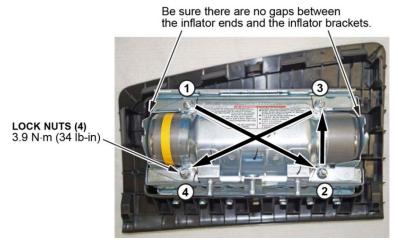
13. Install the new 5 mm locknuts and torque them in sequence to 3.9 Nom (34 lb-in).

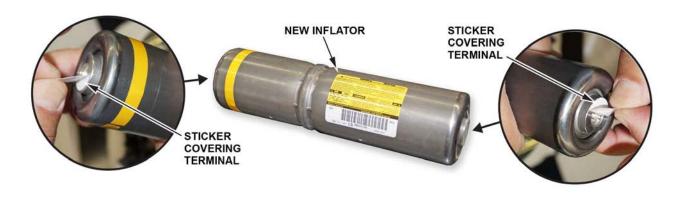
14. Remove the stickers covering the terminals on both sides of the new inflator.

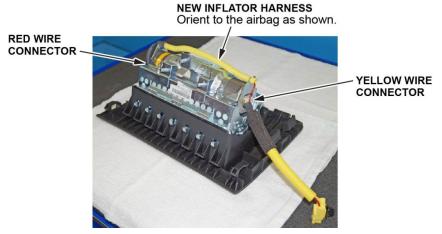
- 15. Install the new inflator harness.
  - Make sure the airbag and harness are aligned as shown.

- Make sure you have the orientation correct as shown below. If you connect the harness incorrectly, the harness cannot be removed, and you will not be able to reinstall the airbag because the harness will be too short.
- On the replacement inflators with plastic collars, connect the red wire connector to the connector with the red dot.
- On the replacement inflators without plastic collars, connect the red wire connector to the connector nearest the yellow band.

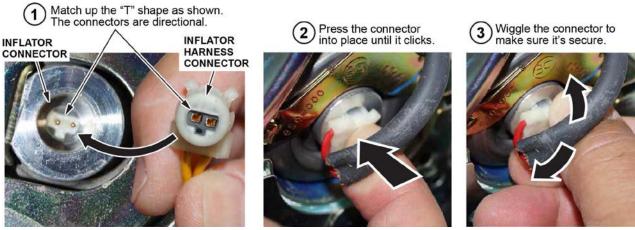
• Connect the two connectors. Align the "T" shape in the inflator harness connector with the T-shaped inflator connector, then press the connector into place.

After you hear each connector click, wiggle it to make sure it is secure.
 NOTE: If the connector is not properly aligned, it will come out.

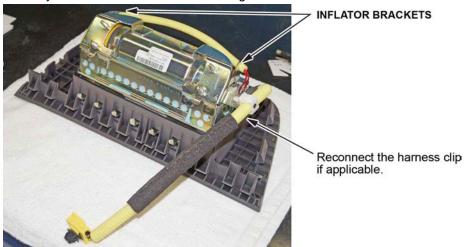
- 16. Connect the harness to the inflator brackets.
  - Insert the side without the shrink-wrap tubing first. Insert the harness at the third "valley" in the corrugated tube.
  - Insert the side of the harness with the shrink-wrap tubing into the inflator bracket. Make sure the harness is securely inserted and that it does not sag.
