April 24, 2015

46169-01892 Version 11

## Safety Recall: Replacement Driver's Airbag Inflator Can Be Over-Pressurized

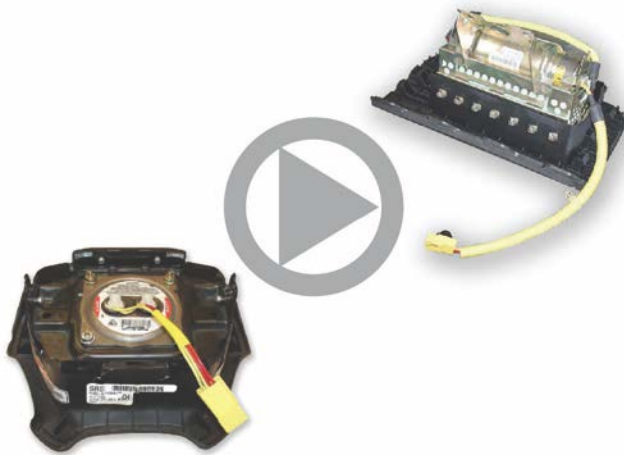
NOTE: There may be some minor surface rust or corrosion on the new inflator; this is OK.  
Click on the image below for a short video about the different inflators.

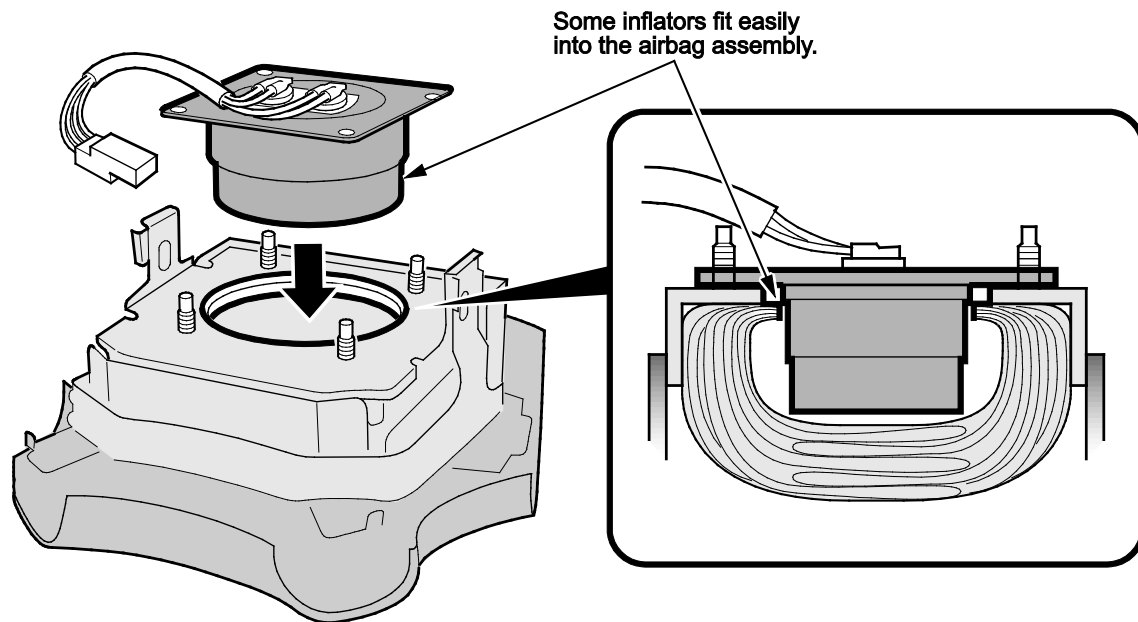
04770-S5A-305

- Insert the inflator into the opening.

NOTE: Make sure the inflator wires are positioned toward the bottom of the airbag. If you install the inflator incorrectly, you may not be able to reconnect the SRS airbag harness.
