40918-01681

Safety Recall: Driver's Airbag Inflator Can Be Over-Pressurized

Supersedes 08-093, dated November 15, 2014, to revise the information highlighted in **yellow**

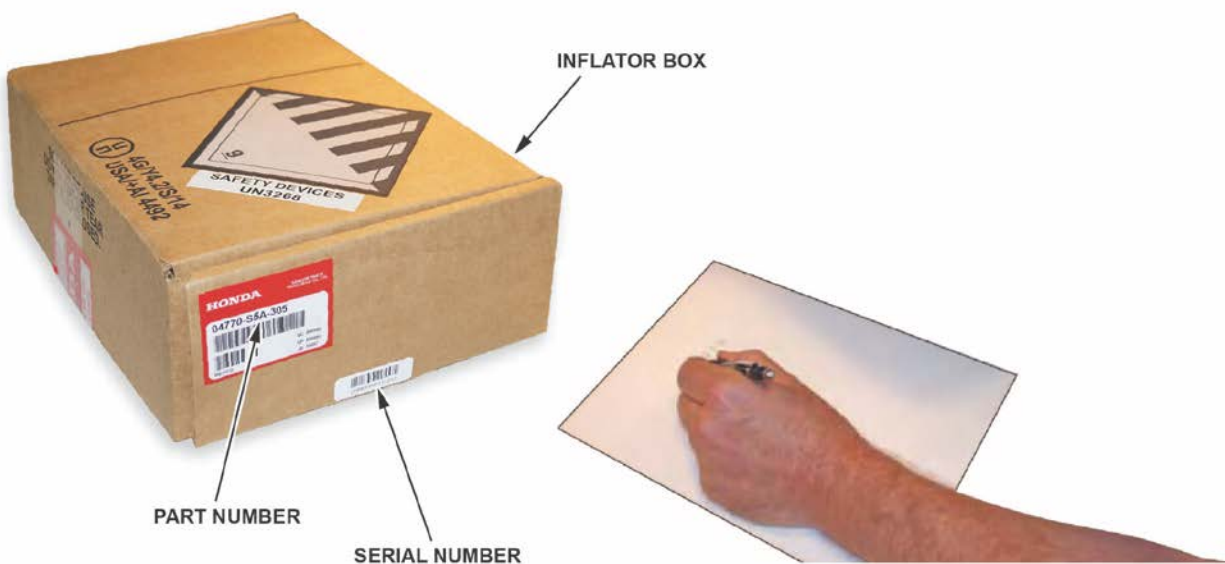
NOTE: Make sure you give the part number on the side inflator box that you received to the warranty clerk. Do not give the warranty clerk the part number that you ordered.

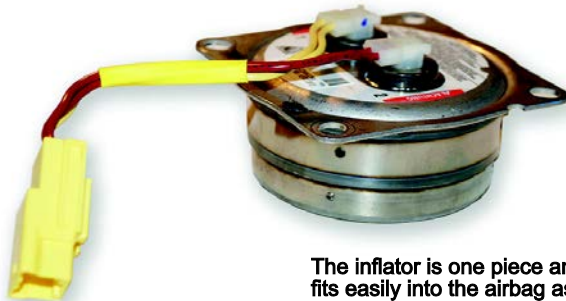
04770-S5A-305

Refer to **Driver's Inflator Type 1** in the video.

The inflator is one piece and fits easily into the airbag assembly.

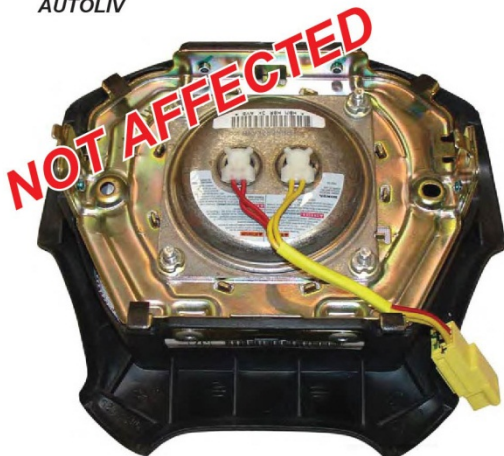
AUTOLIV

5. **Civic only** - Determine if the airbag is made by Autoliv or Takata by comparing the inflators to those in the images below.

NOTE: The Autoliv serial number label is different from the Takata label; the Autoliv has 11 characters, the Takata has 9.

- If the airbag is made by Autoliv, the airbag is OK. Reinstall the airbag using new Torx bolts. Torque the bolts to **9.8 N-m (7.2 lb-ft)**. If you already received a replacement inflator, return the unopened kit to American Honda.
- If the airbag is made by Takata, go to step 6.
