ATB 51811-01830 Version 7

## Safety Recall: Front Passenger's Airbag Inflator Can Be Over-Pressurized

Supersedes 14-040, dated December 11, 2014, to revise the information highlighted in **yellow**

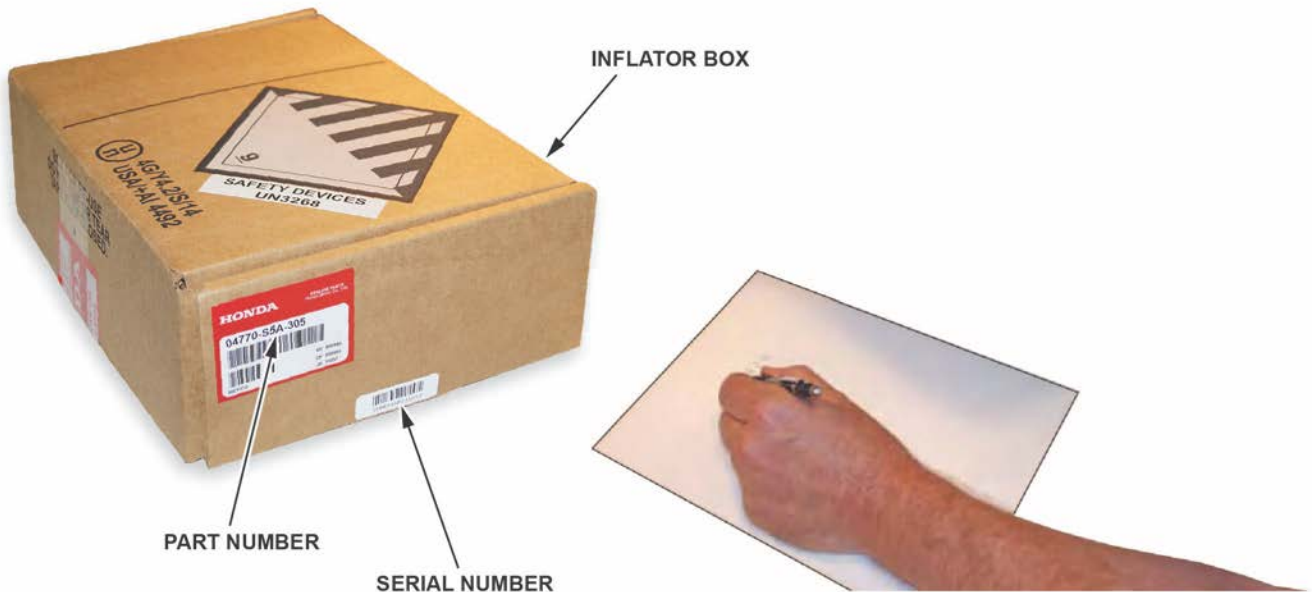
1. Write down the serial number located on the right side of the new inflator box. For the warranty claim to be paid, the **replacement inflator part number that you received** must be on the warranty claim and your warranty clerk must enter the serial number in the Diagnostic Trouble Codes field.

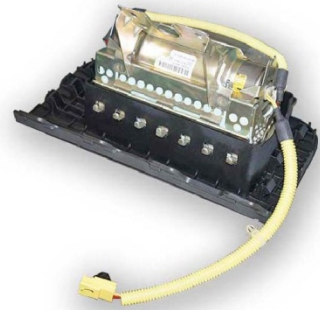
**PILOT**

3. Place the airbag face-down on a clean shop towel as shown.

- The orientation of the airbag is critical because if the inflator is installed incorrectly, the harness will be too short when you reinstall the airbag.
- The brackets between the various models are similar but may differ from the example shown in the procedure.

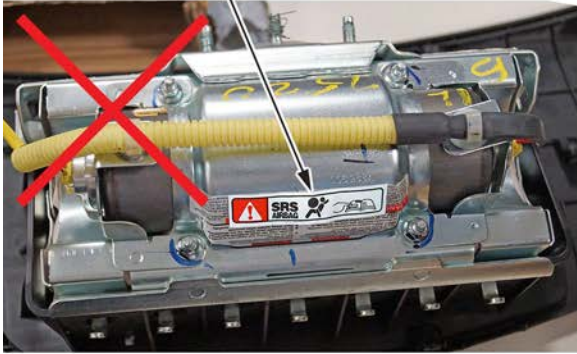
- If there is nothing unusual about the airbag or the inflator, go to step 5.
- If there are any unusual markings, like an incorrect label or a model year written in marker, the airbag and inflator may not be the correct airbag and/or inflator for the vehicle or it may be a counterfeit part. For more information about counterfeit airbags, you can refer to [safercar.gov](http://safercar.gov), enter keywords **MANAGING COUNTERFEIT**, and select **Recommended Dealer Guidance for Managing Counterfeit Air Bags** from the list. **If you suspect that the airbag or inflator is counterfeit, do not continue this procedure.** Contact your DPSM for assistance.

NON-STANDARD SAFETY LABEL

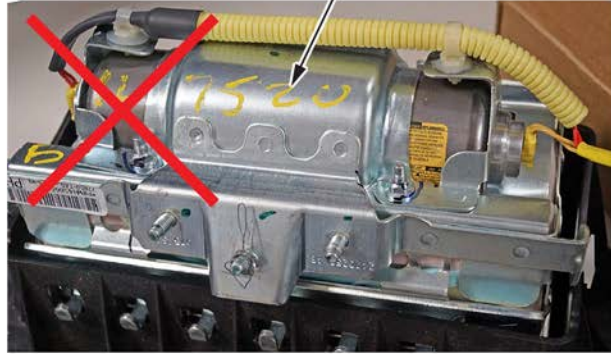
GREASE PENCIL OR PAINT MARKINGS

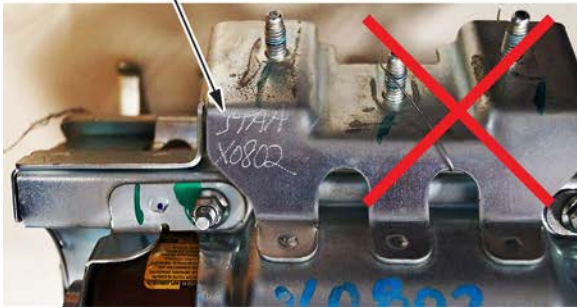
HAND ENGRAVING

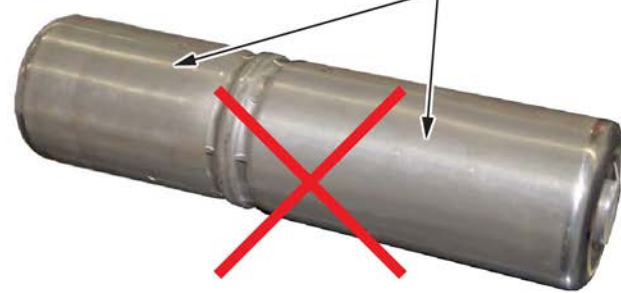
NO LABELS ON INFLATOR

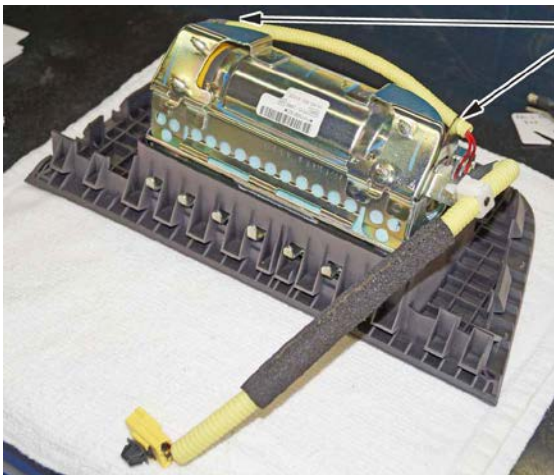
5. Remove the harness from both ends of the inflator bracket.

INFLATOR BRACKETS

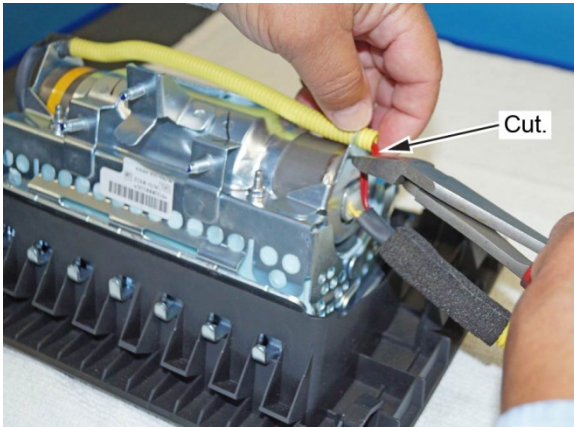
6. Short the red wires.

NOTE: **You must cut and short the wires** as indicated to prevent any accidental deployment.

- Cut the red wires as shown.

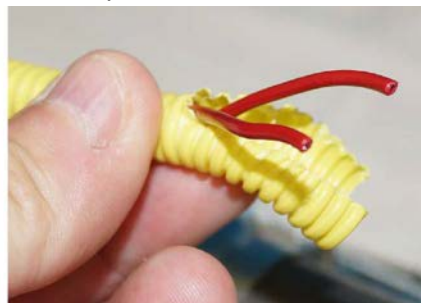
- Cut about 2 inches of the corrugated tube, then pull out the two red wires.

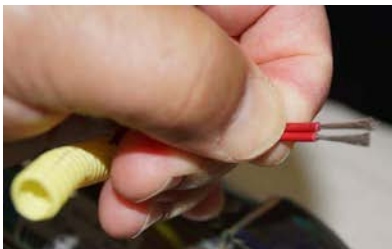
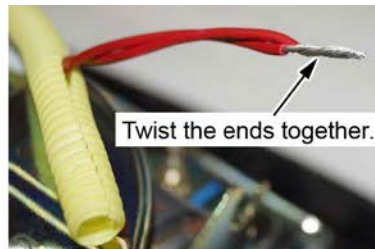
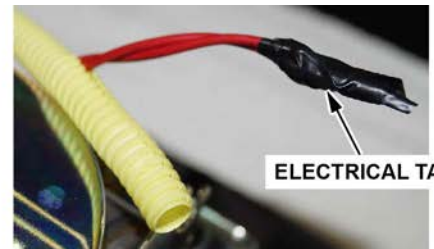
- Strip away about 1 inch of the wire insulation, then twist the wires together.

- Tape the twisted ends with electrical tape.

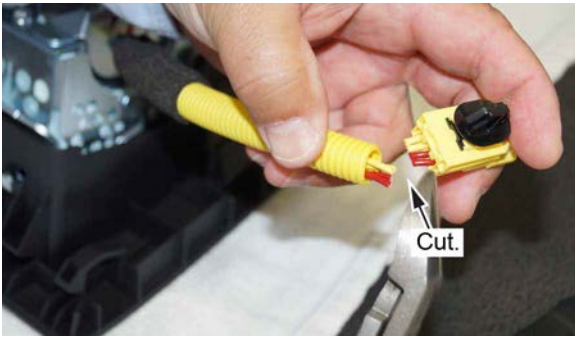
7. Cut off the connector and short the yellow wires.

- Cut all four wires to remove the connector.

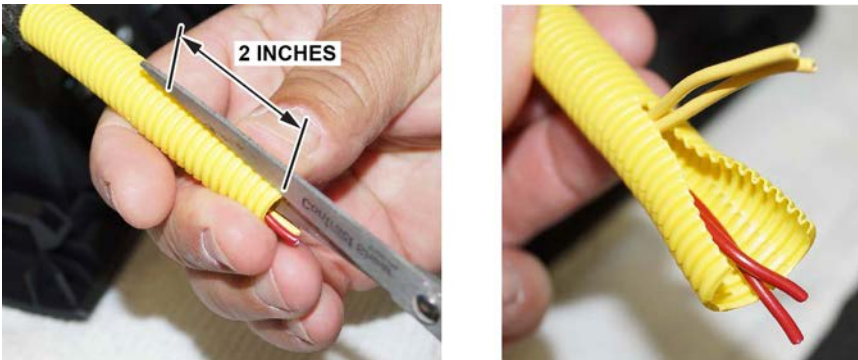
- Cut about 2 inches of the corrugated tube, then pull out the yellow wires.

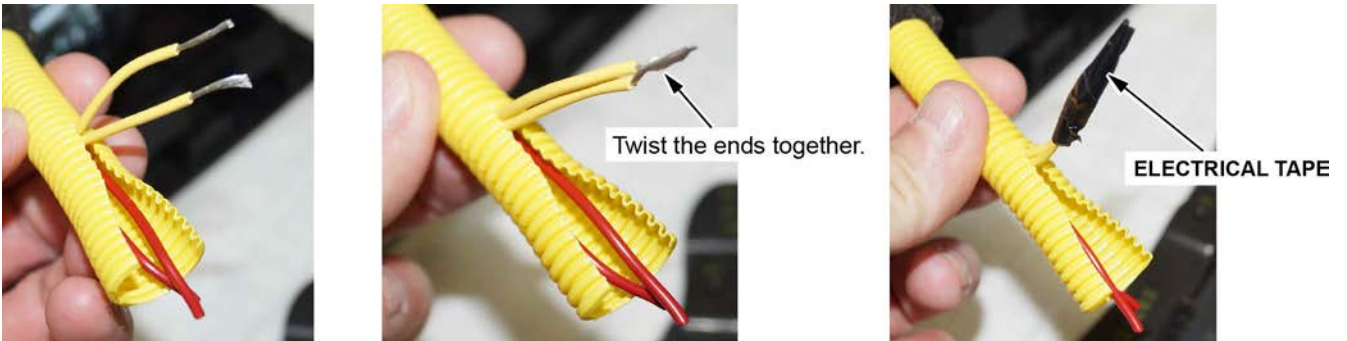
- Strip away about an inch of the wire insulation, then twist the wires together.

- Tape the twisted ends with electrical tape.

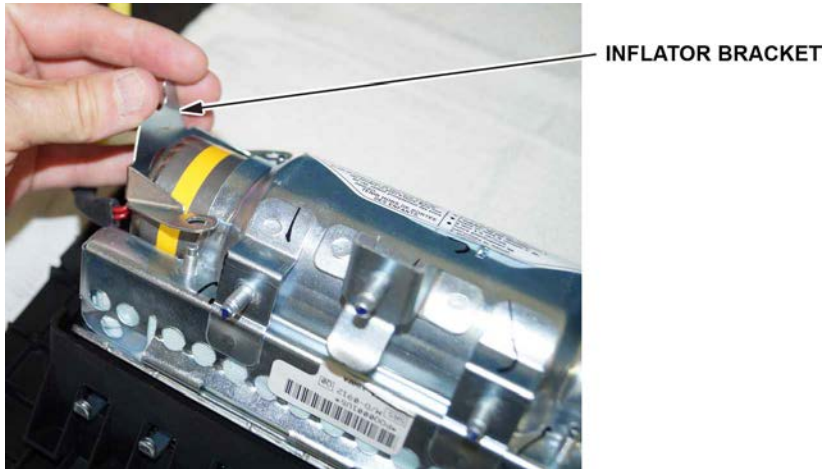
9. Remove the inflator bracket.

NOTE: You can only remove one of the brackets, as the other is welded to the airbag housing.

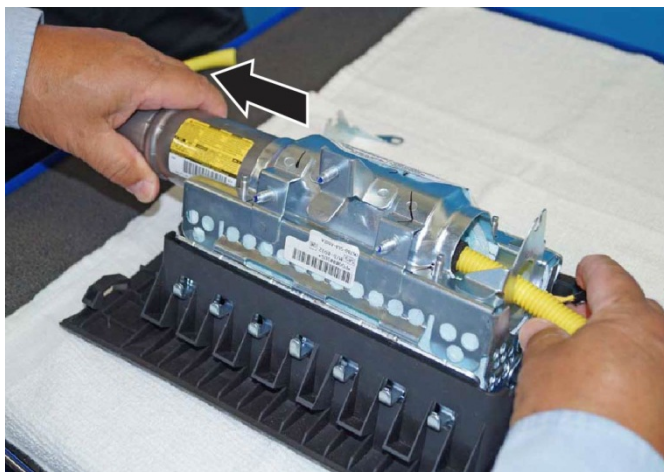
10. Remove the inflator by pushing it out.

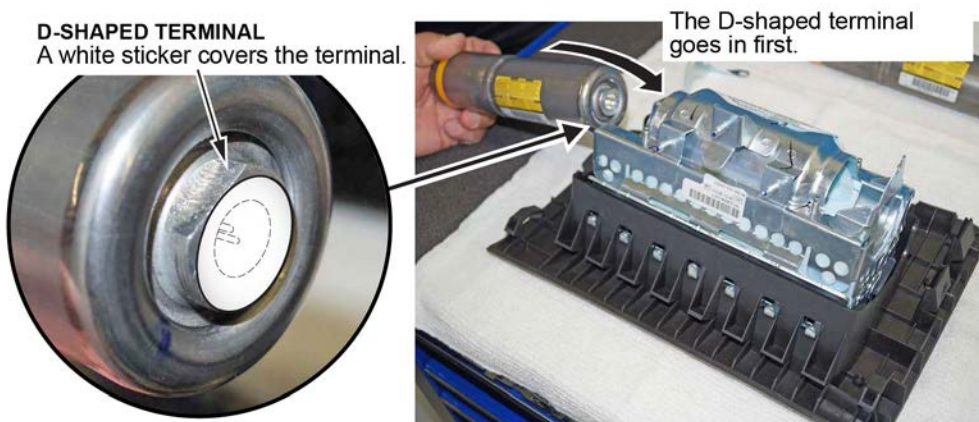
- One connector looks like a "D" whereas the other connector is a circle. Make sure you insert the "D" connector into the airbag first.

NOTE: There is a yellow band marking on the circle side.

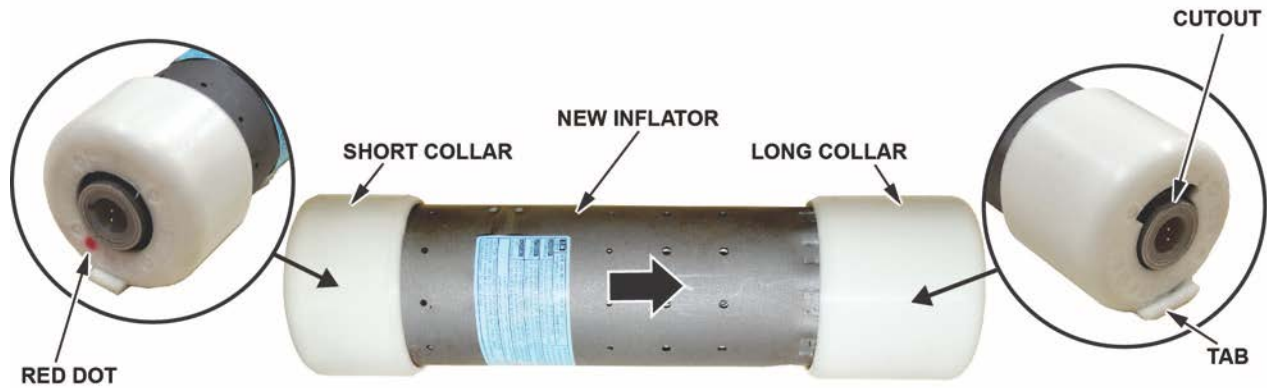
- One side of the inflator has a longer collar, a longer tab, a plastic cutout, and a small flat spot on the connector. The other side of the inflator has a shorter collar, a shorter tab, and a red dot. Make sure you insert the end with the longer collar into the airbag first.

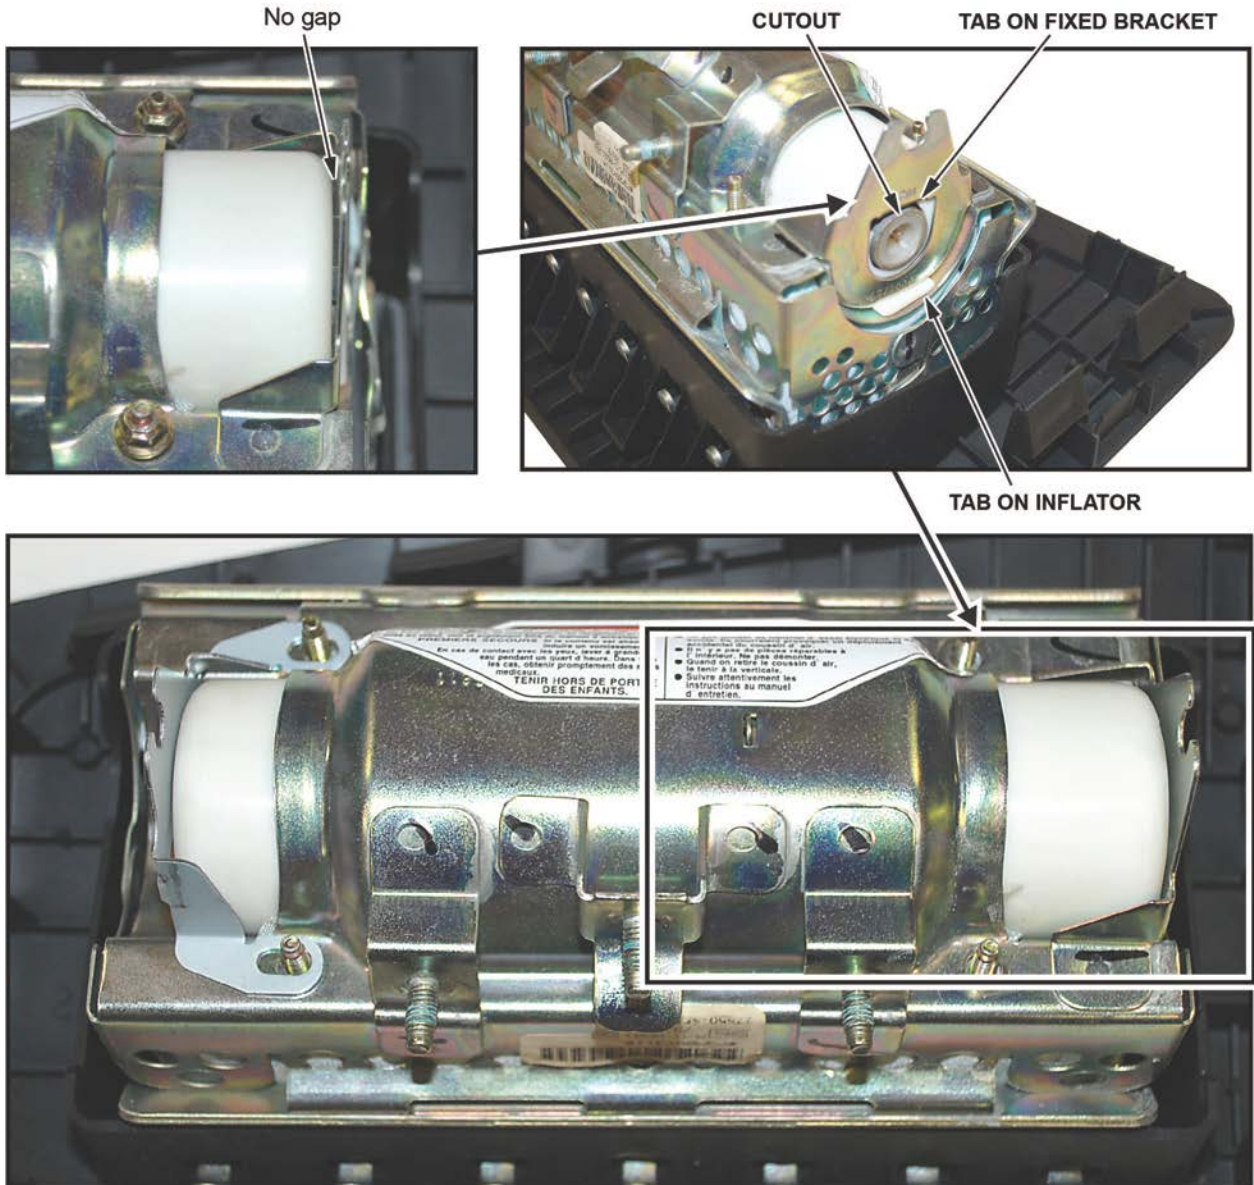
**FIXED BRACKET END**

- Slide the inflator in until the plastic cutout and the small flat spot align with the tab on the bracket. There should be no space or gap between the inflator and bracket.

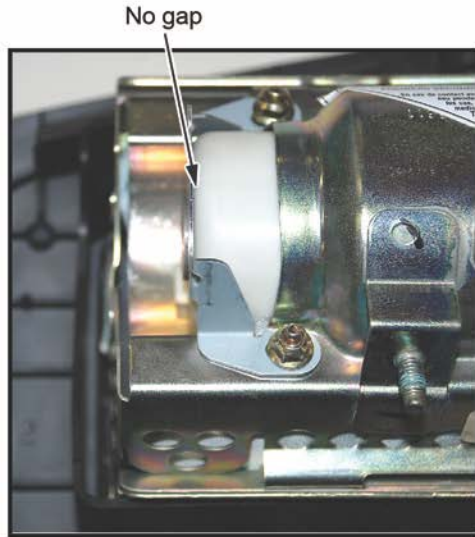
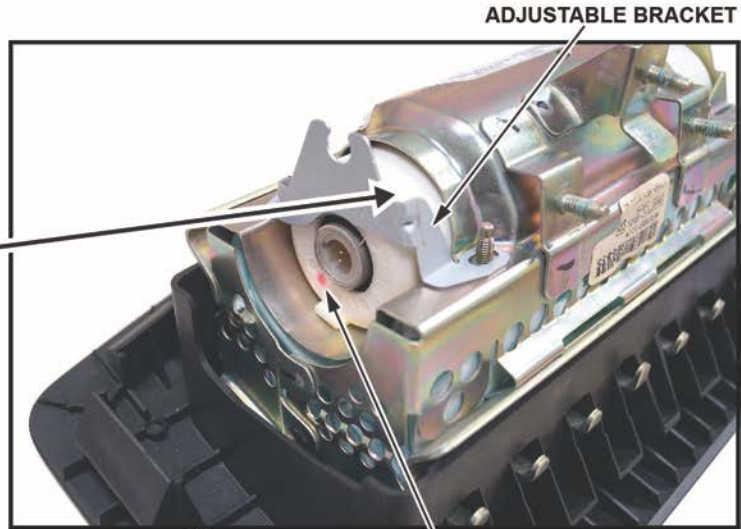
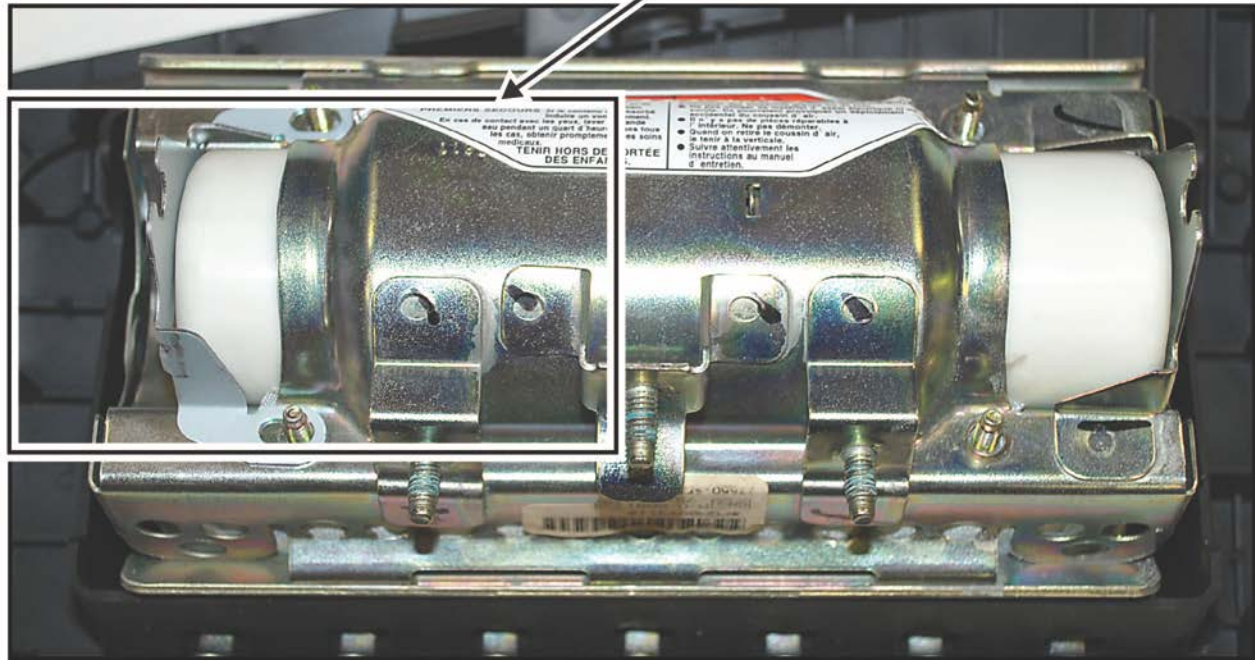
**ADJUSTABLE BRACKET END**

- Install the bracket included in the kit onto the airbag module. There should be a red dot visible on the end of the plastic connector. There should be no space or gap between the inflator and bracket.

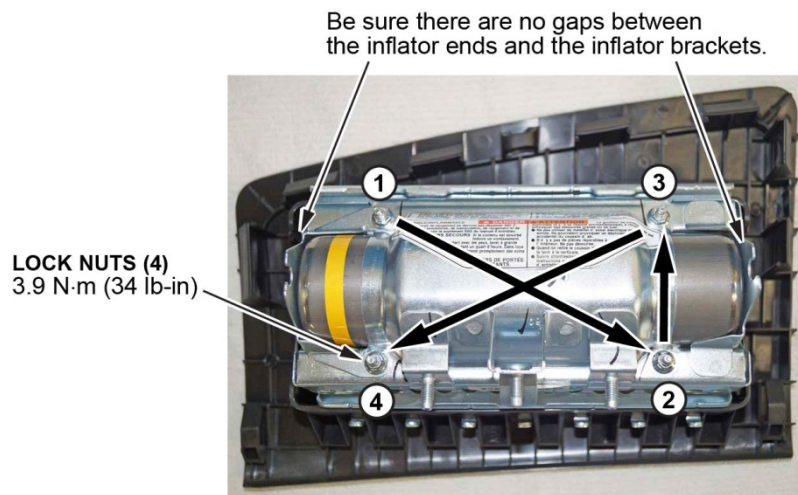
12. Install the new 5 mm locknuts and torque them in sequence to **3.9 N•m (34 lb-in)**.

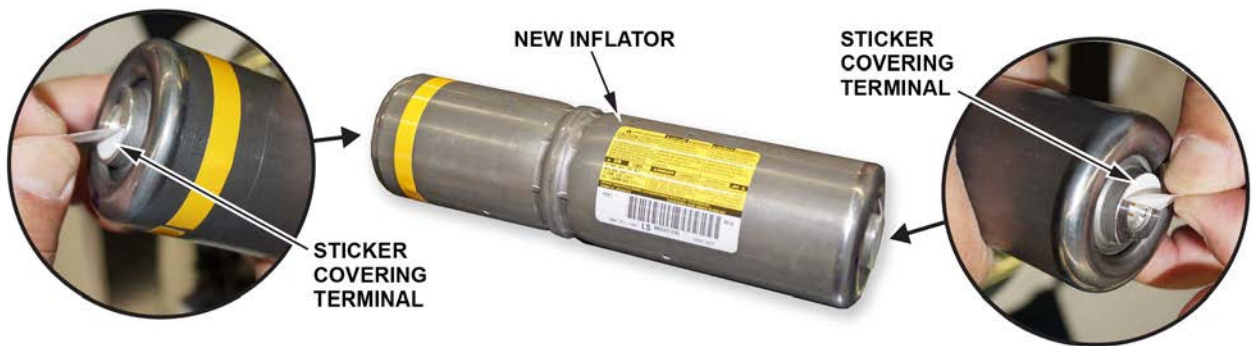
13. Remove the stickers covering the terminals on both sides of the new inflator.

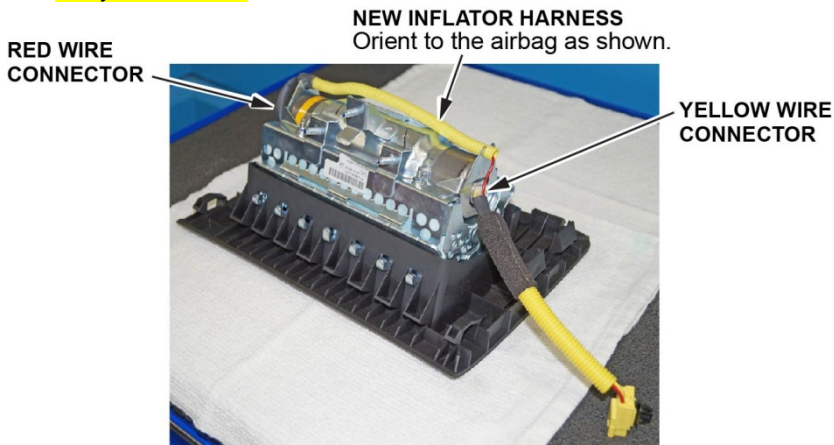
- Make sure the airbag and harness are aligned as shown.

- **Make sure you have the orientation correct as shown below.** If you connect the harness incorrectly, the harness cannot be removed, and you will not be able to reinstall the airbag because the harness will be too short.
- On the replacement inflators with plastic collars, connect the red wire connector to the connector with the red dot.
- On the replacement inflators without plastic collars, connect the red wire connector to the connector nearest the yellow band.

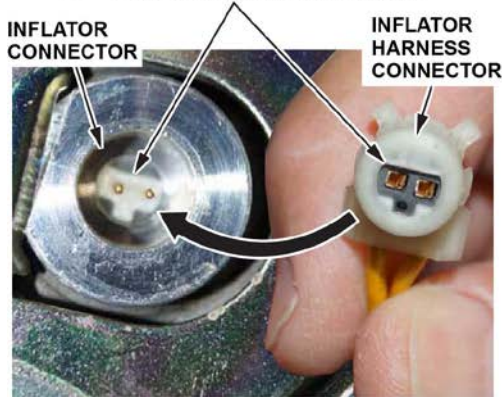
- Connect the two connectors. **Align the "T" shape in the inflator harness connector with the T-shaped inflator connector**, then press the connector into place.

① Match up the "T" shape as shown. The connectors are directional.

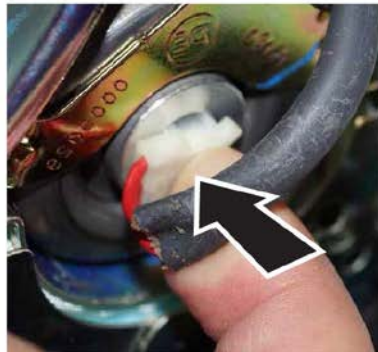
② Press the connector into place until it clicks.

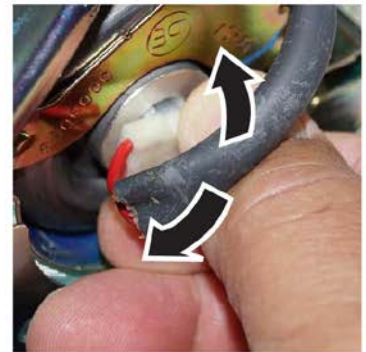
③ Wiggle the connector to make sure it's secure.

- After you hear each connector click, wiggle it to make sure it is secure.  
NOTE: If the connector is not properly aligned, it will come out.

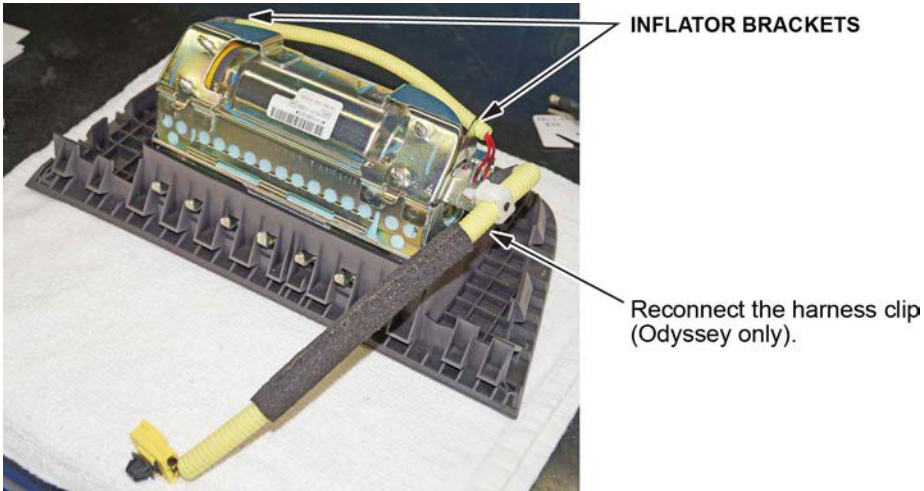
15. Connect the harness to the inflator brackets.

- Insert the side without the shrink-wrap tubing first. Insert the harness at the third “valley” in the corrugated tube.
- Insert the side of the harness with the shrink-wrap tubing into the inflator bracket. Make sure the harness is securely inserted and that it does not sag.
