April 17, 2014

00407-01827 Version 2

## Safety Recall: Front Passenger's Airbag Inflator May Produce Excessive Pressure After Long-Term Exposure To High Absolute Humidity

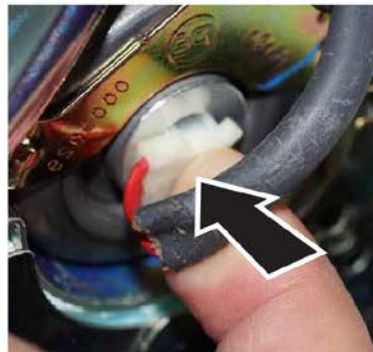
② Press the connector into place until it clicks.
