05854 Version 4

**MIL Comes On with DTC P2422****Supersedes 15-010, dated December 3, 2015; See REVISION SUMMARY****AFFECTED VEHICLES**

The MIL is on with DTC P2422 (EVAP canister vent shut valve stuck closed malfunction).

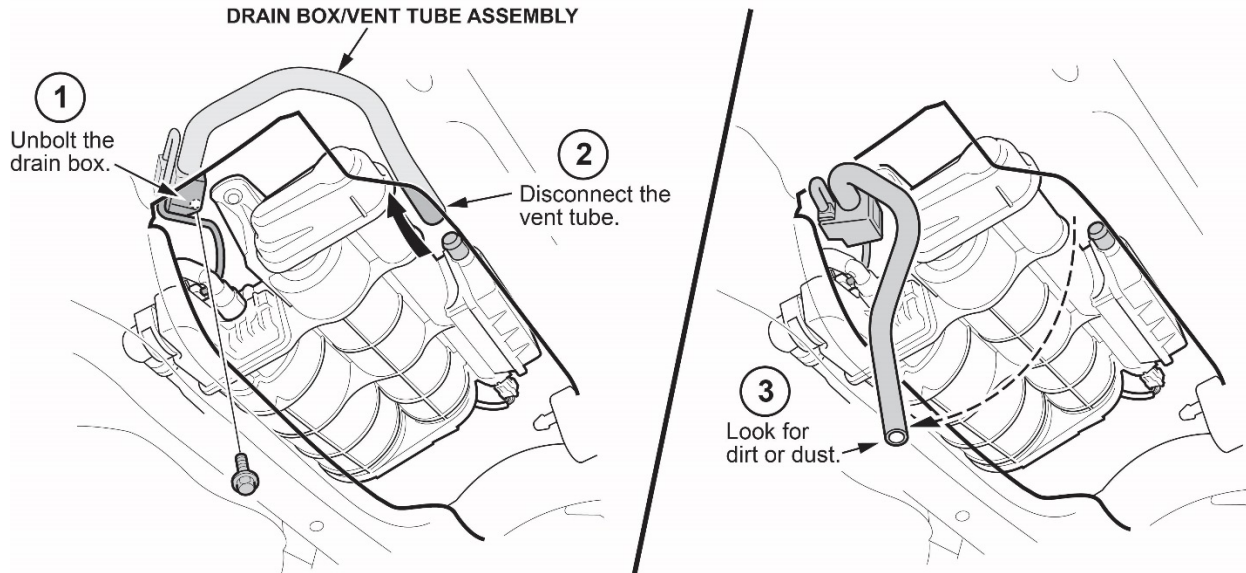
### IF NO CANISTER FILTER BOX IS INSTALLED:

Remove the bolt and the canister vent tube. Check if there is any dust or dirt in the tube by visually inspecting and tapping/shaking it.

- If the vent tube has any dust or dirt inside it, go to REPAIR PROCEDURE.
- If the vehicle has a canister filter box attached and there is dust or dirt inside the vent tube, go to REPAIR PROCEDURE - FILTER BOX REPLACEMENT.
- If the vent tube has no dust or dirt present, this bulletin does not apply. Continue with normal troubleshooting.
