**Rear Combination Lens Service Tips**

2013- 2015 FR-S

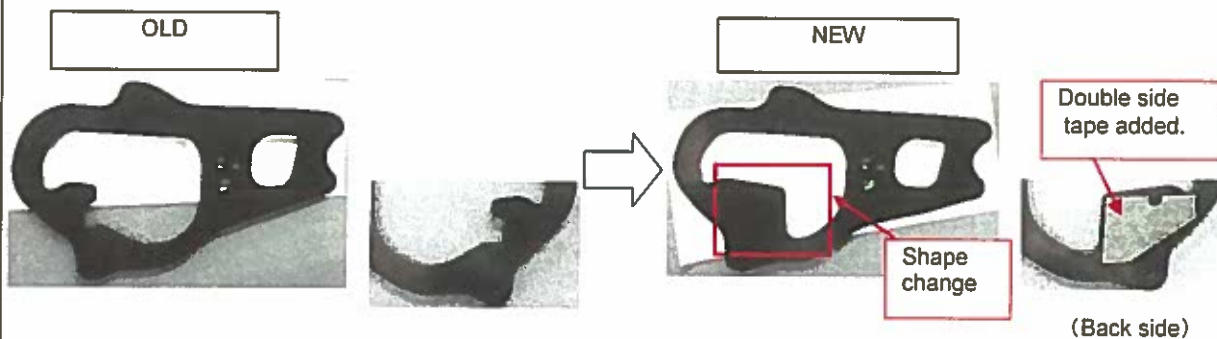
Effective 9/2013 the rear combination light housing and gasket were changed to reduce the possibility of insect intrusion into the rear combination light housing.

**RECOMMENDATIONS**Gasket change Detail

Do not use prior level gaskets on newer tail lights. It is permissible to install current level gaskets with previous level tail lights.
