GROUP
Engine

MODEL
All 2011MY or Newer,
Except Sorento (XM)
and Sedona (VQ)

NUMBER
PS469

SUBJECT: MANUAL EVAPORATIVE EMISSIONS TEST FOR
HARD TO FIND/SMALL LEAKS

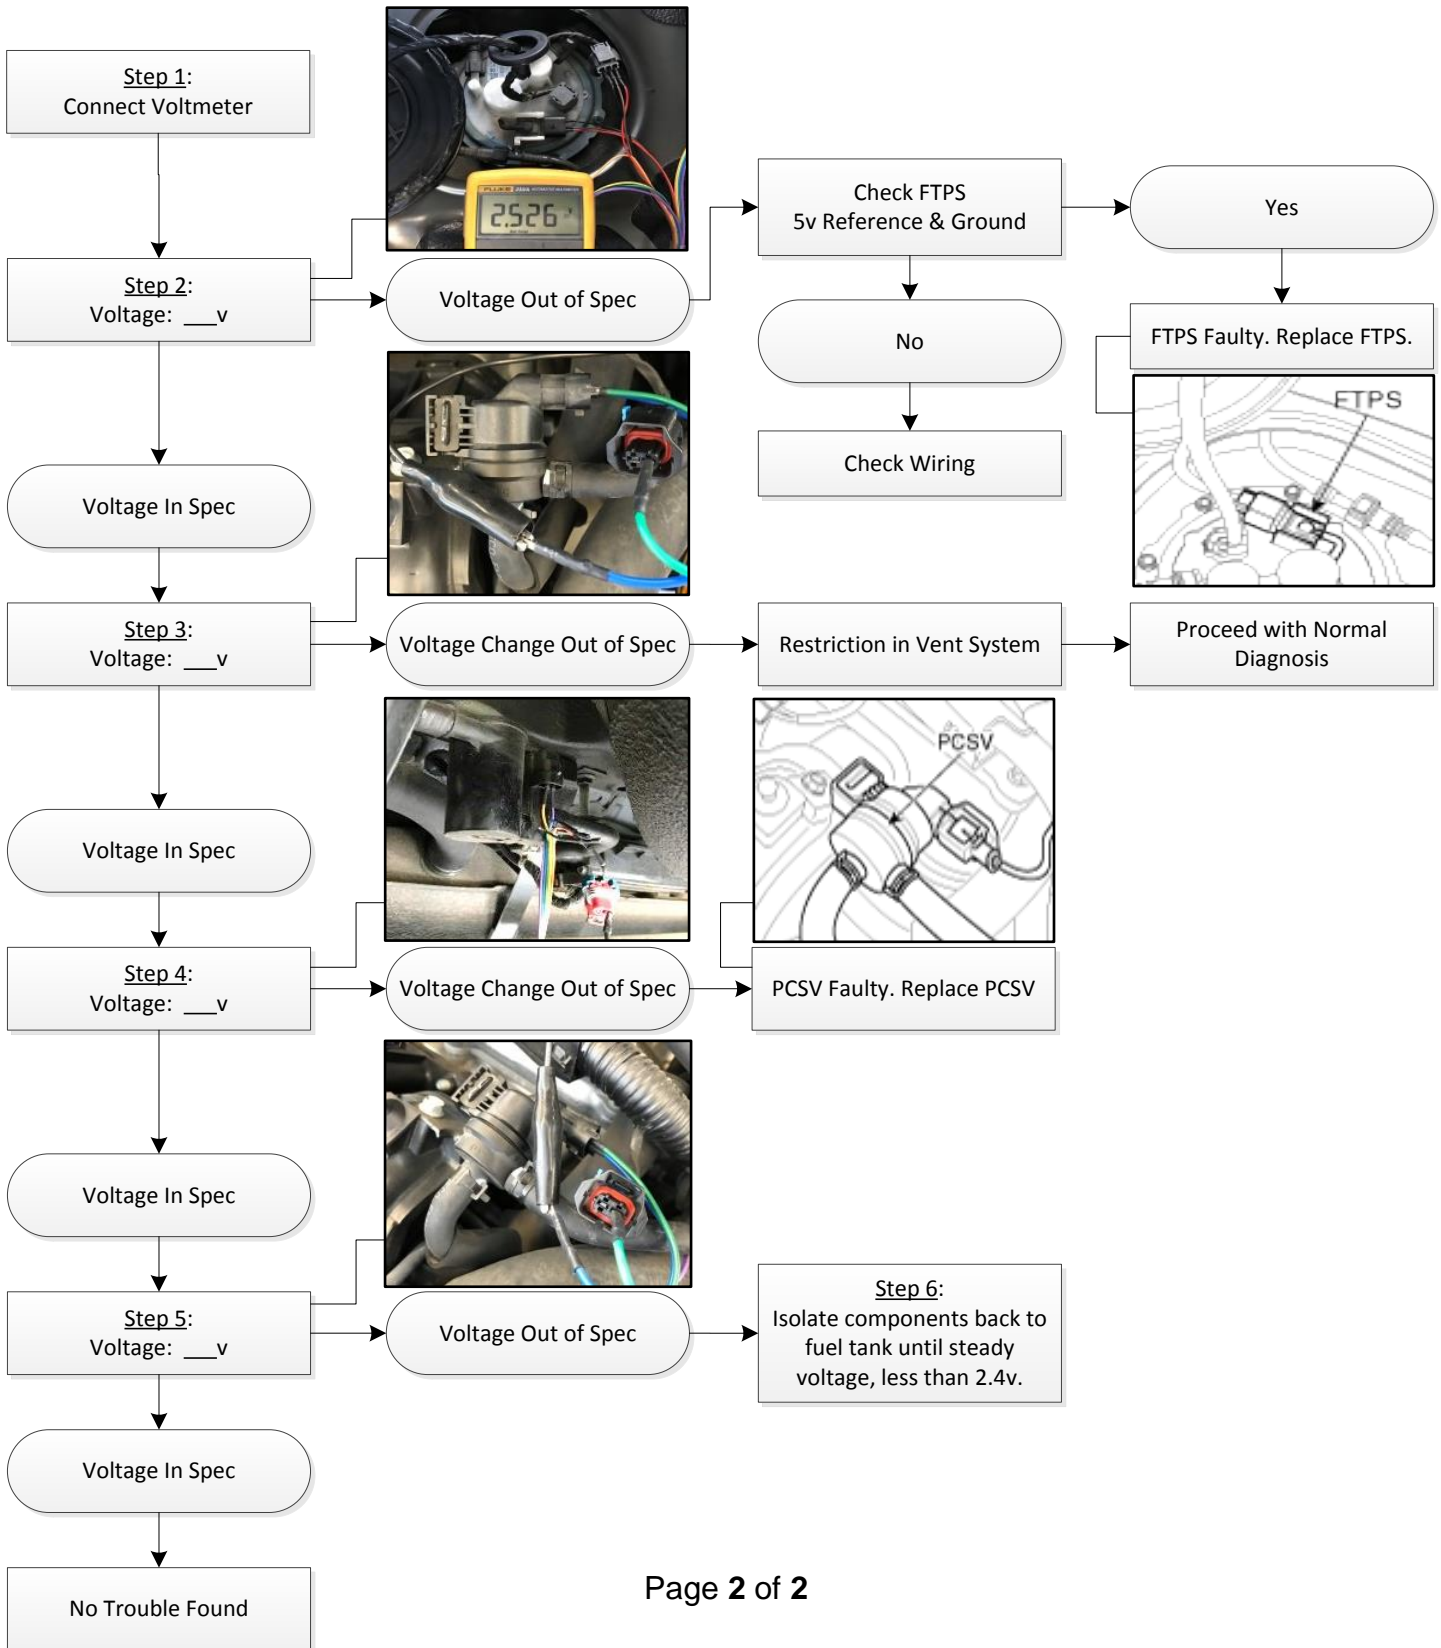
Diagnostic Flowchart:

Step 1: Use a T-connector to monitor the Fuel Tank Pressure Sensor (FTPS) signal voltage. Leave the volt meter connected in parallel throughout this procedure.

Step 2: With the Key On, Engine Off (KOEO), and gas cap OFF, measure the signal voltage at the FTPS. Refer to KGIS for the FTPS Output Voltage specifications of the applicable vehicle. If voltage is within the specified range, proceed to step 3. If the voltage is out of the specified range, verify the 5V reference and ground at the FTPS with the KOEO, gas cap OFF. If the 5V reference and ground are present, the FTPS is likely faulty. If the reference voltage and ground are not present, check all related connections, wiring, and PCM. Follow normal diagnosis as outlined in KGIS for any issues found.

Step 3: Install the gas cap and start the vehicle. Locate the Purge Control Solenoid Valve (PCSV). Using a jumper wire, **TAP** the control wire to ground for 25 seconds while monitoring the volt meter. The signal voltage at the FTPS should be greater than 1.5V. If the voltage is in the specified range, proceed to step 4. If the voltage drops below 1.5v, there is a restriction in the EVAP system (check: rollover valve, charcoal canister, CCV, air filter, evaporator lines).

Step 4: Remove the jumper wire to the PCSV and unplug the connector at the PCSV. Ground the CCV control wire and monitor FTPS Voltage for 25 seconds. If the signal voltage at the FTPS is steady, proceed to step 5. If voltage drops and continues to drop, the PCSV is likely to be leaking.

Step 5: Plug the PCSV back in, and leave the jumper wire for CCV grounded. Use a second (2nd) jumper wire and **TAP** the PCSV control wire to ground (to close the valve and draw partial vacuum) until FTPS signal voltage drops to 1.0v - 1.4v. Unplug the PCSV connector and monitor FTPS signal voltage for one (1) minute. The voltage should not change more than .300v

in one (1) minute. If the voltage change is out of spec, there is a leak in the system. Check for the leak using a smoke machine or the procedure outlined in step 6.

Step 6: Draw a partial vacuum on the system using the procedure outlined in step 5. Monitor the FTPS signal voltage and begin isolating components by pinching off hoses. When the voltage stabilizes, the leak is located on the branch of the EVAP system that was just isolated.
