Subject: 2004-2009 MAZDA3 (5-DOOR) - HAZY REAR COMBINATION LAMP LENS	M-Tips No.: MT-013/17
	Last Issued: 07/06/2017

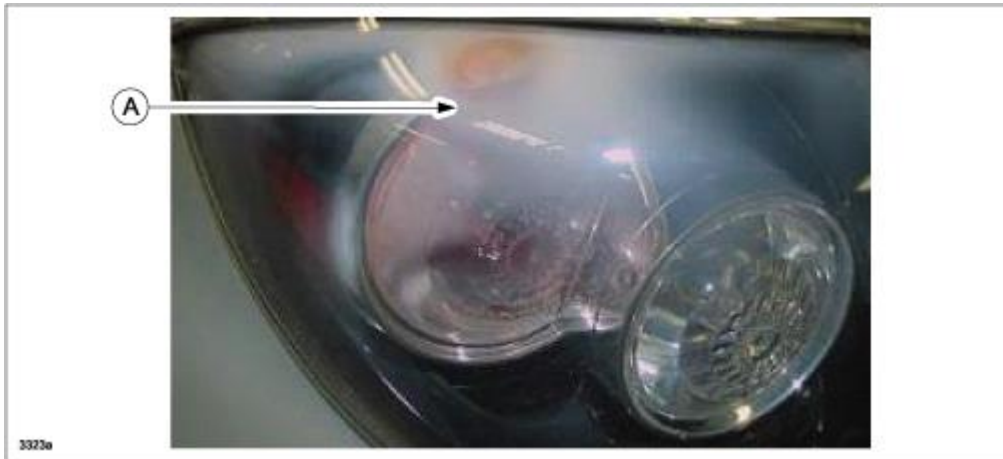
On some vehicles, the rear combination lamp lens becomes hazy and looks white when the brake or taillight is on.

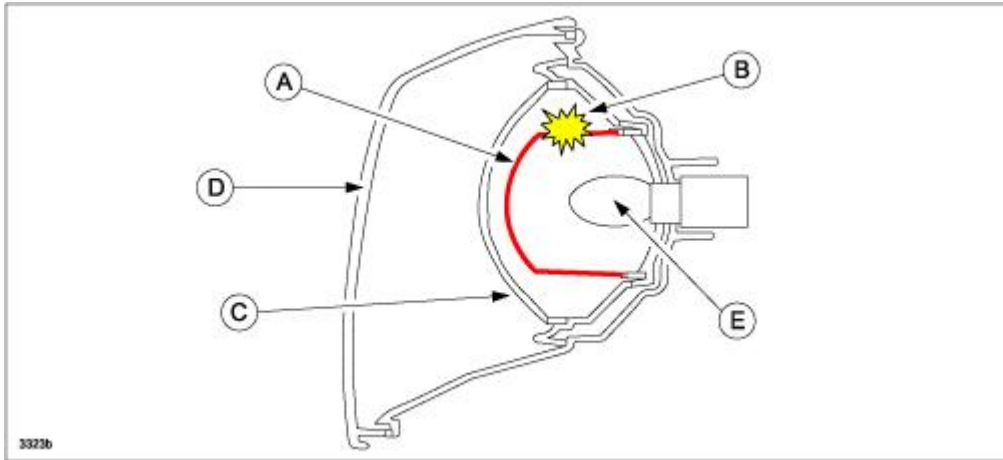
Due to heat accumulated by extended brake light (E) usage, the red inner cap(A) is melted (B) and the inner (C) and/or outer (D) lens becomes hazy.
