Touch Screen Inoperative with Display Audio

Audio/Visual/Telematics

12-14MY Multiple Models w/Display Audio

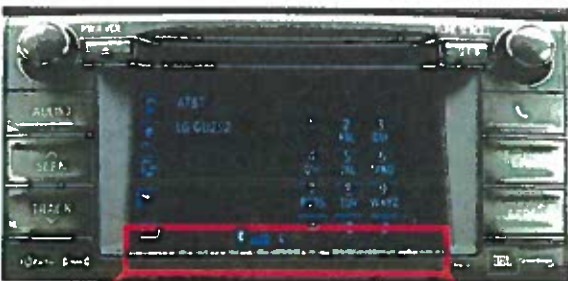
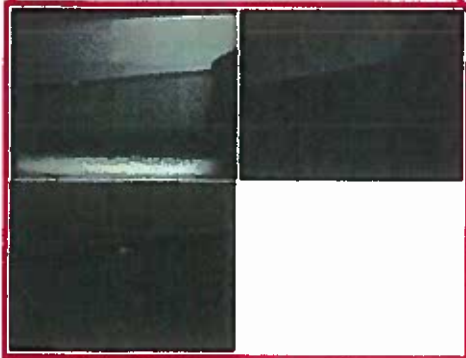
Some vehicles equipped with Display Audio may exhibit a condition where the touch screen is inoperative.

This condition may be caused by foreign object or debris stuck between the display audio screen and the faceplate. If you see any foreign object or debris (refer to the pictures below), please use paper/card with thickness less than 0.1mm (e.g. business card) to remove it.

- Radio screen/button layout can be different by model.
- Do not blow air onto the faceplate to remove the debris, compressed air sprayed on the display can cause moisture inside the radio assembly.
