2AZ-FE Engine Oil Consumption

Introduction

Some 2006 – 2011 model year vehicles equipped with the 2AZ-FE engine may exhibit engine oil consumption. The piston assembly has been changed to minimize oil consumption. Use the following Repair Procedure to address this condition.

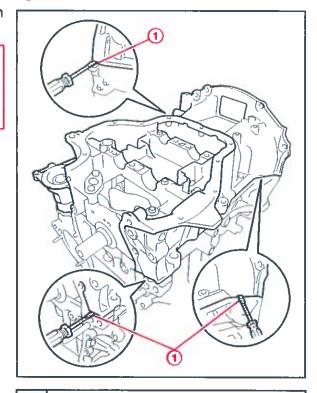
Figure 6.

(2) Using a screwdriver (with a taped tip), remove the crankcase by prying between the crankcase and cylinder block.

Protective Tape

Be careful NOT to damage the contact surfaces of the crankcase and cylinder block.

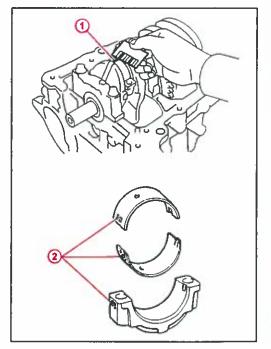
Figure 15.

- 7. Remove the 2 bolts and connecting rod cap.
- 8. Measure the Plastigage™ at its widest point.

Standard Oil Clearance: 0.024 to 0.048 mm (0.0009 to 0.0019 in.) Maximum Oil Clearance: 0.08 mm (0.0032 in.)

If replacing a bearing, replace it with one that has the same number as its respective connecting rod cap. Each bearing's standard thickness is indicated by a 1, 2, or 3 mark on its surface.

1	Plastigage™	
2	1, 2, or 3 Mark

If the oil clearance is greater than the maximum, replace the connecting rod bearings. If necessary, inspect the crankshaft.
