December 11, 2014

ATB 51811-01162 REV4 (1412)

Safety Recall: Front Passenger's Airbag Inflator Can Be Over-Pressurized

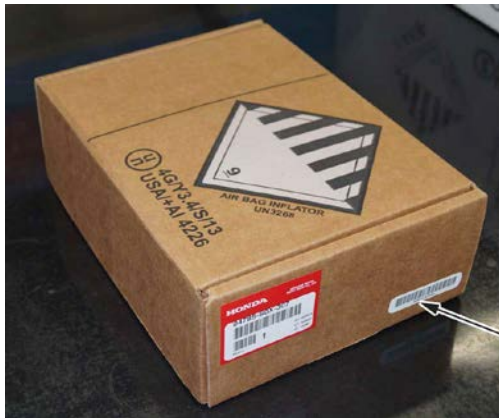
SERIAL NUMBER

- If the VIN status inquiry indicates that the vehicle is subject to any open safety recalls, including the driver's airbag inflator, make sure to also complete those recall repairs before returning the vehicle to the customer. If you are unable to complete any open recall, advise the customer of the recall status and when the recall could be completed.
 - Be careful not to damage any parts when replacing the inflator, and **follow the procedure exactly**.
 - The procedure shows the Civic/CR-V airbag. The brackets on the other vehicles are slightly different but the repair procedure is the same.
1. Write down the serial number located on the right side of the new inflator box. For the warranty claim to be paid, your warranty clerk must enter this serial number in the Diagnostic Trouble Codes field on the warranty claim.

18. Give the warranty clerk the inflator serial number that you wrote down in step 1. For the warranty claim to be paid, your warranty clerk must enter the serial number in the Diagnostic Trouble Codes field on the warranty claim.

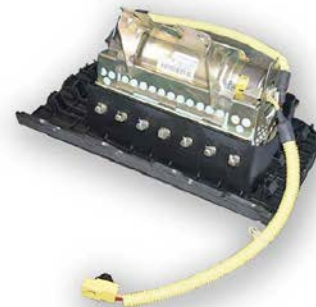
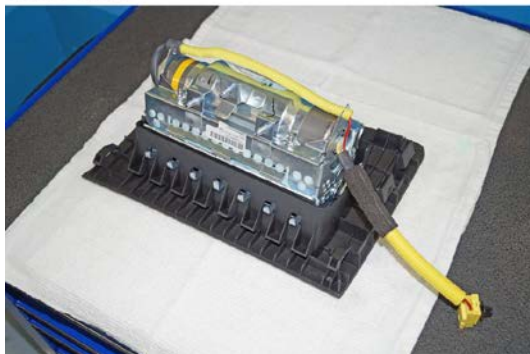
2. Remove the front passenger's airbag by referring to the applicable electronic service manual.
3. Place the airbag face-down on a clean shop towel as shown.

- The orientation of the airbag is critical because if the inflator is installed incorrectly, the harness will be too short when you reinstall the airbag.
- The brackets between the various models are similar but may differ from the example shown in the procedure.

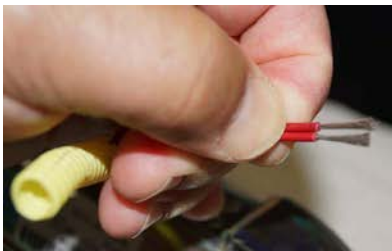
- Strip away about 1 inch of the wire insulation, then twist the wires together.

- Tape the twisted ends with electrical tape.

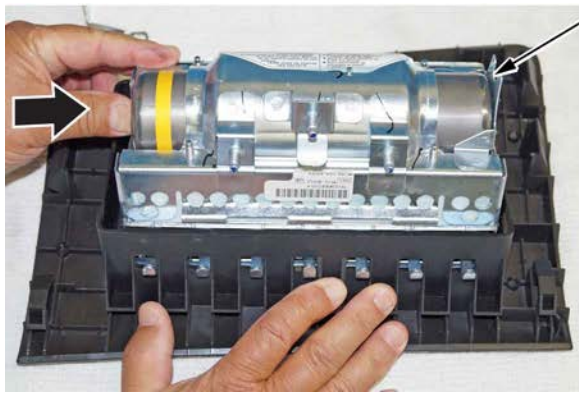
- Slide the inflator in until the “D” aligns with the tab on the inflator bracket. There should be no space or gap between the inflator and bracket.

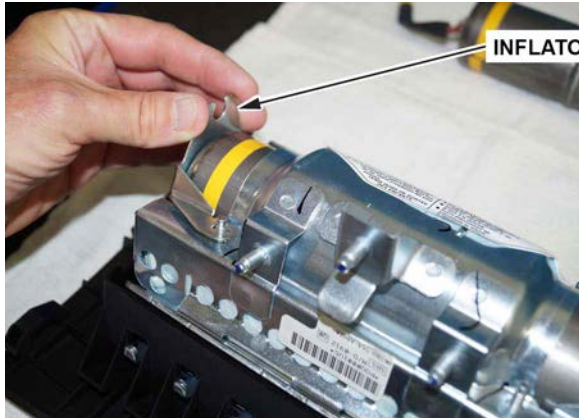
- Reinstall the inflator bracket. There should be no space or gap between the bracket and inflator.

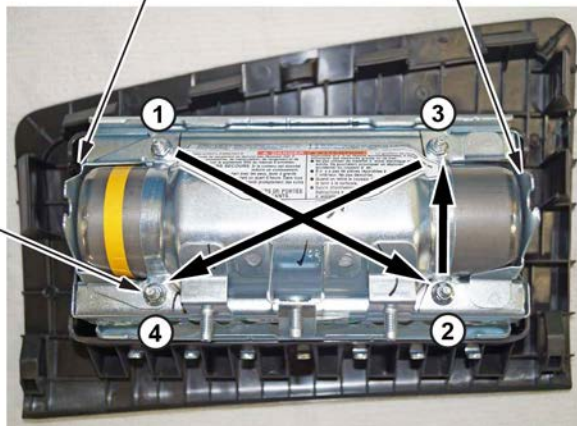
LOCK NUTS (4)
3.9 N•m (34 lb-in)

- Install the new 5 mm locknuts and torque them in sequence to **3.9 N•m (34 lb-in)**.

Be sure there are no gaps between the inflator ends and the inflator brackets.

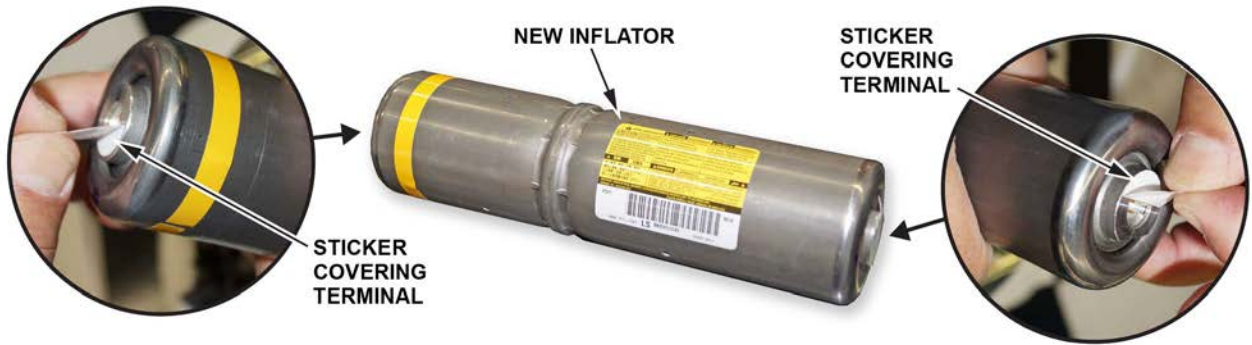
12. Remove the stickers covering the terminals on both sides of the new inflator.

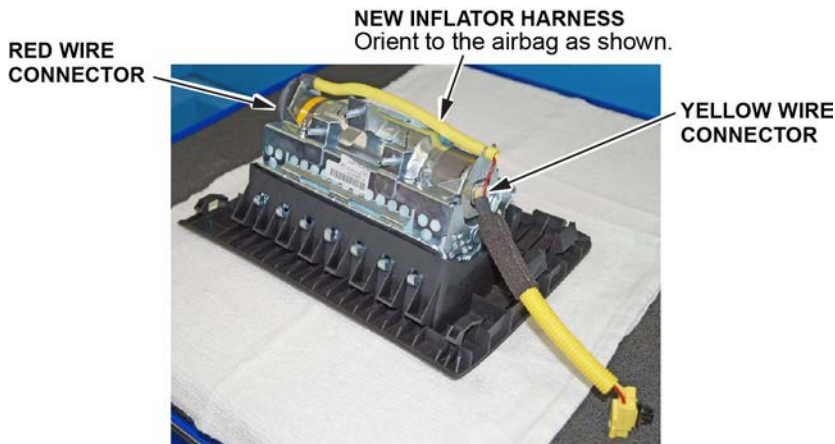
13. Install the new inflator harness.

- Make sure the airbag and harness are aligned as shown.
NOTE: Make sure you have the orientation correct as shown below. If you connect the harness incorrectly, the harness cannot be removed and you will not be able to reinstall the airbag because the harness will be too short.
