ATB 00407 (1412)

Safety Recall: Front Passenger's Airbag Inflator May Produce Excessive Pressure After Long-Term Exposure To High Absolute Humidity

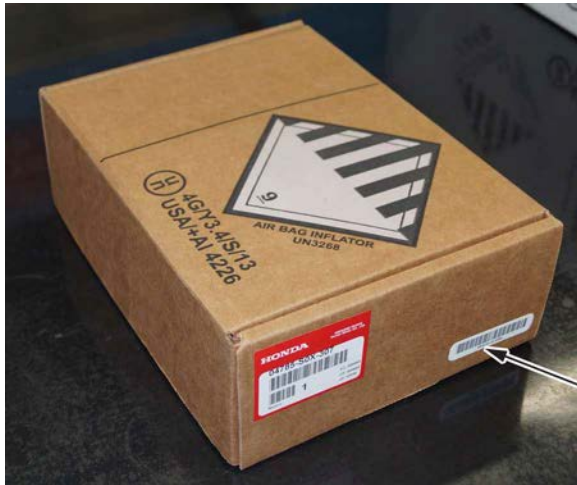
SERIAL NUMBER

- If the VIN status inquiry indicates that the vehicle is subject to any open safety recalls, including the driver's airbag inflator, make sure to also complete those recall repairs before returning the vehicle to the customer. If you are unable to complete any open recall, advise the customer of the recall status and when the recall could be completed.
 - Be careful not to damage any parts when replacing the inflator, and **follow the procedure exactly**.
 - If, before removing the airbag, you suspect that it may be the incorrect airbag for the vehicle or a counterfeit, **do not remove the airbag**. Contact your DPSM for assistance.
1. Write down the serial number located on the right side of the new inflator box. For the warranty claim to be paid, your warranty clerk must enter this serial number in the Diagnostic Trouble Codes field on the warranty claim.

19. Give the warranty clerk the inflator serial number that you wrote down in step 1. For the warranty claim to be paid, your warranty clerk must enter the serial number in the Diagnostic Trouble Codes field on the warranty claim.

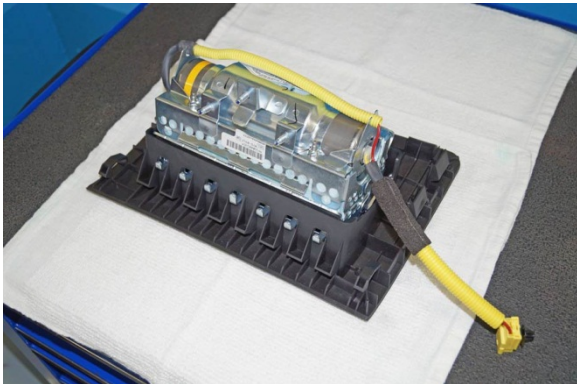
2. Remove the front passenger's airbag.
3. Place the airbag, face-down, on a clean shop towel.

- The orientation of the airbag is critical because if the inflator is installed incorrectly, the harness will be too short when you reinstall the airbag.
- The brackets between the various models are similar but may differ from the example shown.

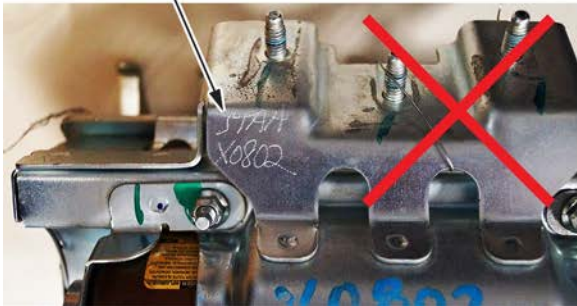
HAND ENGRAVING

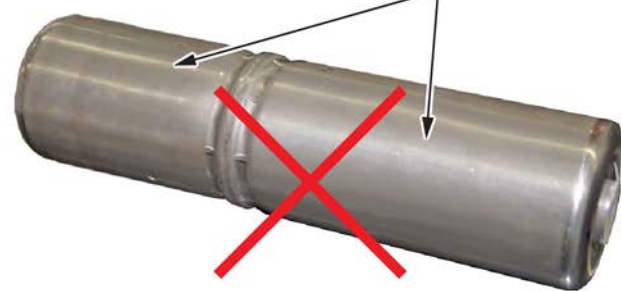
NO LABELS ON INFLATOR

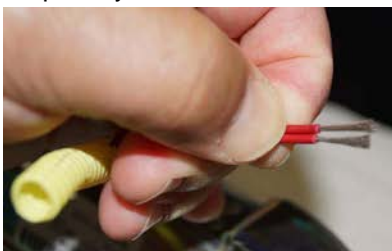
- Strip away about 1 inch of the wire insulation, then twist the wires together.

- Tape the twisted ends with electrical tape.

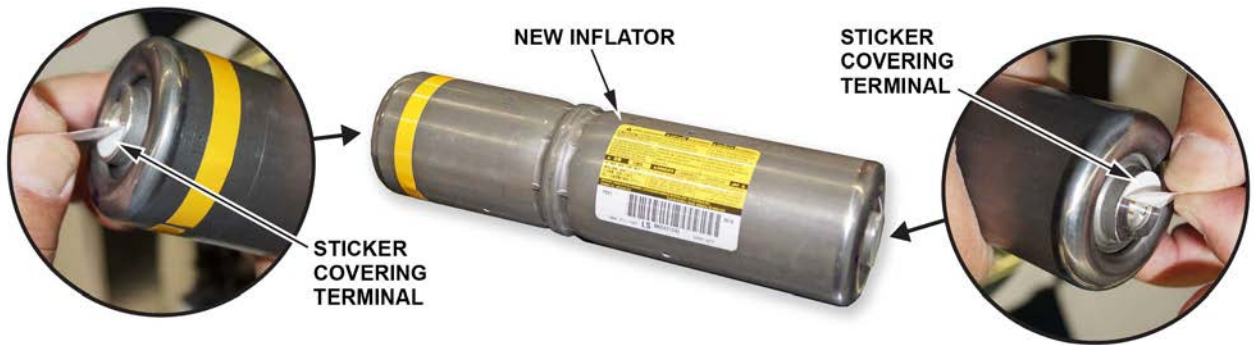
12. Remove the stickers covering the terminals on both sides of the new inflator.

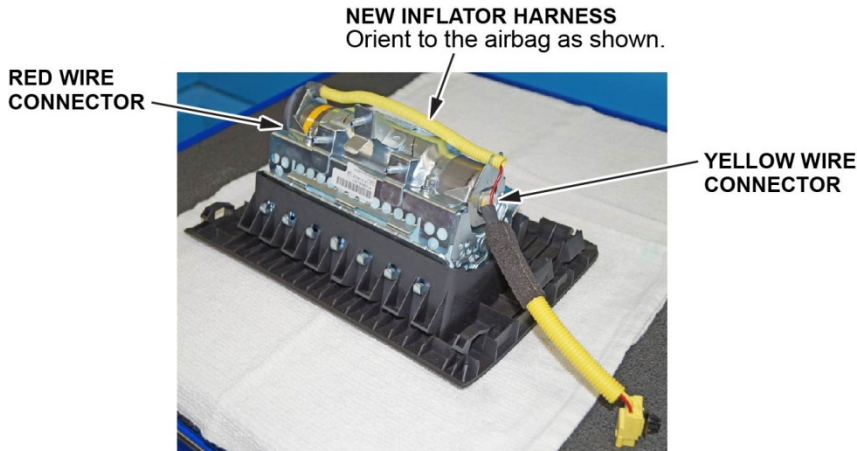
13. Install the new inflator harness.

- Make sure the airbag and harness are aligned as shown.

NOTE: Make sure you have the orientation correct as shown below. If you connect the harness incorrectly, the harness cannot be removed, and you will not be able to reinstall the airbag because the harness will be too short.

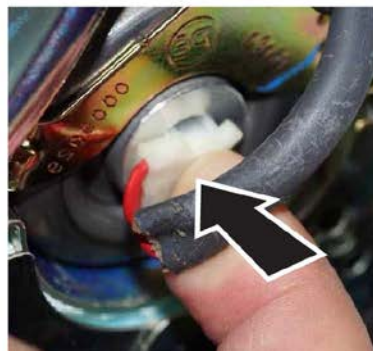
② Press the connector into place until it clicks.

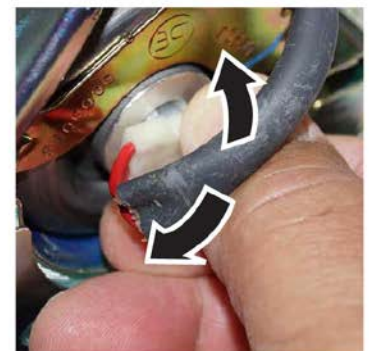
③ Wiggle the connector to make sure it's secure.

- After you hear each connector click, wiggle it to make sure it is secure.

NOTE: If the connector is not properly aligned, it will come out.
