Q627NAS1

TECHNICAL BULLETIN

Service Action: No Service Interval Required Message Displayed in the Message Center

MODEL:	MODEL YEAR:	VIN:	ASSEMBLY PLANT:
Discovery Sport (LC)	2015-2017	501001-627258	Halewood

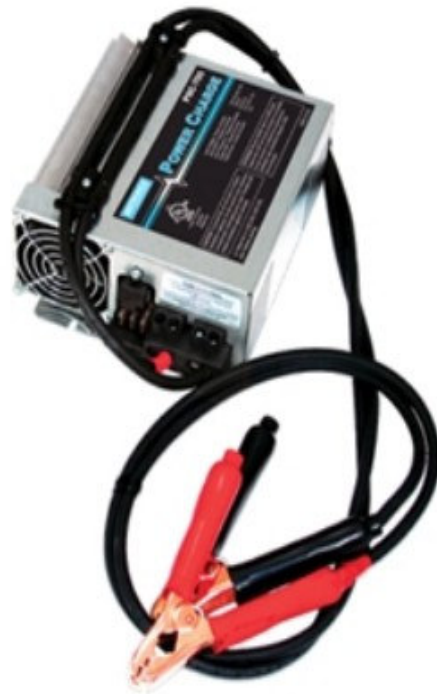
E192494

Jaguar Land Rover-approved Midtronics Battery Power Supply

E179225

Jaguar Land Rover-approved diagnostic tool with latest SDD software and Calibration File
