Service Bulletin

14-039

Steering Vibration/Moan While Turning at Idle or Low Speeds

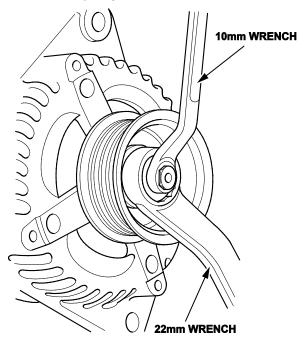
- 4. Remove the coolant reservoir, then remove the power steering fluid reservoir from the bracket.
- 5. Remove the pulley locknut with a 22 mm wrench and a 10 mm wrench, then remove the alternator pulley.

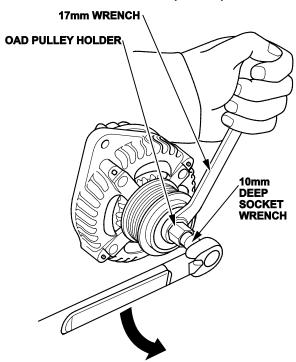
7. Hold the alternator OAD pulley holder with a 17 mm wrench. Place a 10 mm deep socket wrench through the center of the alternator OAD pulley holder onto the hex on the end of the alternator shaft, then torque the alternator shaft counterclockwise to 80 N·m (59 lb-ft).

6. Install the new decoupler alternator pulley by threading it onto the alternator shaft. Then insert the alternator OAD pulley holder into the decoupler pulley.

NOTE: The new decoupler alternator pulley is threaded internally; the nut will no longer be used.
