ATB 51811-00383 REV1(1410)

## Safety Recall: Front Passenger's Airbag Inflator Can Be Over-Pressurized

Supersedes 14-040, dated October 25, 2014, to revise the information highlighted in **yellow**

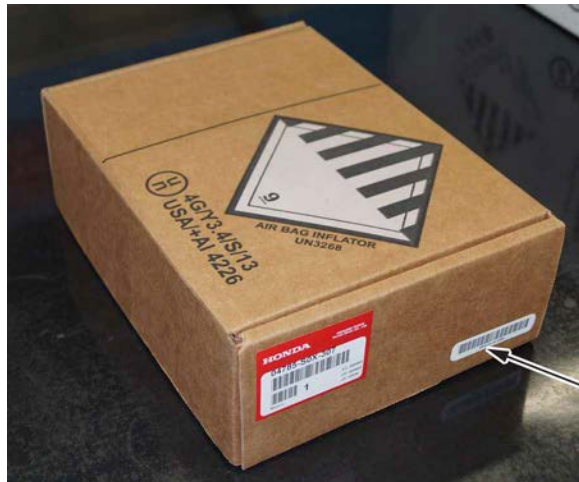
SERIAL NUMBER

- Be careful not to damage any parts when replacing the inflator, and **follow the procedure exactly**.
  - The procedure shows the Civic/CR-V airbag. The brackets on the other vehicles are slightly different but the repair procedure is the same.
1. Write down the serial number located on the right side of the new inflator box. For the warranty claim to be paid, your warranty clerk must enter this serial number in the Diagnostic Trouble Codes field on the warranty claim.

18. Give the warranty clerk the inflator serial number that you wrote down in step 1. For the warranty claim to be paid, your warranty clerk must enter the serial number in the Diagnostic Trouble Codes field on the warranty claim.

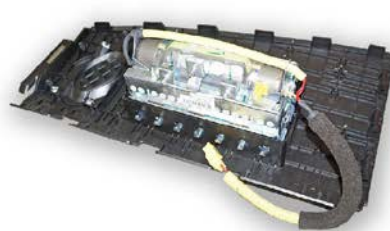
**ELEMENT**

2. Remove the front passenger's airbag by referring to the applicable electronic service manual.
3. Place the airbag face-down on a clean shop towel as shown.

- The orientation of the airbag is critical because if the inflator is installed incorrectly, the harness will be too short when you reinstall the airbag.
- The brackets between the various models are similar but may differ from the example shown in the procedure.

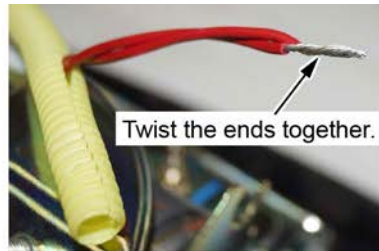
- Strip away about 1 inch of the wire insulation, then twist the wires together.

- Tape the twisted ends with electrical tape.

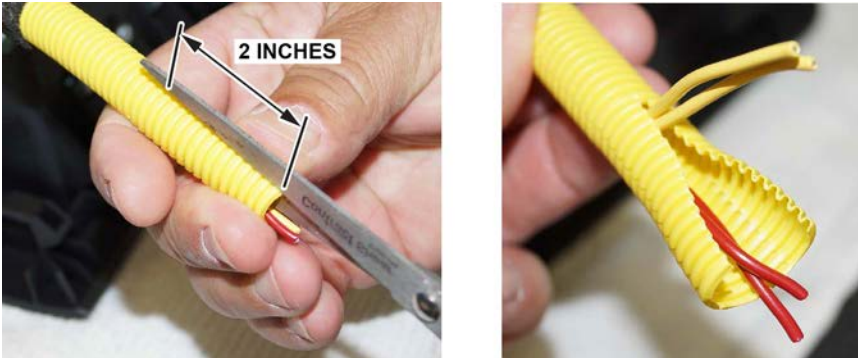
- Cut about 2 inches of the corrugated tube, then pull out the yellow wires.

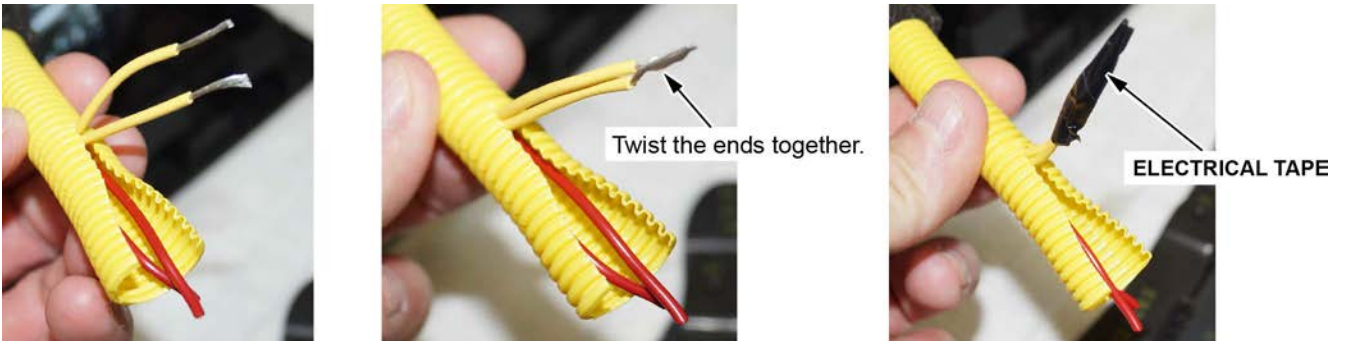
- Strip away about an inch of the wire insulation, then twist the wires together.

- Tape the twisted ends with electrical tape.

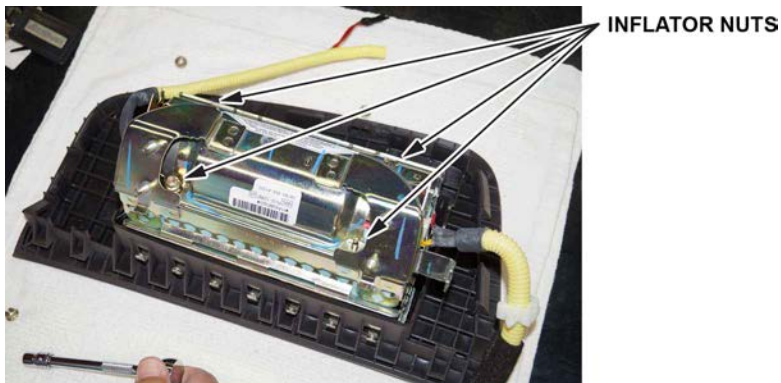
8. Remove the four inflator nuts.

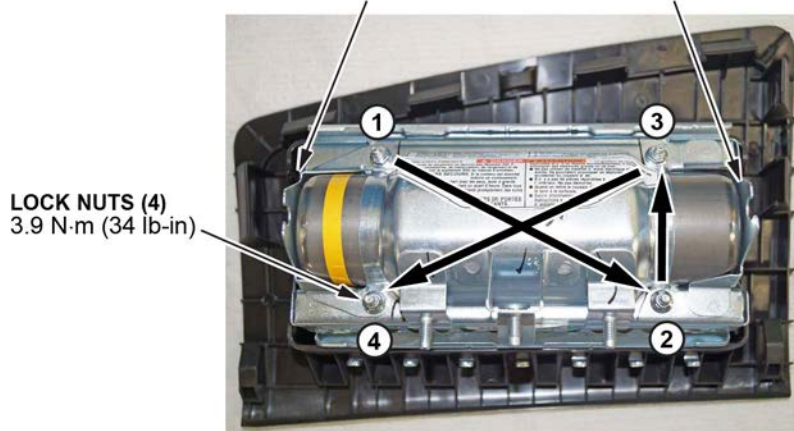
- Install the new 5 mm locknuts and torque them in sequence to **3.9 N•m (34 lb-in)**.  
Be sure there are no gaps between the inflator ends and the inflator brackets.

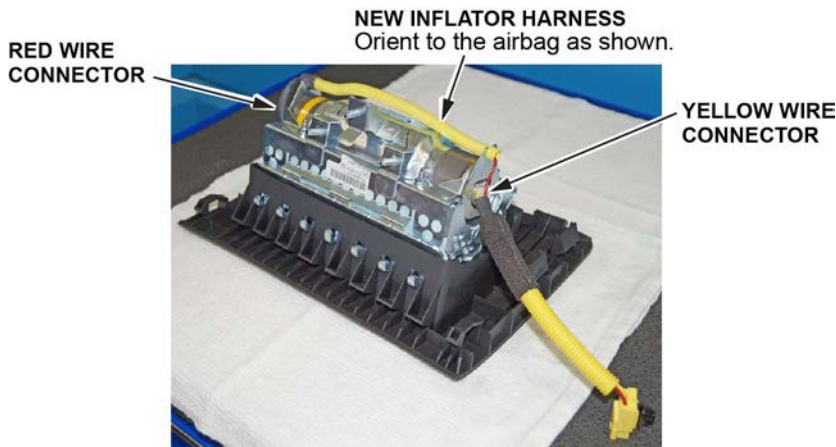
13. Install the new inflator harness.

- Make sure the airbag and harness are aligned as shown.  
**NOTE: Make sure you have the orientation correct as shown below.** If you connect the harness incorrectly, the harness cannot be removed and you will not be able to reinstall the airbag because the harness will be too short.

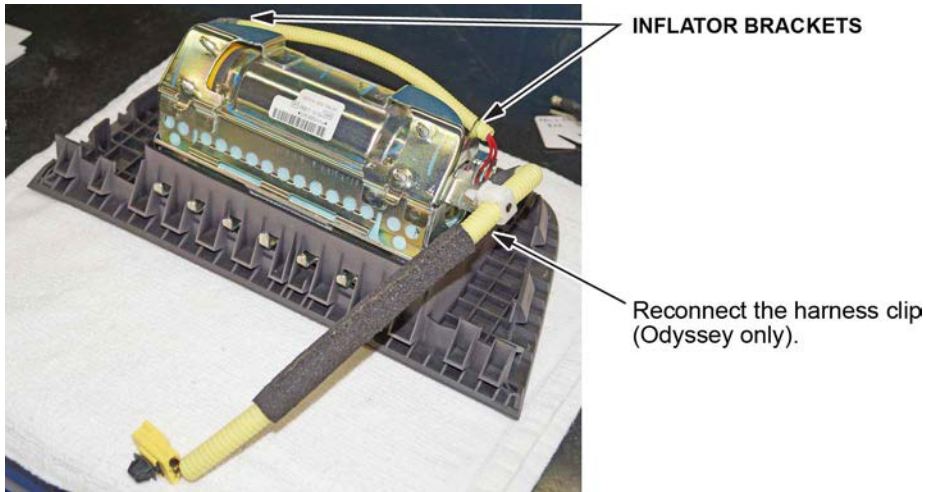
14. Connect the harness to the inflator brackets.

- Insert the side without the shrink-wrap tubing first. Insert the harness at the third “valley” in the corrugated tube.
- Insert the side of the harness with the shrink-wrap tubing into the inflator bracket. Make sure the harness is securely inserted and that it does not sag.
