BTB 00179-00238 REV1 (1410)

Noncompliance Recall: TLX Certification Label

Year	Model	Trim	VIN Range
2015	TLX	V6 AWD	Check the iN VIN status for eligibility

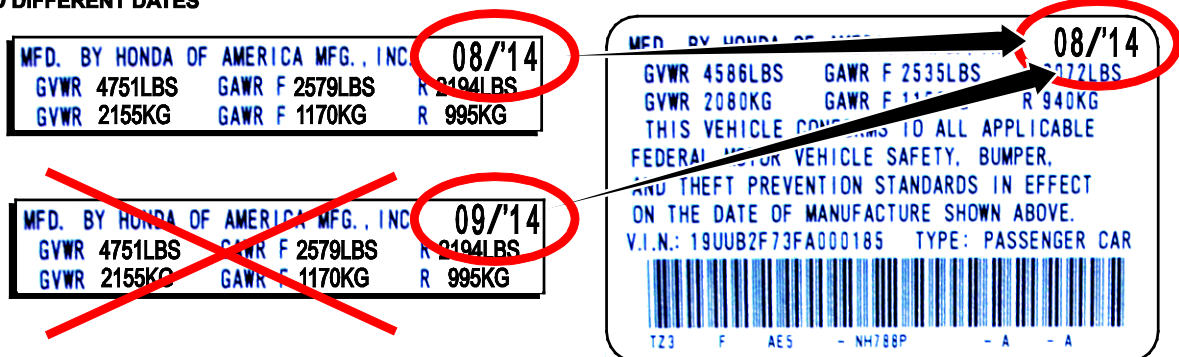
TWO DIFFERENT CORRECTION STICKERS WITH TWO DIFFERENT DATES

- Select the proper correction sticker option because there are two correction sticker options involved in this recall. One has a manufacturing date of 8/14 and the other is 9/14. **You must put the correction sticker with the same production date as the certification label.**

Match the production dates.

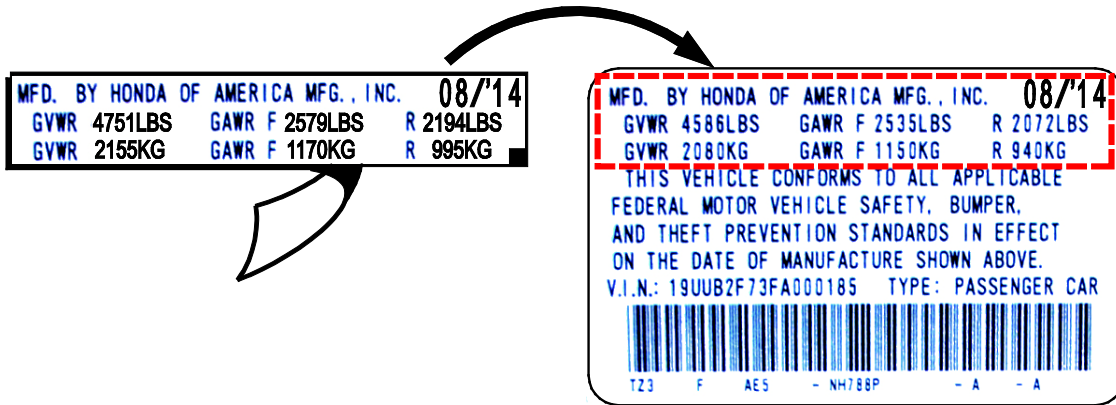
3. Peel off the backing from the correction sticker, and apply it to the certification label in the exact position shown below. Press the correction sticker firmly to make sure it sticks.

Apply a correction sticker over lines 1, 2, and 3 of the certification label on the driver's doorjamb.
