Document Number TS-WI-0249

CARB LABEL INSPECTION AND REPLACEMENT

ASSEMBLY AREA	Field Repair
MODEL	2008-2016 Model Chrysler Town and Country and Dodge Grand Caravan,
	2017 Model Dodge Grand Caravan

Some 2008-2017 Model year Chrysler Town and Country and 2017 Dodge Grand Caravans <u>built</u> <u>between from 10/28/2016 to 3/13/2017</u> may have the incorrect CARB Executive Order (EO) number typed into the VMI label attached to the fuel tank. This letter will provide inspection criteria and replacement instructions if the label is incorrect.

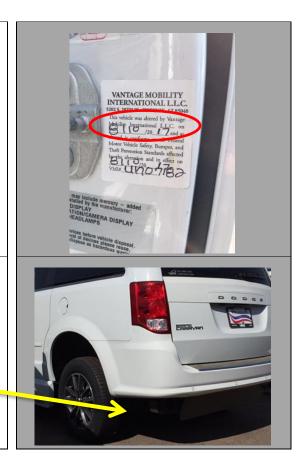
If the vehicle's VMI build date falls between 10/28/2016 to 3/13/2017 locate the fuel tank label located on the driver's side on the vehicle.

(see picture for examples)

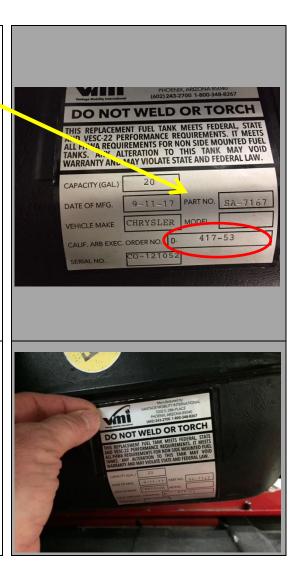
- 3) Locate the Calif. ARB EXEC. ORDER NO.
- 4) If the number is D417-53;
 YOU HAVE NO FURTHER ACTION

IF the number is NOT D417-53;

- a. take a picture of the incorrect label and contact VMI Tech Support.
- b. Send a copy of the picture along with the VIN and a request for a replacement label.
- Do Not remove the incorrect label until you have the replacement ready to install
- 5) AFTER RECEIPT of the correct label, carefully remove the discrepant label using your fingers or a PLASTIC PUTTY KNIFE

Do NOT use any tool that can cause damage to the tank or generate any sparks
