ATB 00284 (1410)

Clunk/Rattle From Front Suspension or Under Dash When Driving Over Bumps or Turning

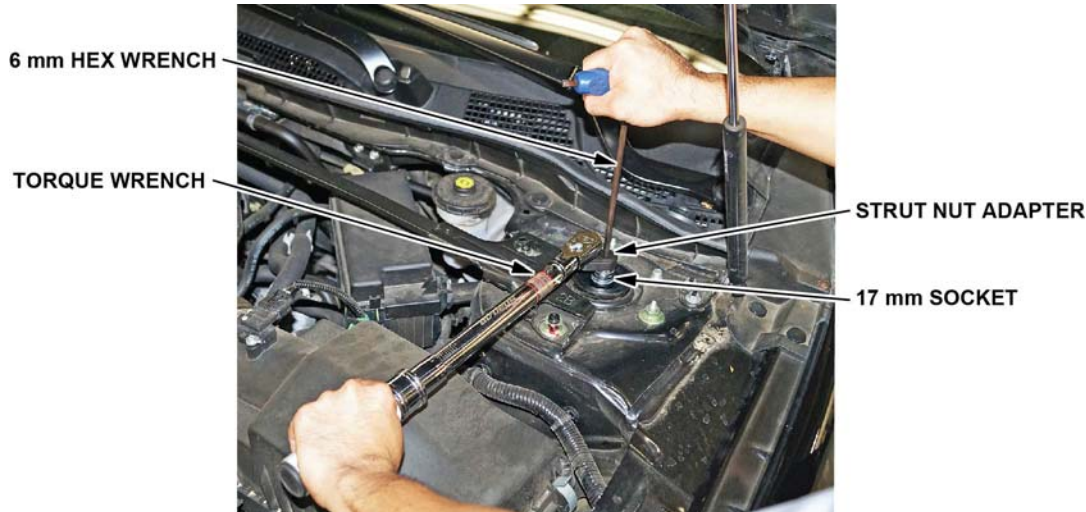
1. Test-drive the vehicle to confirm if the clunk or rattle is coming from the front suspension. The noise may also sound like it is coming from under the dash.
2. Check the torque of the two self-locking nuts located at the top of the front damper/spring assemblies using a 6mm hex wrench, 17mm socket, strut nut adapter, and a torque wrench set to **44 N·m (32 ft-lb)**.
 - If the nuts are properly torqued and do not move, this bulletin does not apply. Continue with normal troubleshooting.
 - If either nut is loose, go to step 3.

3. Remove the loose self-locking nut(s), install new a self-locking nut(s) and torque them to **44 N·m (32 ft-lb)** using a 6mm hex wrench, 17mm socket, strut nut adapter, and a torque wrench.
