ATB 51811-00413 REV3(1411)

Safety Recall: Front Passenger's Airbag Inflator Can Be Over-Pressurized

Supersedes 14-040, dated October 31, 2014, to revise the information highlighted in **yellow**

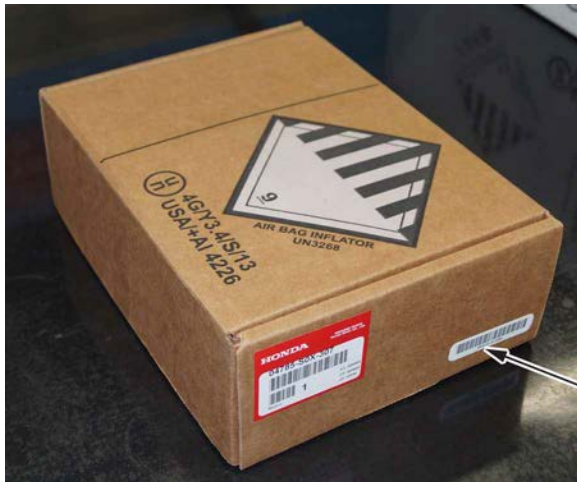
SERIAL NUMBER

- Be careful not to damage any parts when replacing the inflator, and **follow the procedure exactly**.
 - The procedure shows the Civic/CR-V airbag. The brackets on the other vehicles are slightly different but the repair procedure is the same.
1. Write down the serial number located on the right side of the new inflator box. For the warranty claim to be paid, your warranty clerk must enter this serial number in the Diagnostic Trouble Codes field on the warranty claim.

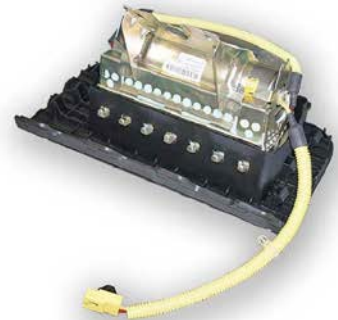
PILOT

2. Remove the front passenger's airbag by referring to the applicable electronic service manual.
3. Place the airbag face-down on a clean shop towel as shown.

- The orientation of the airbag is critical because if the inflator is installed incorrectly, the harness will be too short when you reinstall the airbag.
- The brackets between the various models are similar but may differ from the example shown in the procedure.

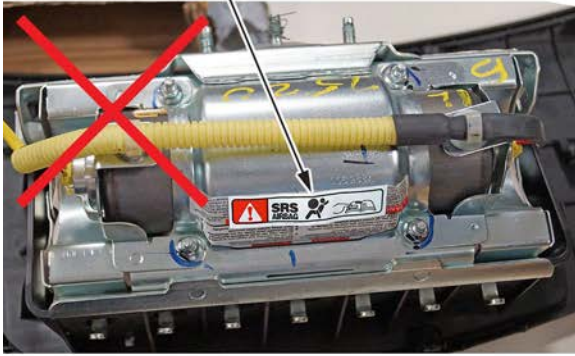
NON-STANDARD SAFETY LABEL

4. Visually inspect the airbag and the inflator for any unusual writing or markings.

- If there is nothing unusual about the airbag or the inflator, go to step 5.
- If there are any unusual markings, like an incorrect label or a model year written in marker, the airbag and inflator may not be the correct airbag and/or inflator for the vehicle or it may be a counterfeit part. For more information about counterfeit airbags, you can refer to safercar.gov, enter keywords **MANAGING COUNTERFEIT**, and select **Recommended Dealer Guidance for Managing Counterfeit Air Bags** from the list. **If you suspect that the airbag or inflator is counterfeit, do not continue this procedure.** Contact your DPSM for assistance.

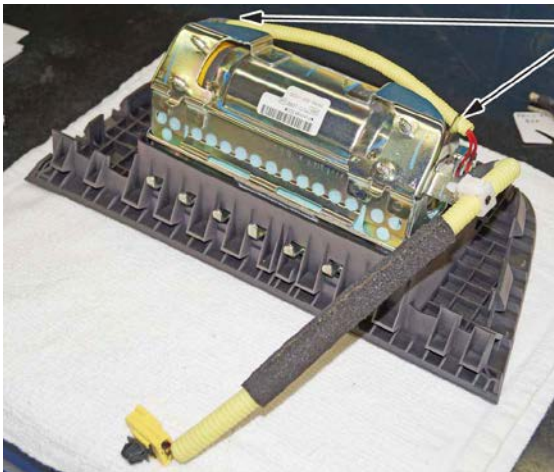
INFLATOR BRACKETS

5. Remove the harness from both ends of the inflator bracket.

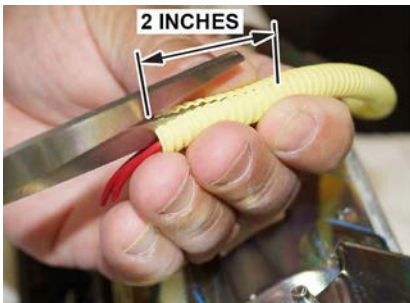
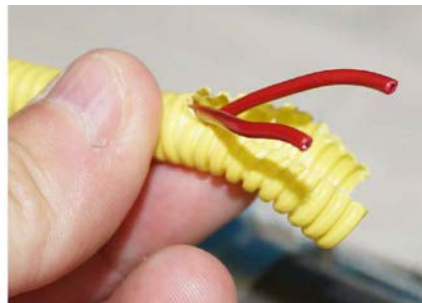
- Cut about 2 inches of the corrugated tube, then pull out the two red wires.

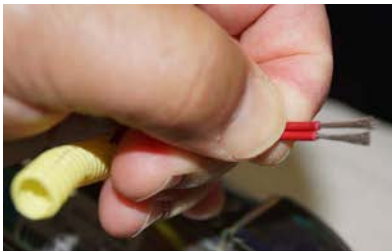
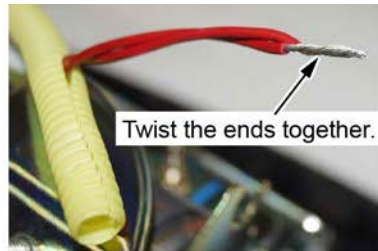
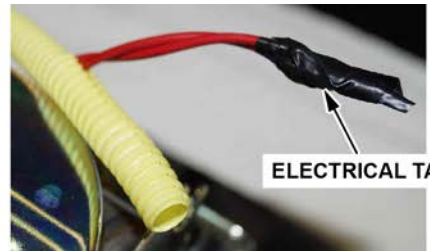
- Strip away about 1 inch of the wire insulation, then twist the wires together.

- Tape the twisted ends with electrical tape.

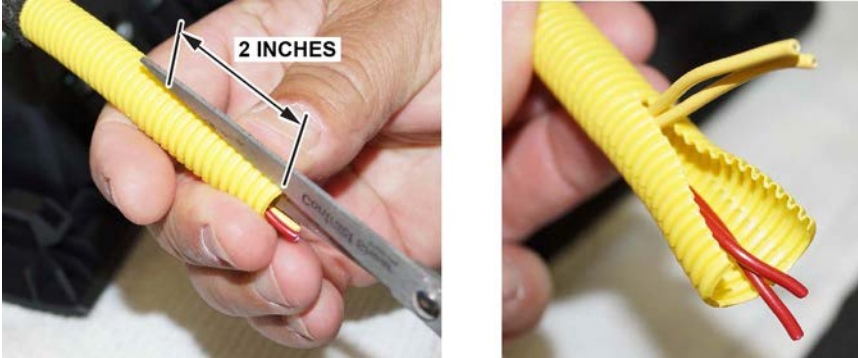
- Cut about 2 inches of the corrugated tube, then pull out the yellow wires.

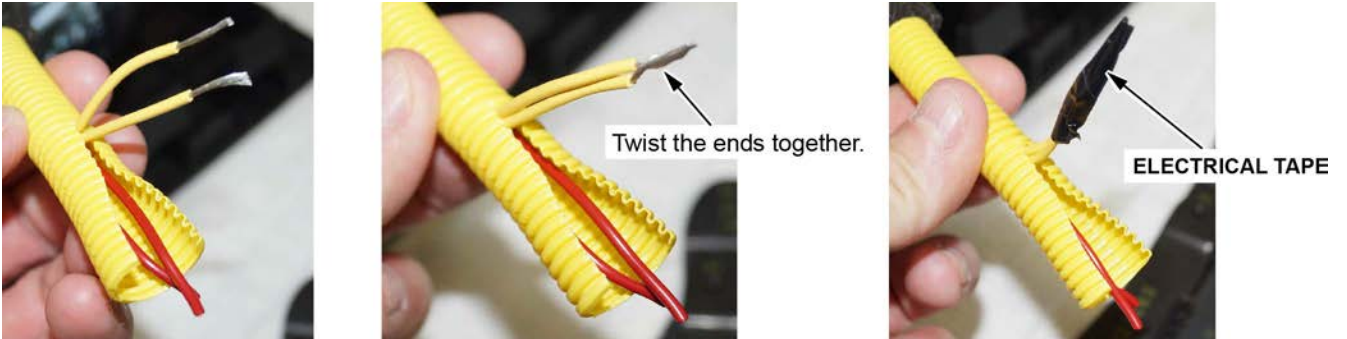
- Strip away about an inch of the wire insulation, then twist the wires together.

- Tape the twisted ends with electrical tape.

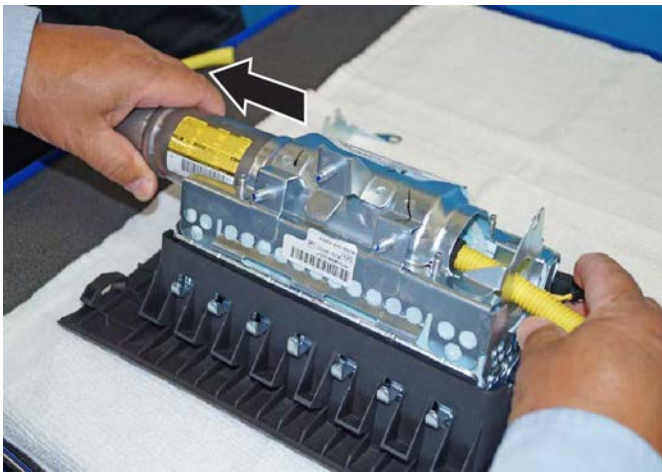
10. Remove the inflator by pushing it out.

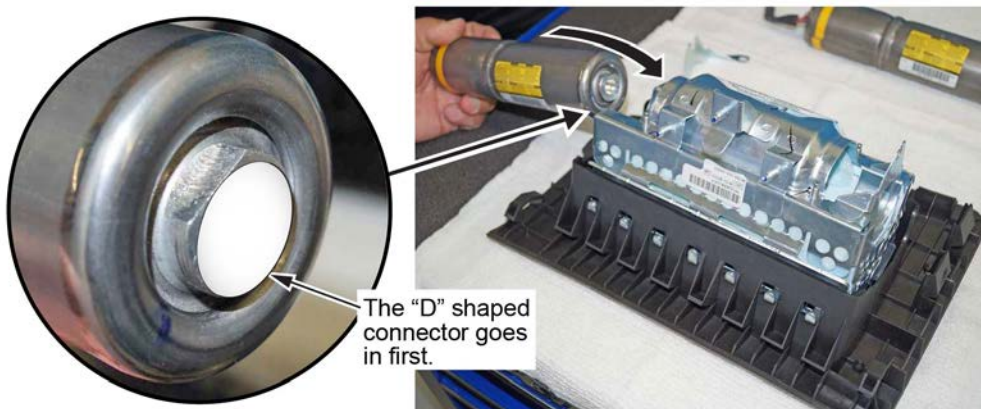
11. Install the new inflator.

- One connector looks like a "D" whereas the other connector is a circle. Make sure you insert the "D" connector into the airbag first.

NOTE: There is a yellow band marking on the circle side.

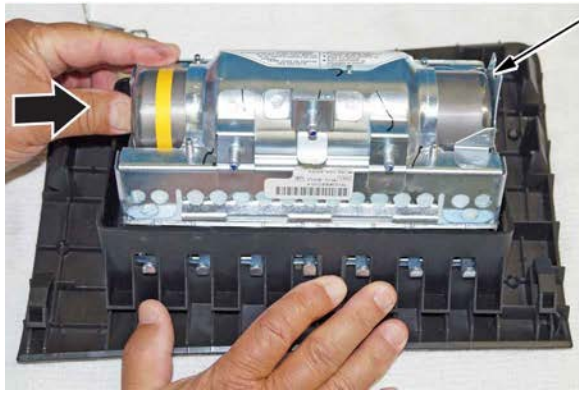
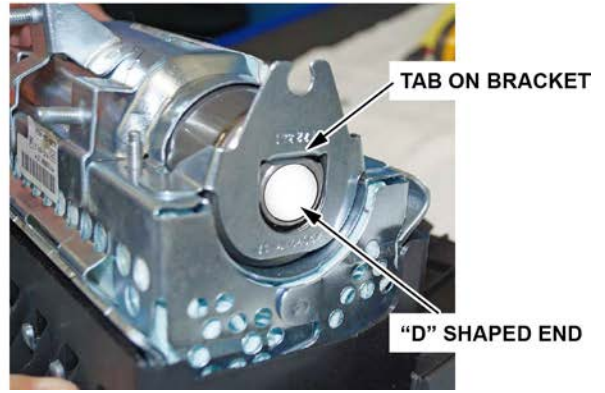
- Slide the inflator in until the “D” aligns with the tab on the inflator bracket. There should be no space or gap between the inflator and bracket.

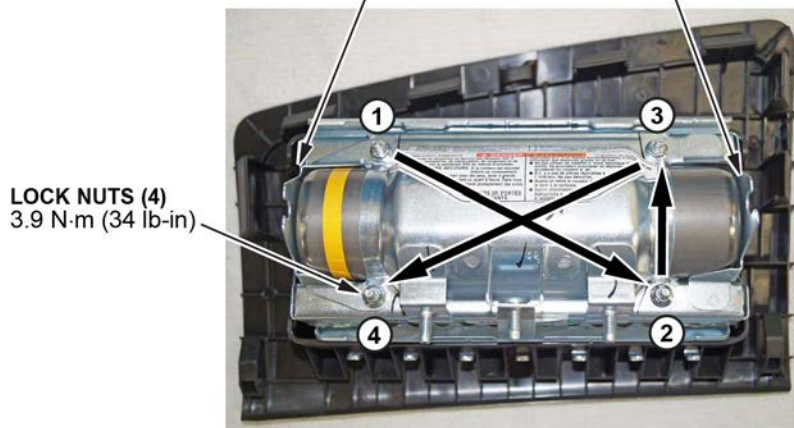
- Install the new 5 mm locknuts and torque them in sequence to **3.9 N•m (34 lb-in)**.
Be sure there are no gaps between the inflator ends and the inflator brackets.

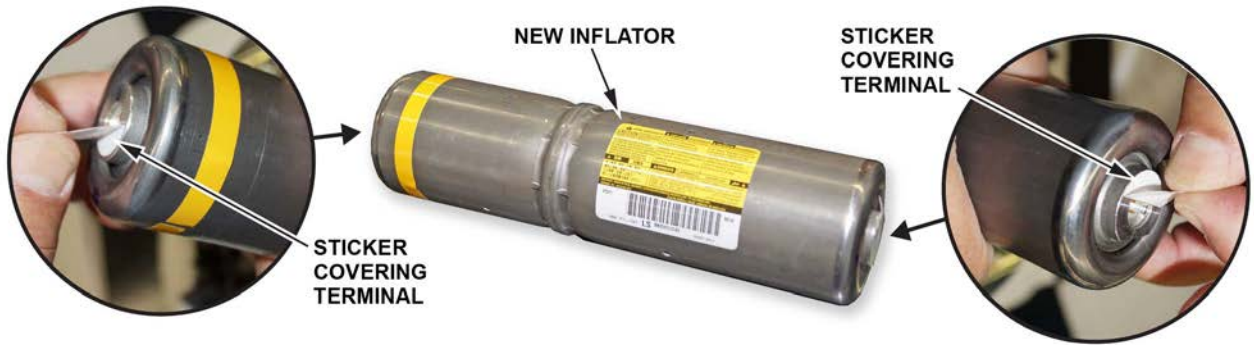
12. Remove the stickers covering the terminals on both sides of the new inflator.

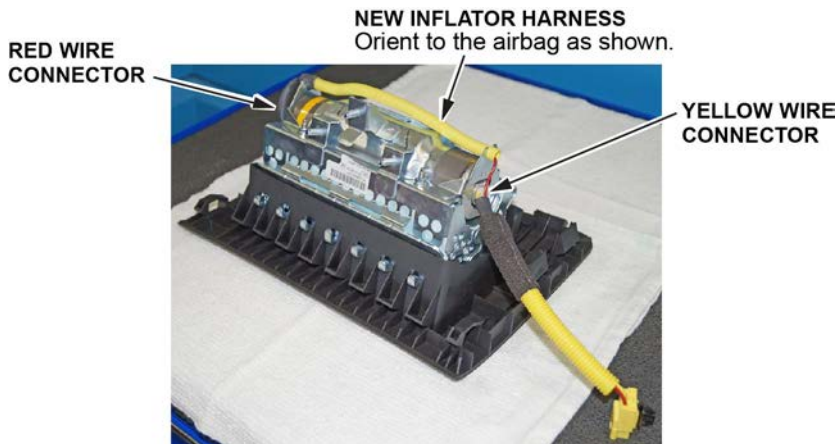
13. Install the new inflator harness.

- Make sure the airbag and harness are aligned as shown.
NOTE: Make sure you have the orientation correct as shown below. If you connect the harness incorrectly, the harness cannot be removed and you will not be able to reinstall the airbag because the harness will be too short.

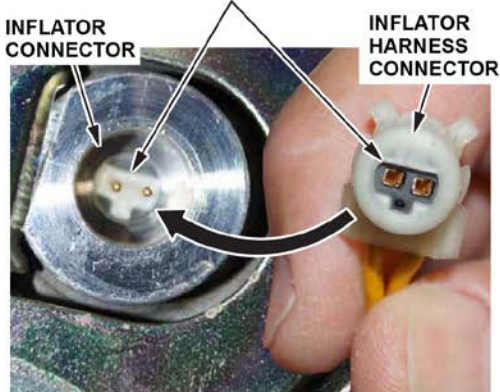
- Connect the two connectors. **Align the “T” shape in the inflator harness connector with the T-shaped inflator connector**, then press the connector into place.

① Match up the “T” shape as shown. The connectors are directional.

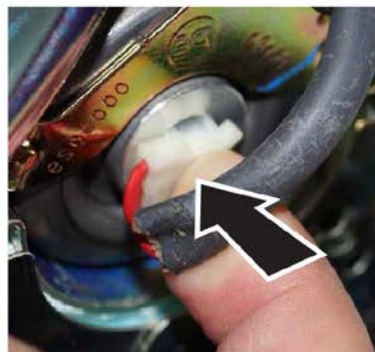
② Press the connector into place until it clicks.

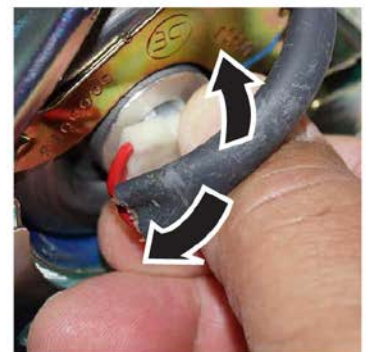
③ Wiggle the connector to make sure it's secure.

- After you hear each connector click, wiggle it to make sure it is secure.
NOTE: If the connector is not properly aligned, it will come out.
