Technical Service Bulletin

24BN UPDATE – ECM Software Update (FED_EMS)

June 16, 2015

Model(s)	Year	VIN Range	Vehicle-Specific Equipment
A6, A7, A8	2015 – 2016	See Campaign/Action screen in Elsa	3.0L TFSI

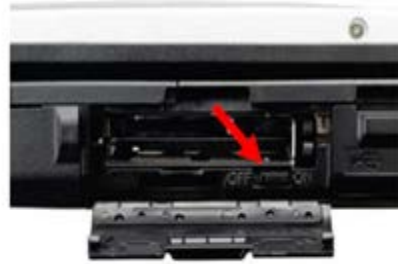
VAS 6150 & VAS 6150A
(Front panel behind handle)

The Bluetooth function of the scan tool **MUST BE PHYSICALLY SWITCHED OFF** prior to performing this update. <See pictures>
