Technical Service Bulletin

24BN UPDATE – ECM Software Update (FED_EMS)

Model(s)	Year	VIN Range	Vehicle-Specific Equipment
A6, A7, A8	2015 – 2016	See Campaign/Action screen in Elsa	3.0L TFSI

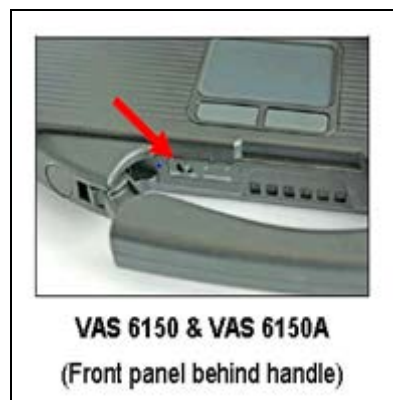
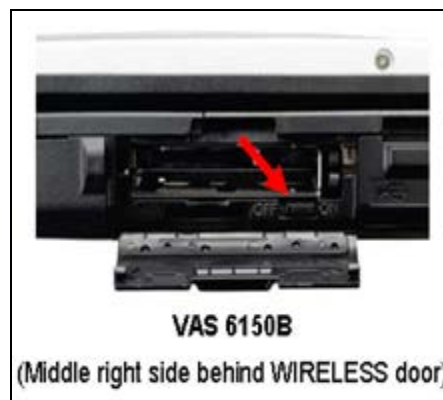
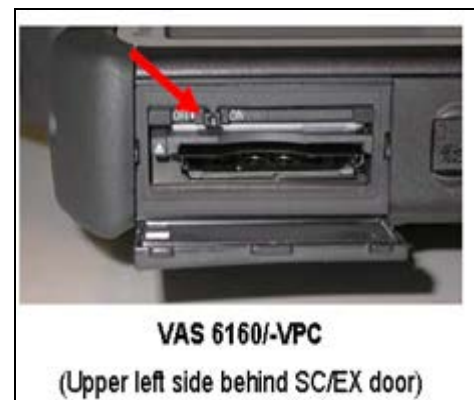
The Bluetooth function of the scan tool **MUST BE PHYSICALLY SWITCHED OFF** prior to performing this update. <See pictures>

If the Bluetooth wireless VAS 5054A transmitter head is used in conjunction with a VAS tester, the transmitter head **MUST BE** connected with a USB cable to the tester.
