# Technical Service Bulletin

## 90I7 UPDATE – Instrument Cluster Software Update (NVLW)

June 16, 2015

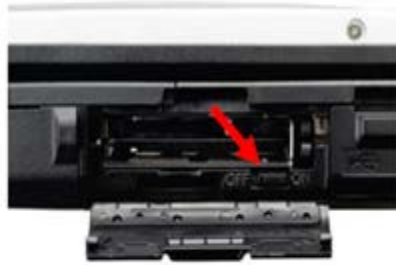
**VAS 6150 & VAS 6150A**  
(Front panel behind handle)

The Bluetooth function of the scan tool **MUST BE PHYSICALLY SWITCHED OFF** prior to performing this update. <See pictures>
