# Technical Bulletin

26 16 02 March 31, 2016 2039436 Supersedes Technical Bulletin V261601 dated February 25, 2016 to include AdBlue® part number.

**AdBlue® Warning and or MIL ON – AdBlue® Leakage at Reductant Injector**

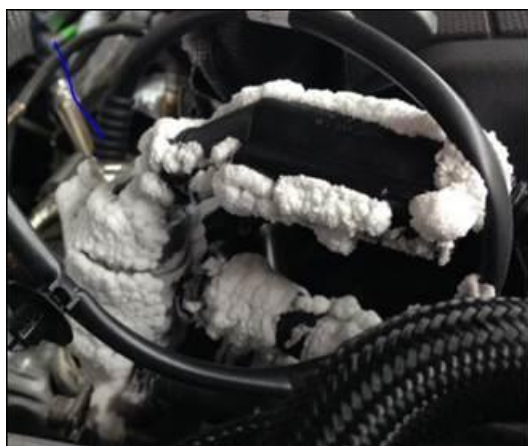
Welding process issues of the reductant line connector to the supply line may cause AdBlue® leakage at the reductant injector.

Inspect the connection of the reductant supply line connector at the reductant injector in the engine compartment. If white crystallized (dried) AdBlue® is found at the reductant injector (see Figure 1 & 2), it will be necessary to replace the reductant supply line.

Thoroughly clean the area of the reductant supply line connection with water to remove the crystallized AdBlue®.  
Replace the reductant supply line.

It is not necessary to replace the reductant injector.
