Tech Tips

TT 27-11-02

2011-2015 Jetta Sedan, 2012-2015 Passat, 2012-2015 Beetle,
2013-2015 Beetle Convertible – No Charging System Voltage

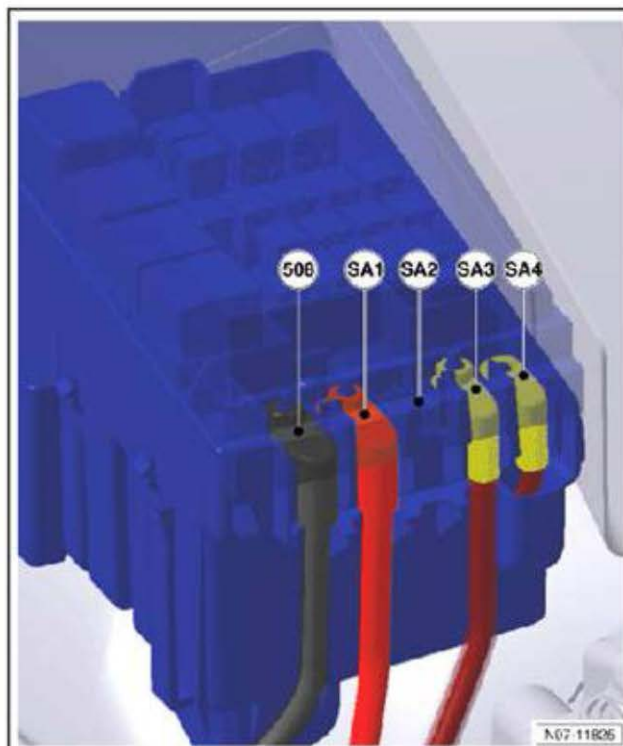
Location of Fuses (SA), on electronics box

When diagnosing a low battery or no charging system concern, start by inspecting the SA1 200 amp fuse in the SA fuse block. **DO NOT replace the generator.** Perform a voltage drop test between threaded connections 508 and SA1 as shown in Figure 1. If the voltage drop is above .02V, disconnect the battery and remove the cables at the 508 connection and the SA1 connection. Check for continuity of the threaded plate connection between 508 and SA1. If fuse SA1 is found to have an open circuit, replace the fuse and check the threaded connections closely.

Torque Settings

⇒ Electrical System, Repair Group 97, Removing and Installing Fuse Panel
