NUMBER: 23-053-16

Hemi Emblems Installed On Vehicles Equipped with A 3.6L Engine

2017 (DS) Ram 1500 Pickup

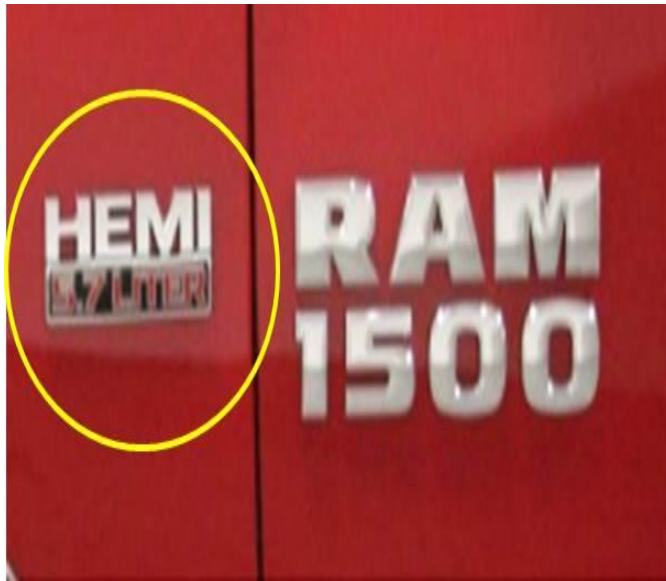
Fig. 1 HEMI Emblem

Customers may notice Hemi emblems on the front fenders (Fig. 1) of their 3.6L engine and midnight package (Sales Code 22Q) vehicle.

1. If the vehicle has Hemi emblems installed and the vehicle does not have a Hemi engine, the emblem will need to be removed.

2. Remove the Hemi emblems on the front fenders.
 - a. If temperature is below 21°C (70°F), warm emblem with a heat lamp/gun. Do not exceed 52°C (120°F) when heating emblem for removal.
 - b. Using a trim removal tool or equivalent, carefully remove the name plate from the body panel as necessary.
 - c. Thoroughly clean all residue from the name plate attachment areas of the body.
 - d. Wipe the attachment areas with a clean, lint-free cloth moistened with a 50% solution of water and alcohol. Wipe dry the areas immediately with a dry, lint-free cloth.
