Technical Service Bulletin

46 S4 and S5 squealing from front brakes (PR-1LJ)

46 14 89 2027636/8 July 21, 2014. Supersedes Technical Service Bulletin Group 46 number 14-73 dated March 12, 2014 for reasons listed below.

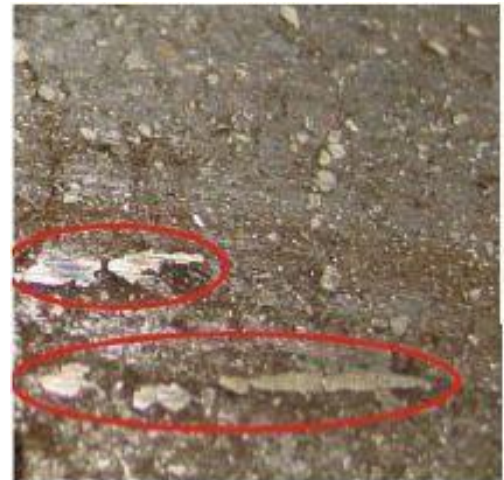
Figure 1. *Metallic deposits.*

- Foreign bodies between brake disc and brake pad, such as small stones, grit, or sand.
- Un-ground or corroded friction materials.
- Brake discs or brake pads are close to their wear limit. (Front brake disc wear limit: 28mm. Front brake pads wear limit with backing plate and dampening sheet: 10 mm.)
- Metallic deposits from disc material in brake pad (Figure 1).

- Deposits in brake pad.
