# Technical Bulletin

53 15 02 May 21, 2015 2040536 Supersedes Technical Bulletin V531501 dated April 29, 2015 to correct A5 Jetta side panel part number.

### Rear Quarter Panel Corrosion (U.S. Only)

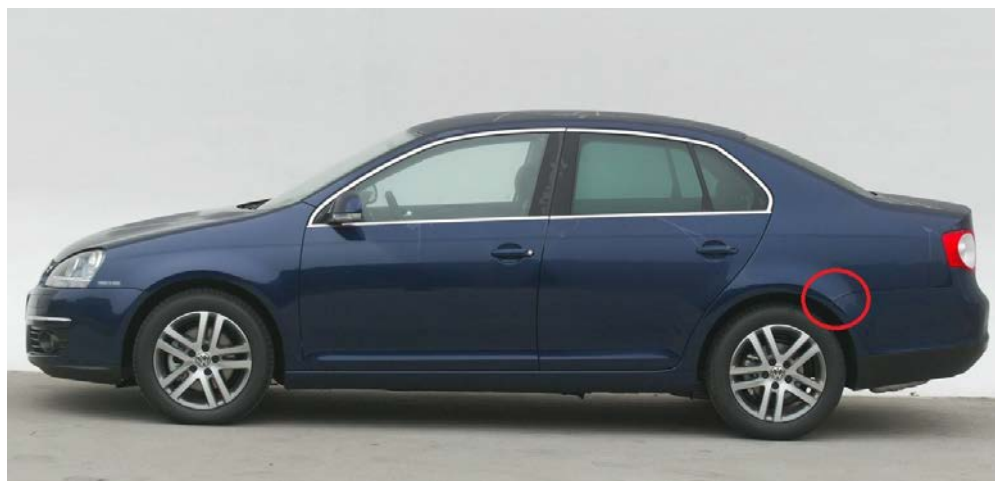
Figure 1

Corrosion is found where the rear bumper cover meets the quarter panel.

1a. Repair rear quarter panel.

1b. Replace rear quarter panel (Only if through-corrosion is present or if the repair cost is 80% or more of the replacement cost).

2. Replace the speed nut (N 906 988 03) on the bumper cover (both sides).

3. Apply the paint protection film (AKL 448 300 04) to the contact area of the quarter panel as shown in Figure 3 (both sides).

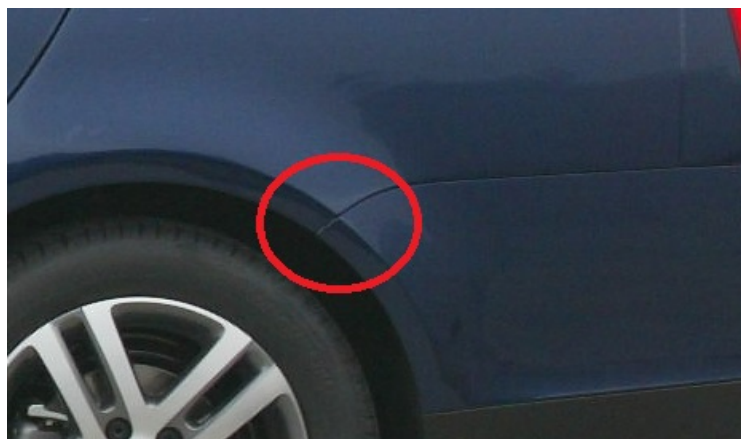
Figure 2

A Speed nut is used to assemble the rear bumper cover to the rear quarter panel. Relative movement between this metal speed nut and the quarter panel scratches away the paint and/or the corrosion protection (Figure 2).
