Technical Service Bulletin

45E1 UPDATE – ESP Control Module Software Update (NVLW)

October 6, 2015

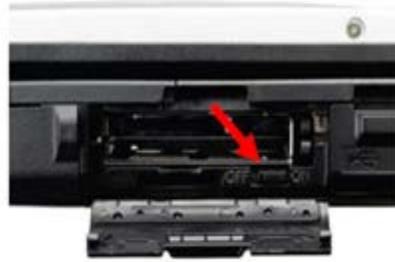
VAS 6150 & VAS 6150A
(Front panel behind handle)

The Bluetooth function of the scan tool **MUST BE PHYSICALLY SWITCHED OFF** prior to performing this update. <See pictures>
