ATB 51968-52554 REV1 (1409)

Recall: Front Passenger's Airbag Inflator May Produce Excessive Pressure After Long-Term Exposure To High Absolute Humidity

(Supersedes 14-046, dated July 23, 2014; parts, warranty, and repair information have been added. Make sure to read this bulletin in its entirety)

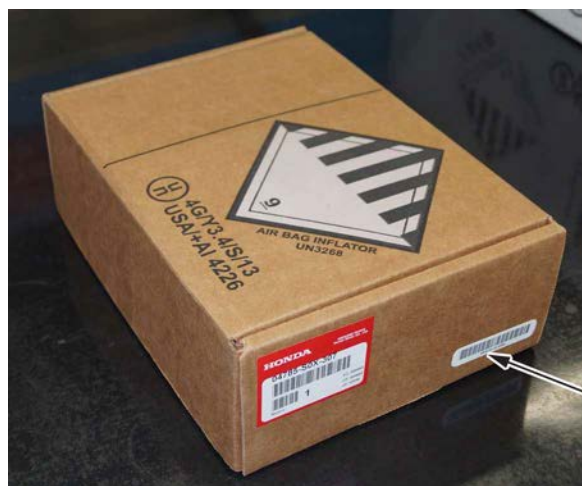
SERIAL NUMBER

- Be careful not to damage any parts when replacing the inflator, and **follow the procedure exactly**.
 - If, before removing the airbag, you suspect that it may be the incorrect airbag for the vehicle or a counterfeit, **do not remove the airbag**. Contact your DPSM for assistance.
- Write down the serial number located on the right side of the new inflator box. For the warranty claim to be paid, your warranty clerk must enter this serial number in the Diagnostic Trouble Codes field on the warranty claim.

19. Give the warranty clerk the inflator serial number that you wrote down in step 1. For the warranty claim to be paid, your warranty clerk must enter the serial number in the Diagnostic Trouble Codes field on the warranty claim.

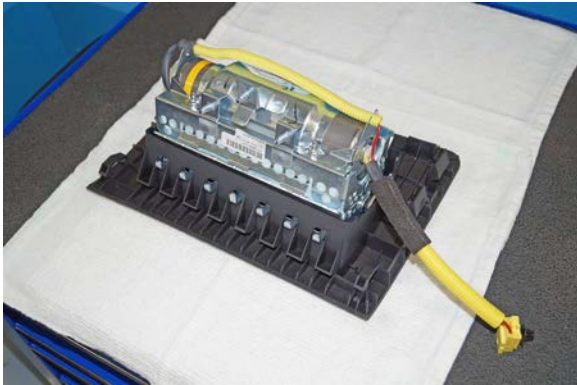
2. Remove the front passenger's airbag.
3. Place the airbag, face-down, on a clean shop towel.

- The orientation of the airbag is critical because if the inflator is installed incorrectly, the harness will be too short when you reinstall the airbag.
- The brackets between the various models are similar but may differ from the example shown.

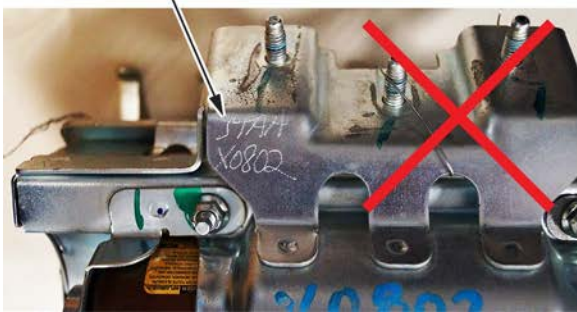
4. Visually inspect the airbag and the inflator for any unusual writing or markings.
 - If there is nothing unusual about the airbag or the inflator, go to step 5.
 - If there are any unusual markings, like an incorrect label or a model year written in marker, the airbag and inflator may not be the correct airbag and/or inflator for the vehicle or it may be a counterfeit part. For more information about counterfeit airbags, you can refer to safercar.gov, enter keywords **MANAGING COUNTERFEIT**, and select **Recommended Dealer Guidance for Managing Counterfeit Air Bags** from the list. **If you suspect that the airbag or inflator is counterfeit, do not continue this procedure.** Contact your DPSM for assistance.

HAND ENGRAVING

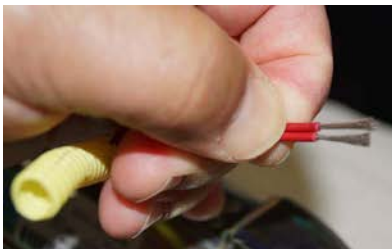
- Strip away about 1 inch of the wire insulation, then twist the wires together.

- Tape the twisted ends with electrical tape.

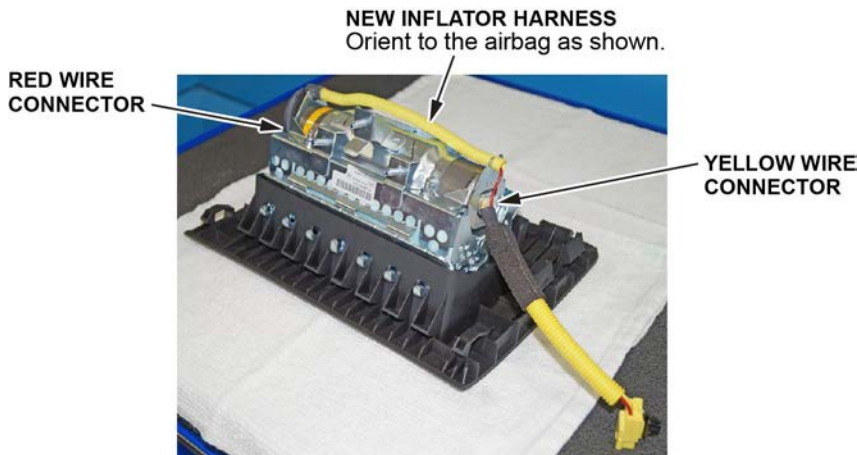
13. Install the new inflator harness.

- Make sure the airbag and harness are aligned as shown.
NOTE: Make sure you have the orientation correct as shown below. If you connect the harness incorrectly, the harness cannot be removed, and you will not be able to reinstall the airbag because the harness will be too short.
