Service Bulletin

Bulletin No.: 17-NA-237

Subject: Wet Floor or Interior Water Leak due to HVAC Drain Hose

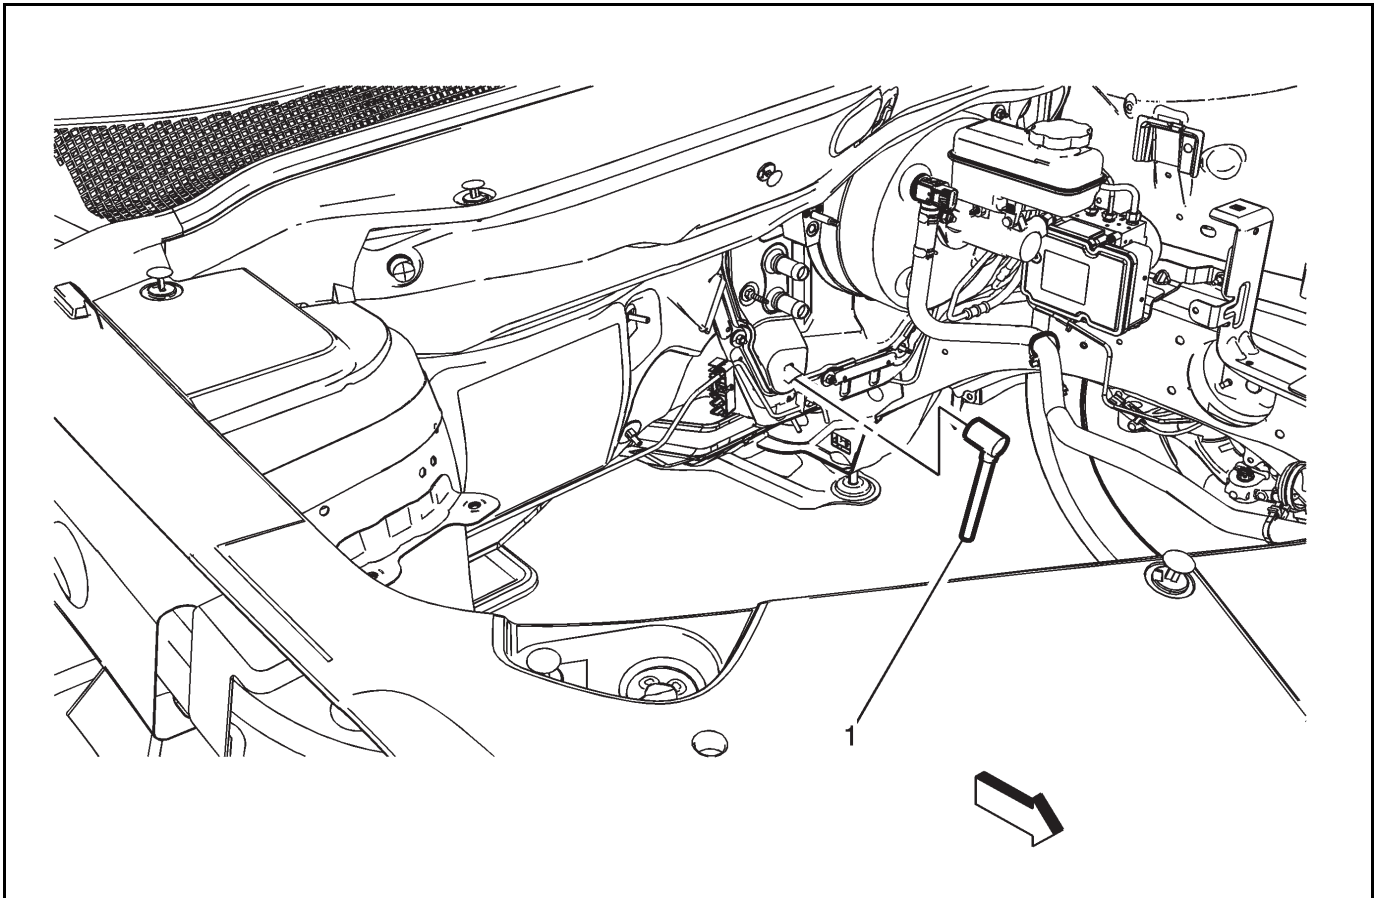
2912899

Involved Region or Country	North America, Middle East, Israel
Condition	Some customers may comment on an interior water leak and/or the floor is wet. During diagnosis a technician may find that the leak is due to the HVAC drain hose.
Cause	This may be due to the older design drain hose being a smaller diameter that is prone to clogging.
Correction	Replace the drain hose with newly designed drain hose.

If you encounter a vehicle with the above concern, replace the drain hose. Refer to *Air Conditioning Evaporator and Blower Module Drain Hose Replacement* in SI.
