| Technical Service Bulletin: TSB140019 | Released Date: 17-Nov-2017 |

Fuel Pump - Plunger and Tappet Roller Inspection and Repair

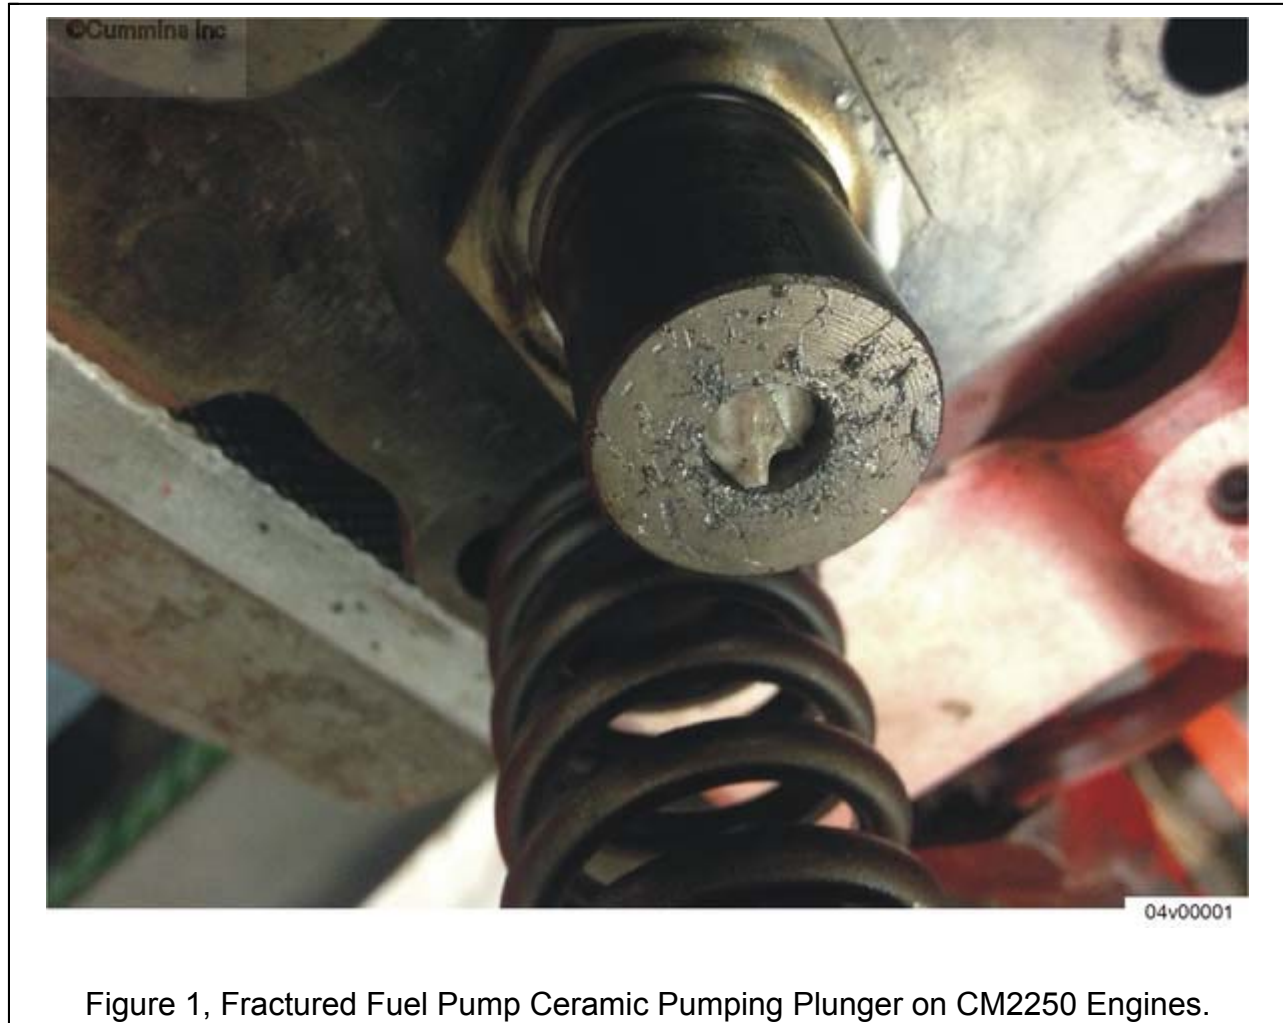
Inspect and verify the condition of the fuel pump tappet rollers and fuel pumping plungers if ceramic (CM2250 only). Reference Figure 1 and Figure 2 above and Procedure 005-227 in Table 3 below.

Scenario 1: The fuel pump tappet rollers are damaged or ceramic pumping plunger damage is found:

- Remove, cut open, and inspect the lubricating oil filter for debris. See Procedure 007-083 in Table 3.
- Connect INSITE™ electronic service tool to the service tool data link and review any logged fault codes.
- Reference Table 1 below for repair direction.
