**Warranty Extension: MIL Comes On With DTCs P0301 Through P0304**
(Supersedes 13-080, dated July 24, 2014, to revise the information marked by the black bars)**REVISION SUMMARY**

The piston rings on certain cylinders may rotate and align which can lead to spark plug fouling. This can set DTCs P0301 through P0304 and cause the MIL to come on.

Inspect the vehicle and, if necessary, clean the pistons, and replace the piston rings in the affected cylinders.

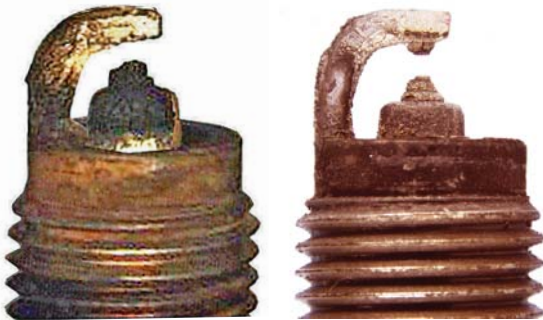
NOTE: Below are examples of good and fouled spark plugs.

GOOD

NO GOOD

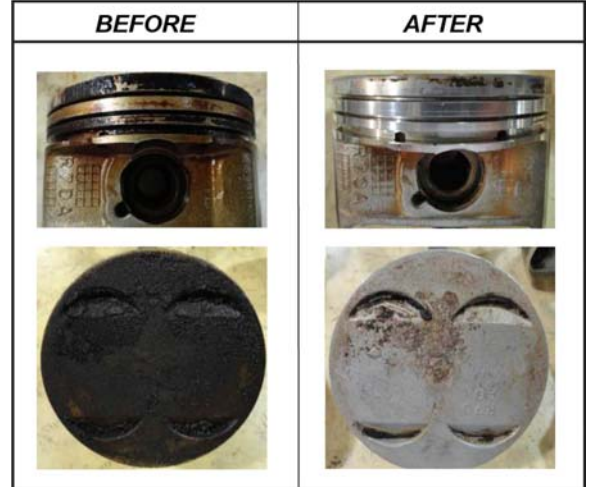
54K PISTON

NOTE: Below are some examples of before and after pictures. Depending on mileage and running conditions, the pistons will achieve different levels of cleanliness.
