Technical Service Bulletin

01 MIL on (P0491 and P0492 stored at same time)

01 16 81 2033001/9 October 13, 2016. Supersedes Technical Service Bulletin Group 01 number 16-69 dated July 27, 2016 for reasons listed below.

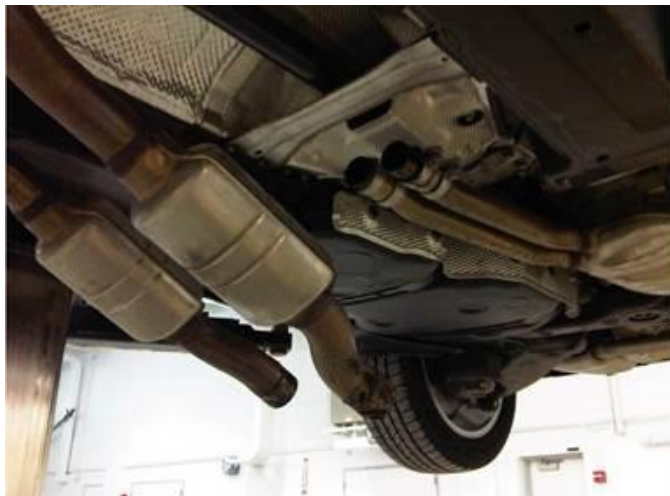
Figure 7. Lowered catalytic converter pipes.

1. Move the exhaust sliding bushings (that connect the catalytic converter and muffler) back, then lower the catalytic converter pipes (Figure 7).

For Q7, unbolt muffler from catalytic converter. Cover mufflers with plastic bag to prevent water from entering.

Cleaning water will drain out of the catalytic converter pipes during the cleaning process.

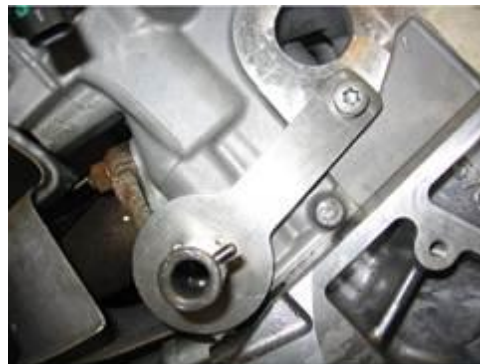
Figure 13. Engine adaptor on bank one.

2. To catch water, put a pan under the front of the engine and under the disconnected catalytic converter pipes.
3. Install engine adaptors on the appropriate banks (Figure 13 and Figure 14).

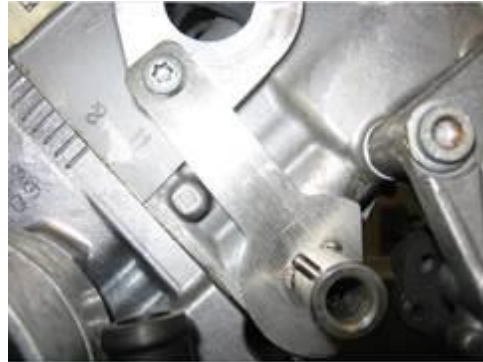
Figure 14. Engine adaptor on bank two.

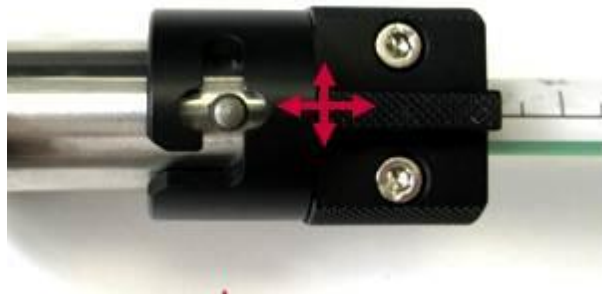
Figure 16. Locking position / transvers longitudinal movement and of the hose adaptor

- After adjusting the position of the hose adaptor, insert the special single port cleaning hose into the hose adaptor, and bring it back into locking position (Figure 16).

- While cleaning, make sure that the pressure washer is supplying pressure greater than 1800 psi.
- Based on the washer's pressure, clean the port based on the table below. While cleaning, continuously move the hose adaptor within the longitudinal and transvers slots (Figure 16).

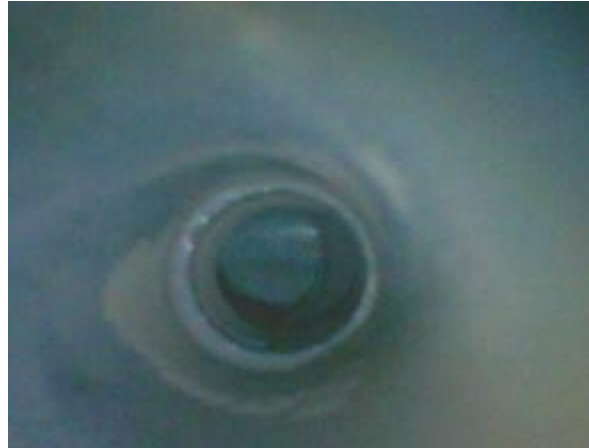
Figure 17. Clean single port.

6. It is recommended that after cleaning, all single ports are checked with snap-on boroscope BK6000 (or similar, with 90-degree lens), to make sure all ports are clean (Figure 17).
