08191 Version 13

Warranty Extension: MIL Comes On With DTCs P0301 thru P0304

Year	Model	Trim	VIN Range
2011–13	Odyssey	ALL	Check the iN VIN Status for Eligibility

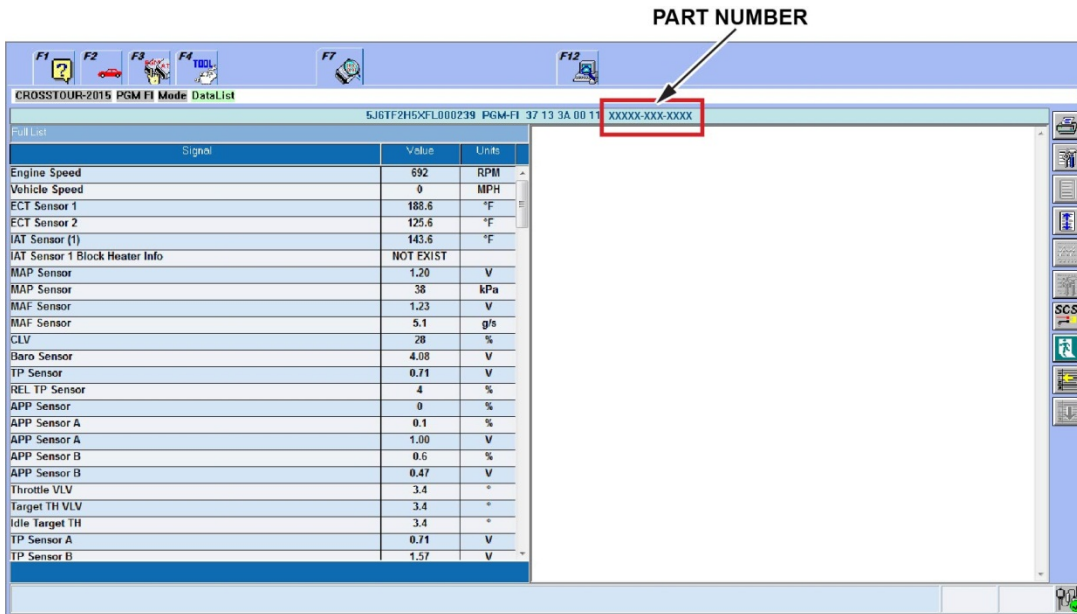
3. For 2011 Odyssey only: Check the PCM software version P/N located above the **PGM FI Data List**.

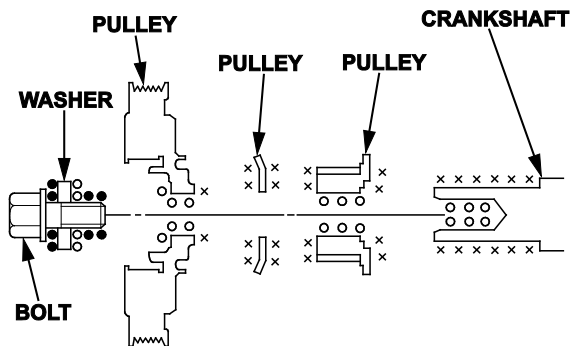
13. Depending on the diagnosis, remove the appropriate WU-TWC support bracket bolts.
14. Remove the EGR lower pipe nuts.
15. Remove the crankshaft pulley bolt but not the pulley.

NOTE: Make sure to apply new oil to the bolt flange and threads before reinstallation.

- X : Remove any oil
- O : Clean
- : Lubricate with new engine oil

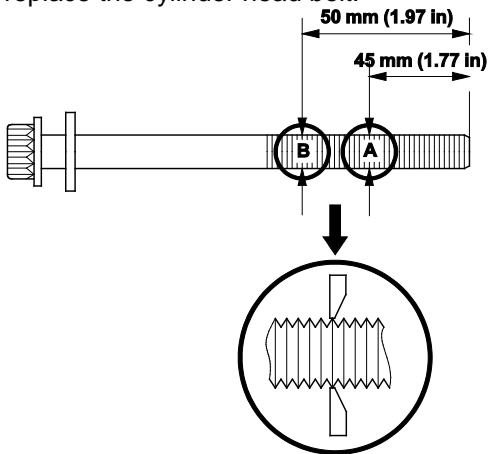
41. Measure the head bolts to determine if they need replacement. If either diameter is less than **11.3 mm (0.445 in)**, replace the cylinder head bolt.

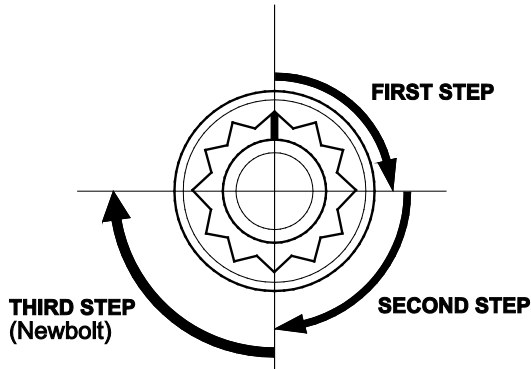
NOTE: Below are the head bolt torque specifications for reinstallation.

- First step: torque the cylinder bolts in sequence to **29 N•m (22 lb-ft)**.
- Second step: tighten in sequence an additional **90 degrees**.
- Third step: tighten in sequence an additional **90 degrees**.
- If the bolts are new, tighten an additional **90 degrees**.

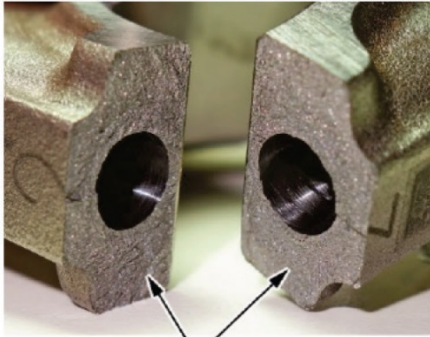
The uneven mating surfaces are uniquely matched and not interchangeable.

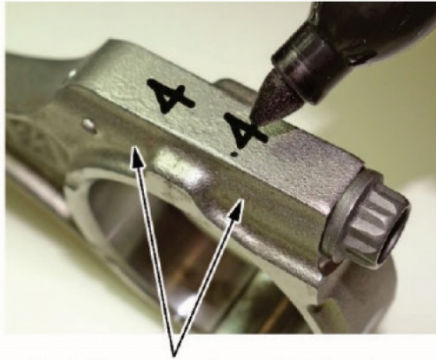
Mark the connecting rod and rod cap with the cylinder number.

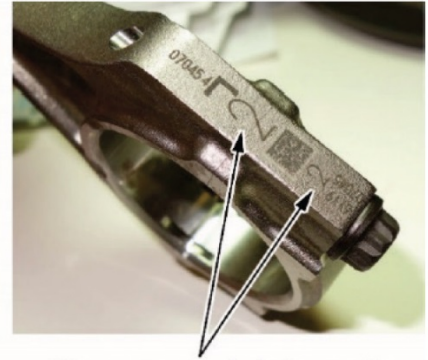
These are manufacturing marks, and do not indicate the cylinder number.

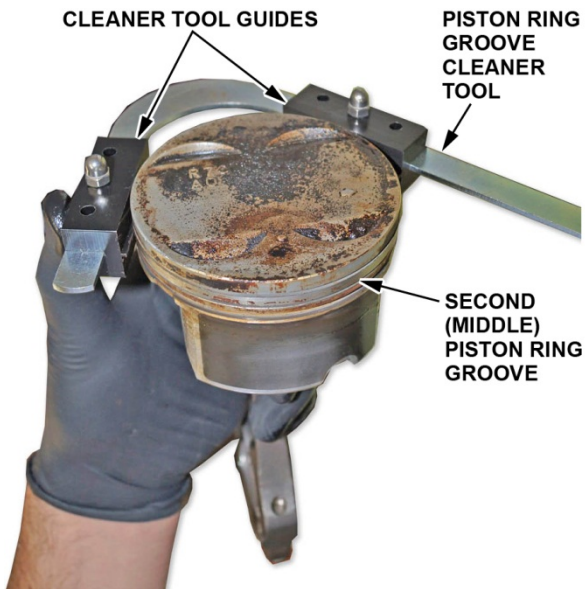
3. While holding the piston upright in your left hand, take the piston ring groove cleaner tool in your right hand and line up the cleaner tool guides with the second (middle) piston ring groove.

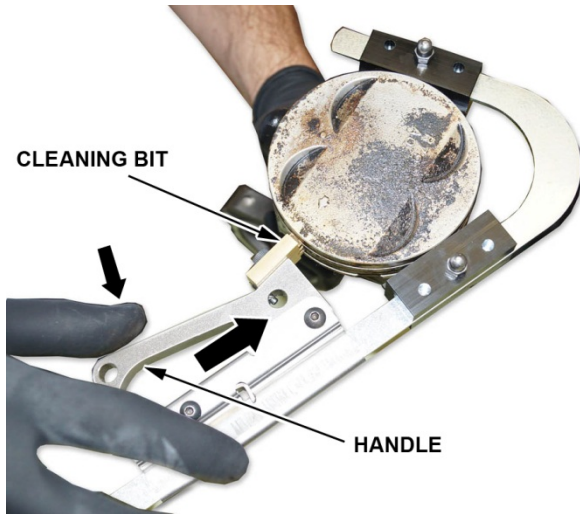
4. Press the handle on the piston ring groove cleaner tool and slide the cleaning bit onto the appropriate piston ring grooves.

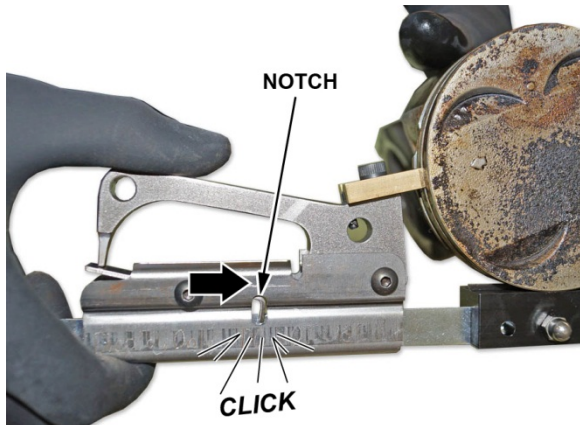
5. Once the cleaning bit is in the appropriate ring grooves of the piston, make sure the tool handle clicks in to place.
NOTE: There is only one notch on the tool for the handle to engage.

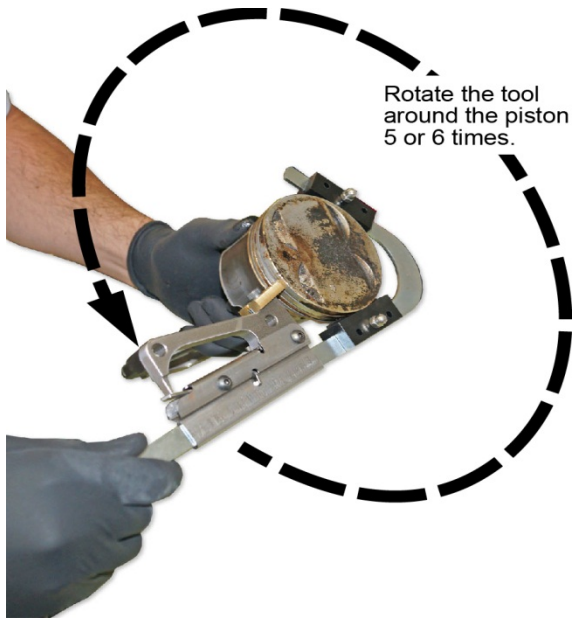
6. Hold the piston steady and rotate the tool counter-clockwise five to six times to remove any carbon deposits in the piston ring grooves. **Do not** rotate the tool clockwise.

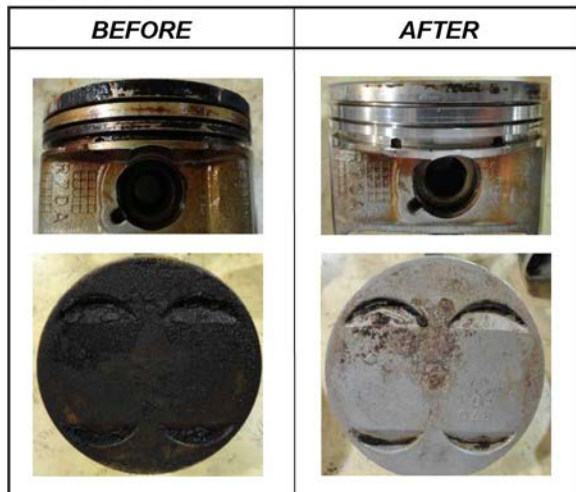
54K PISTON

NOTE: Below are some examples of before and after pictures. Depending on mileage and running conditions, the pistons will achieve different levels of cleanliness.

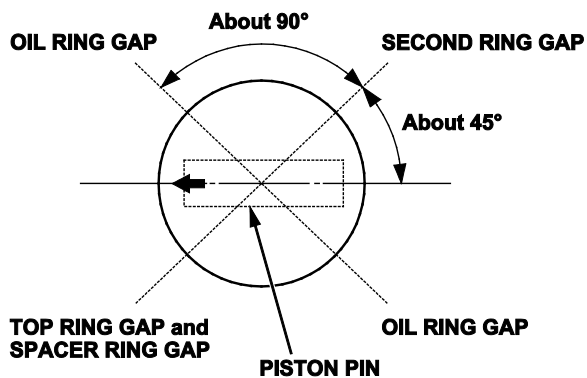
10. Position the ring end gaps as shown.

NOTE: If the ring gaps are not positioned correctly, excessive blowby may occur.

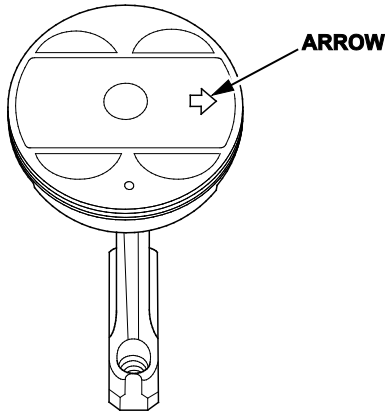
12. Install the piston/connecting rod assembly into the cylinder bore with the arrow on top of the piston facing the timing belt side of the engine.

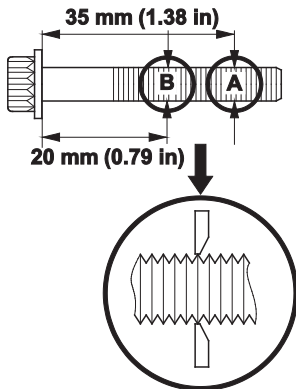
13. Measure the diameter of the connecting rod bolts to determine if they need replacement. Calculate the difference in diameter between point A and point B. It should not be more than **0–0.1 mm (0–0.004 in)**.

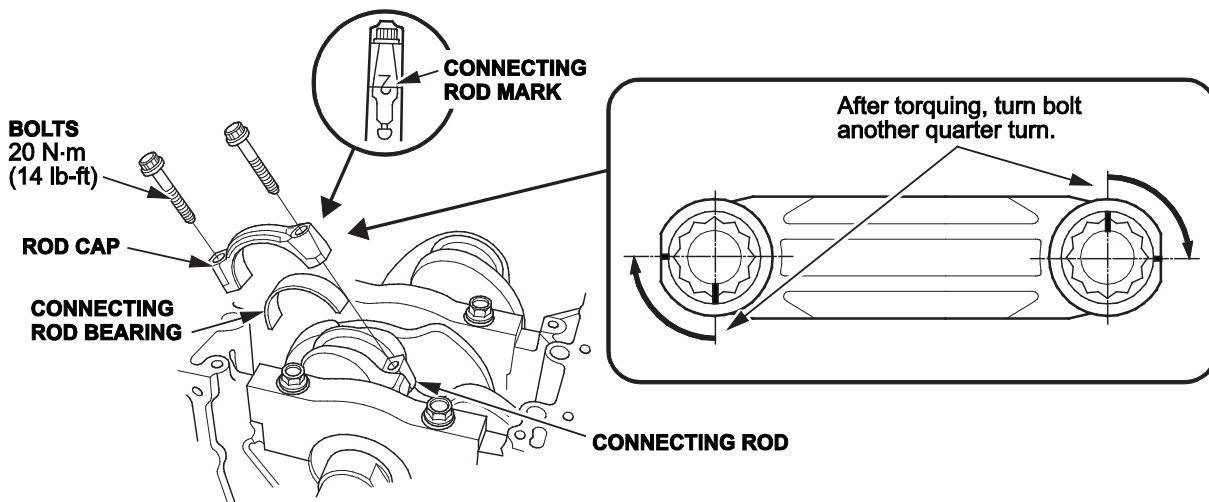
14. Apply new oil to the connecting rod bolt threads and flanges. Torque the bolts to **20 N•m (14 lb-ft)** then tighten the connecting rod bolts an additional **90 degrees**.
