08123 Version 8

Warranty Extension: MIL Comes On With DTCs P0301 thru P0304

Year	Model	Trim	VIN Range
2009–13	Pilot	ALL	Check the iN VIN Status for Eligibility

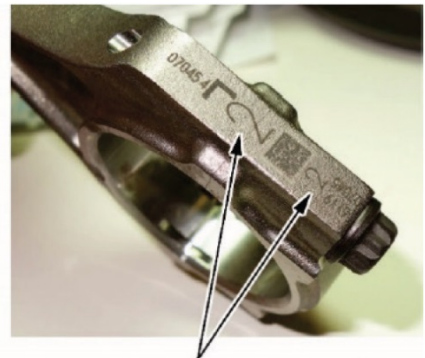
These are manufacturing marks, and do not indicate the cylinder number.

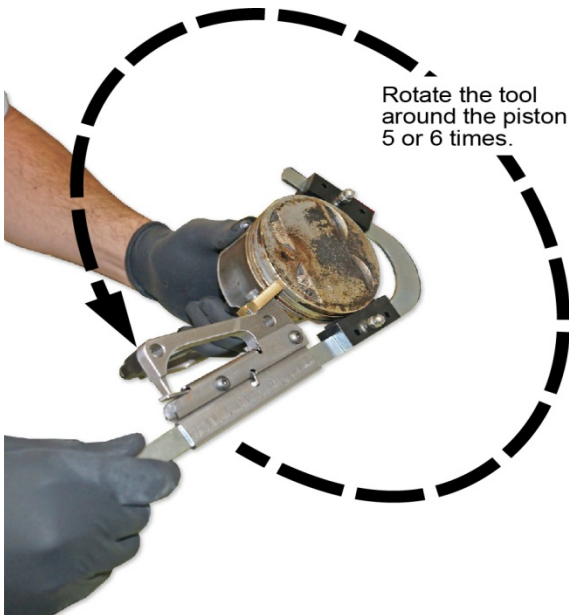
6. Hold the piston steady and rotate the tool counter-clockwise five to six times to remove any carbon deposits in the piston ring grooves. **Do not** rotate the tool clockwise.

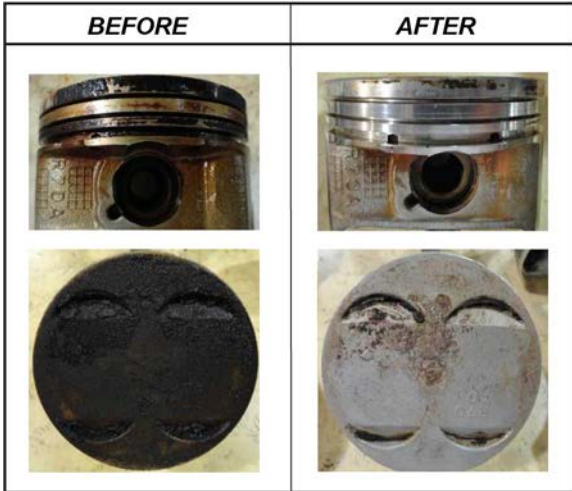
54K PISTON

NOTE: Below are some examples of before and after pictures. Depending on mileage and running conditions, the pistons will achieve different levels of cleanliness.
