Subject Squeak Noise from Rear Leaf Springs		Market USA
Service Category Suspension	Section Rear Suspension	
Applicability 16-17MY Tacoma

'16-17MY Tacoma customers may complain about a squeak noise from rear leaf springs when vehicle experiences any up and down movement.

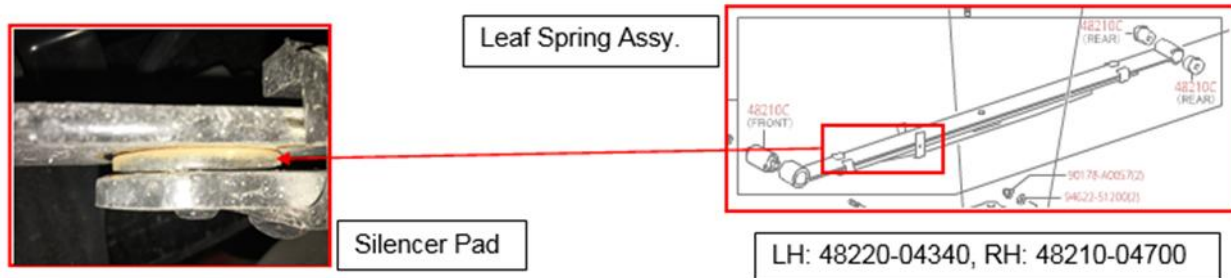
Sand, dirt and/or debris may enter the space between the silencer pad and contact surface of the leaf spring. When the vehicle rear suspension experiences any movement, friction is caused between the silencer pad and spring components, which may result in a squeak noise.

To remedy this condition, it is recommended to clean the surfaces between the spacer and the leaf spring. This is best performed by lifting the vehicle so the wheels are suspended off the ground. Using a Nylon pry tool, carefully pry each leaf apart on the contact surface of the leaf ensuring not to damage the metal contact surface (as this can contribute to the squeak).
