**Touch Screen Inoperative with Display Audio**

**Navigation/Multi Info Display**

**12-14MY Multiple Models w/Display Audio**

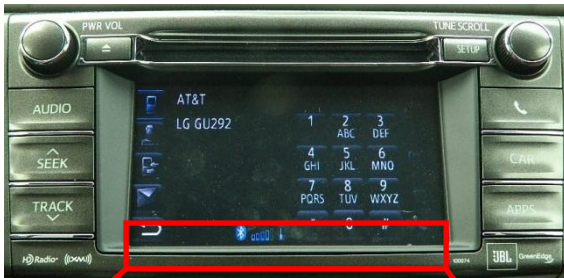
This condition may be caused by foreign object or debris stuck between the display audio screen and the faceplate. If you see any foreign object or debris (refer to the pictures below), please use paper/card with thickness less than 0.1mm (e.g. business card) to remove it.

- Radio screen/button layout can be different by model.
- Do not blow air onto the faceplate to remove the debris, compressed air sprayed on the display can cause moisture inside the radio assembly.
