DTC U0323/U0423/U3000 Cannot be Deleted

Service Category Audio/Visual/Telematics

Section Navigation/Multi Info Display

YEAR(S)	MODEL(S)	ADDITIONAL INFORMATION
2016	iA

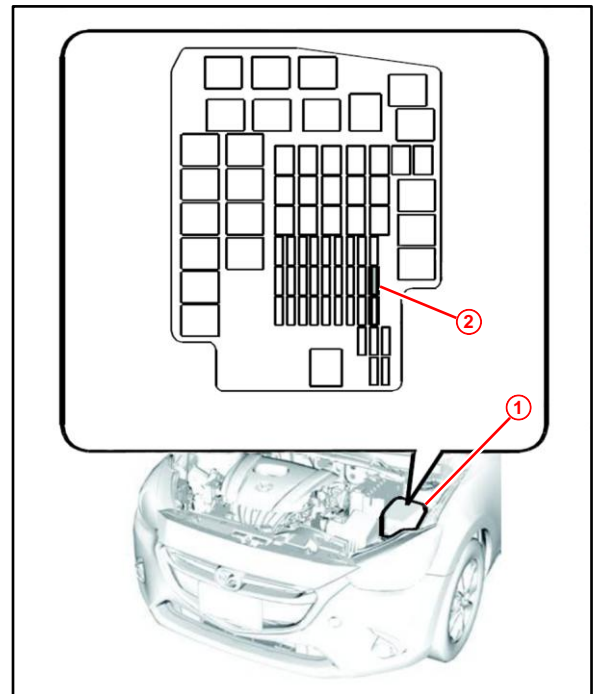
Figure 1. ROOM Fuse

- **YES** — Continue to step 2.
 - **NO** — This bulletin does NOT apply. Continue diagnosis using the applicable Repair Manual.
2. Using Techstream, clear the DTCs.
3. Using Techstream, perform a Health Check. Was DTC U0323, U04423, or U3000 retrieved?
 - **YES** — Continue to step 4.
 - **NO** — This bulletin does NOT apply. Continue diagnosis using the applicable Repair Manual.
4. Verify that the navigation receiver and the ROOM fuse are properly installed.
 - A. Verify that the ROOM fuse is installed in the Relay Block as shown.

1	Relay Block
2	ROOM Fuse Installation Location

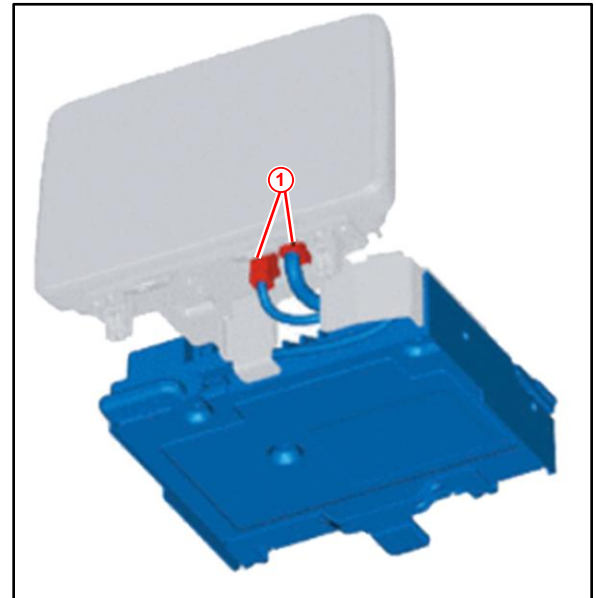
Figure 2. Navigation Receiver

- B. Verify that the navigation receiver connectors are properly seated.

Are the navigation receiver connectors properly seated?

1	Connector
----------	-----------

5. If the navigation receiver connectors are NOT properly seated, complete the following procedure:
- A. Properly seat the connectors.
 - B. Switch the ignition ON (engine OFF or ON) and wait 1 minute or more.
 - C. Switch the ignition OFF and wait for 3 seconds or more.
 - D. Switch the ignition ON (engine OFF or ON) and complete the navigation receiver automatic configuration.
6. Reinstall the multimedia display, audio panel #1 and audio panel #2.
Refer to TIS, applicable model and model year Repair Manual:
- 2016 iA:
Audio/Visual/Telematics – Audio Visual – “Audio/Video: Navigation Receiver: [Installation](#)”

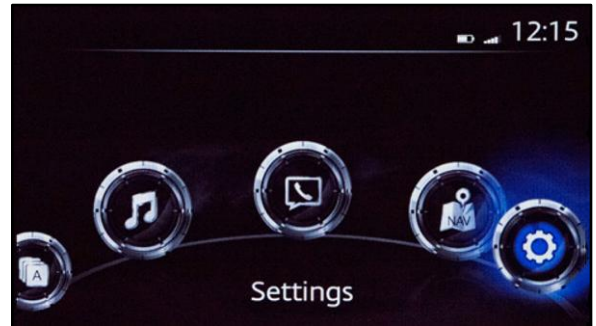
Figure 3.

7. On the "Home" screen, press the rightmost icon labeled *Settings*.

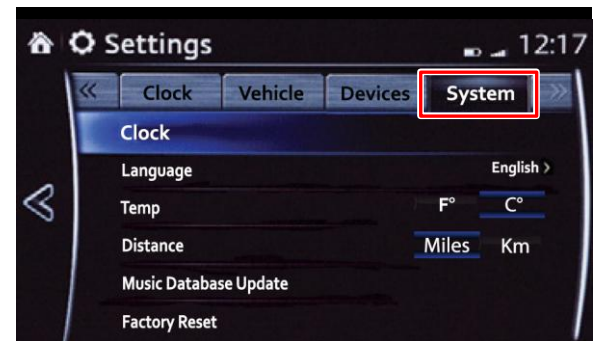
Figure 4.

8. In the "Settings" menu, press *System*.

The change to the "Settings" menu can be made using either the *Temp* or *Distance* submenu. If *Distance* is selected, go to substep B.

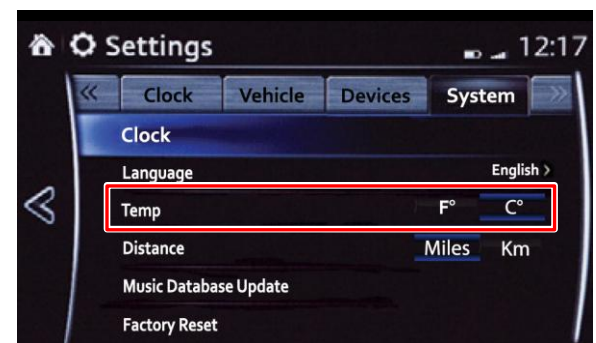
Figure 5.

- A. In the "System" submenu, press *Temp* and Select *F°* or *C°* to change the temperature units. Choose the alternate setting from the previously selected measurement unit.

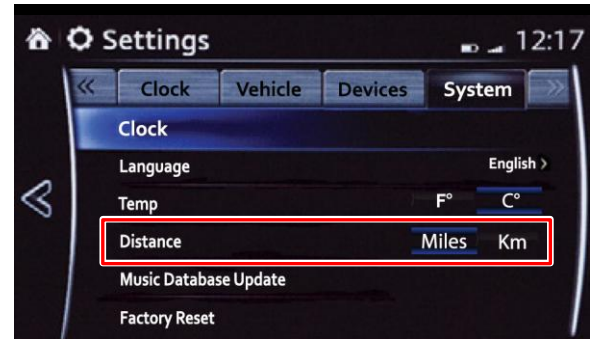
Figure 6.

- B. In the “System” submenu, press *Distance* and select *Miles* or *Km* to change the mileage units. Choose the alternate setting from the previously selected measurement unit.

9. Turn the ignition key to the OFF position.
10. Turn the ignition key to the ON position and delete the DTCs using Techstream.
11. Confirm that the DTCs have been cleared using Techstream.
12. Return the original temperature and/or mileage units using the multimedia menu system.
13. Confirm that the DTCs do NOT reset.
