# 2ZR-FXE Engine Oil Consumption Repair Procedure

**Service Category** Engine/Hybrid System

YEAR(S)	MODEL(S)	ADDITIONAL INFORMATION
2011 - 2014	CT200H

Some 2011 – 2014 model year CT 200h vehicles equipped with the 2ZZ-FXE engine may exhibit engine oil consumption. The piston and piston ring assembly have been changed to reduce the potential for oil consumption. Use the following Repair Procedure to address this condition.

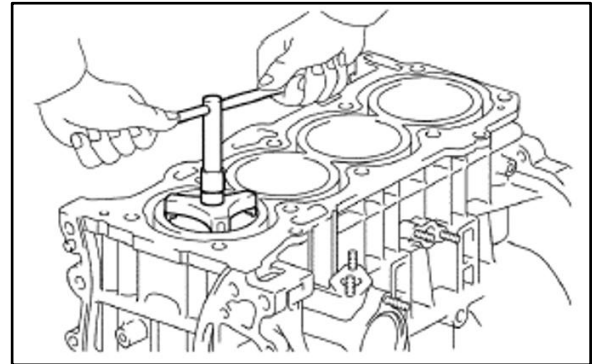
**Figure 1.**

- (1) Using a ridge reamer, remove ALL the carbon from the top of the cylinder.

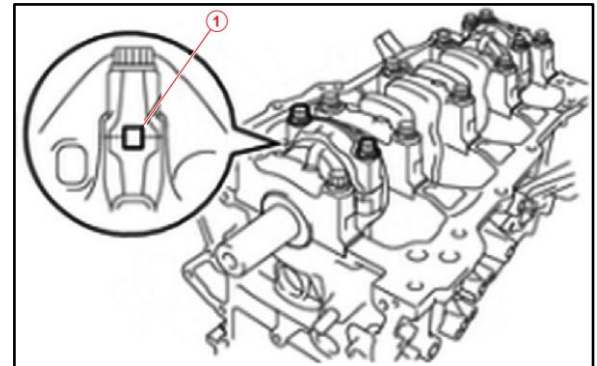
**Figure 2.**

- (2) Check that the matchmarks on the connecting rod and cap are aligned to ensure correct reassembly.

The matchmarks on the connecting rods and caps are provided for ensuring correct reassembly.

<b>1</b>	<b>Matchmark</b>
----------	------------------

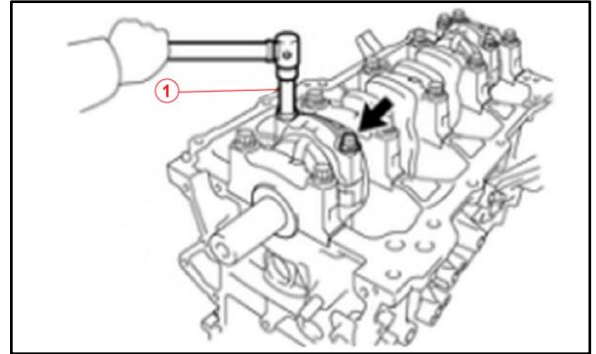
**Figure 3.**

- (3) Using SST 09205-16011, uniformly loosen the 2 bolts.

<b>1</b>	<b>SST</b>
----------	------------

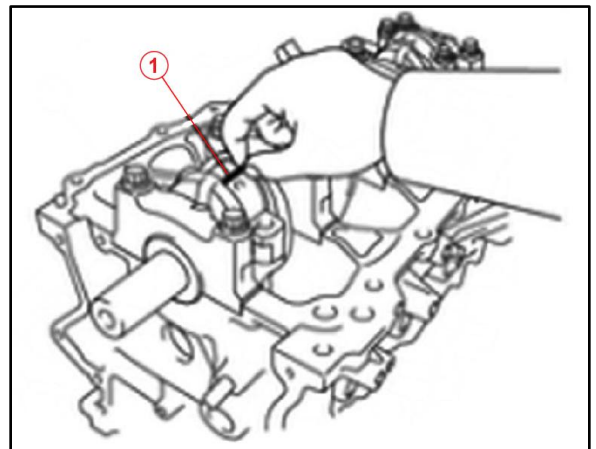
**Figure 4.**

- (5) Inspect the connecting rod oil clearance.
  - a. Clean the crank pin and bearing.
  - b. Check the crank pin and bearing for pitting and scratches.
  - c. Lay a strip of Plastigage™ on the crank pin.

<b>1</b>	<b>Plastigage™</b>
----------	--------------------

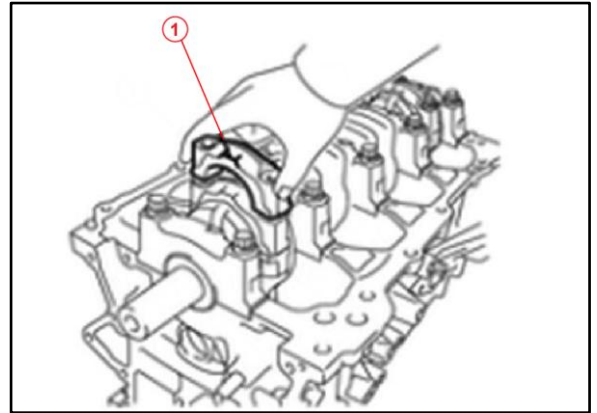
**Figure 5.**

- d. Check that the front mark of the connecting rod cap is facing forward.

<b>1</b>	<b>Front Mark</b>
----------	-------------------

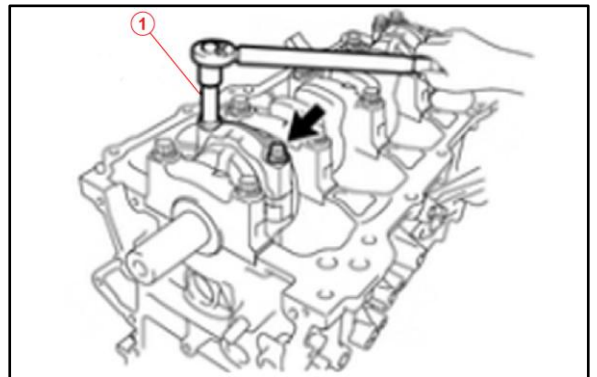
**Figure 6.**

- e. Install and alternately tighten the bolts of the connecting rod cap in several steps.  
Torque: 20 N\*m (204 kgf\*cm, 15 ft\*lbf)

The connecting cap bolts should be tightened in 2 progressive steps.

<b>1</b>	<b>SST</b>
----------	------------

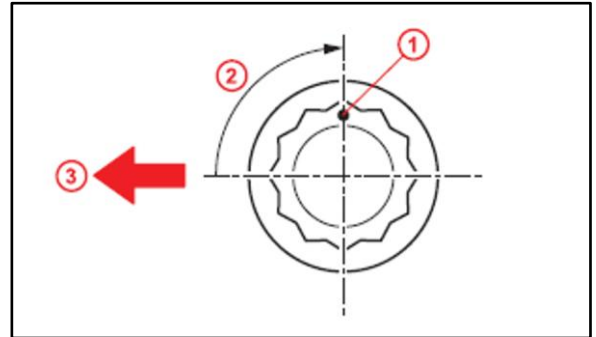
**Figure 7.**

- f. Mark the front of the connecting rod cap bolts with paint.  
Retighten the cap bolts by 90° as shown.

<b>1</b>	<b>Paint Mark</b>
<b>2</b>	<b>90°</b>
<b>3</b>	<b>Engine Front</b>

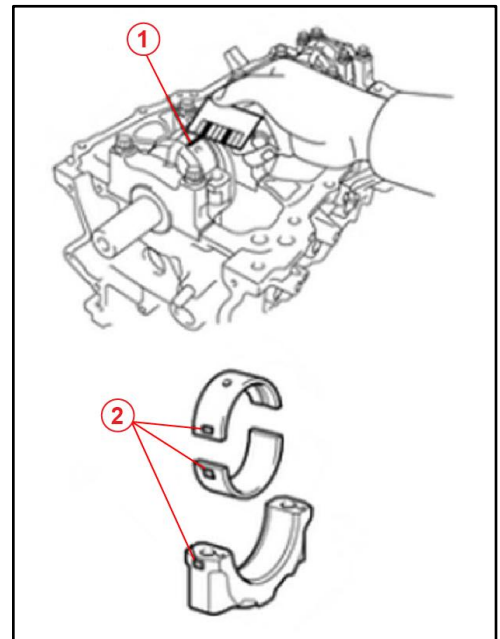
**Figure 8.**

- h. Measure the Plastigage™ at its widest point.

**Standard Oil Clearance: 0.014 to 0.038 mm (0.000551 to 0.00150 in.)**

**Maximum Oil Clearance: 0.070 mm (0.00276 in.)**

If the oil clearance is greater than the maximum, replace the connecting rod bearings. If necessary, inspect the crankshaft.

If replacing a bearing, replace it with one that has the same number as its respective connecting rod cap. Each bearing's standard thickness is indicated by a 1, 2, or 3 mark on its surface.

1	Plastigage™
2	1, 2, or 3 Mark

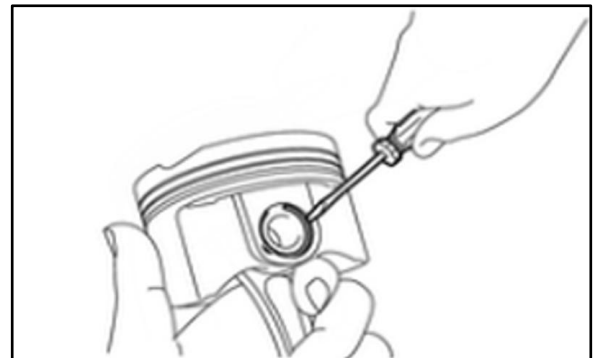
**Figure 9.**

- D. Using a screwdriver, pry out the 2 piston pin hole snap rings.

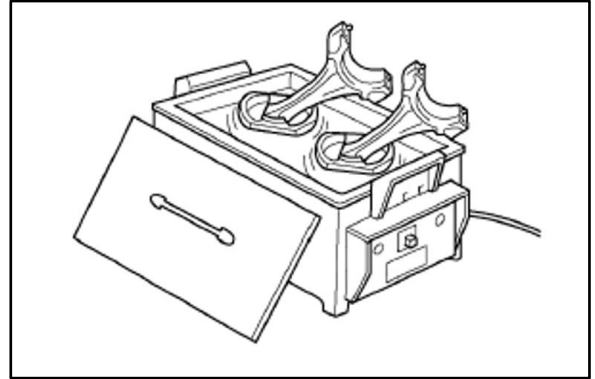
**Figure 10.**

- (1) Gradually heat the piston to approximately 176° to 194°F (80° to 90°C).

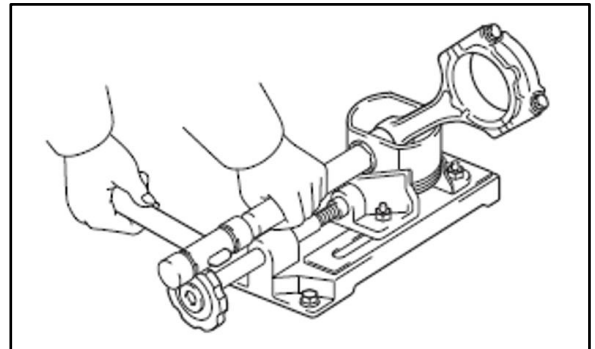
**Figure 11.**

- (2) Using a plastic hammer and brass bar, lightly tap out the piston pin and remove the connecting rod.

- The piston, pin and connecting rod are a matched set.
- Arrange the piston, pins, rings, and connecting rods, and bearings in the correct order.

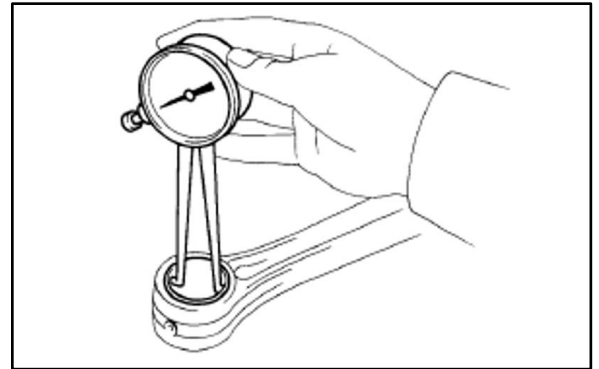
**Figure 12.**

- A. Using a caliper gauge, measure the connecting rod small end bore diameter.

**Standard Connecting Rod Small End Bore Diameter: 20.012 to 20.021 mm (0.78787 to 0.78823 in.)**

Ensure the connecting rod small end bore diameter measurement is within specification for the piston bore diameter.

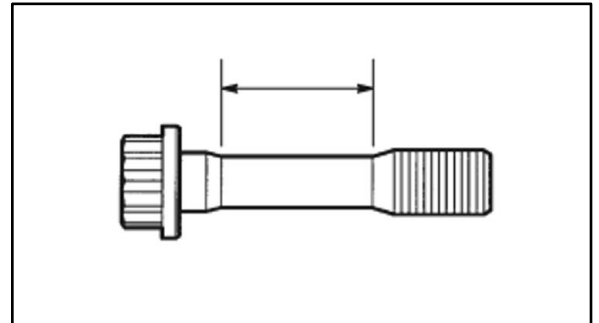
**Figure 13.**

Using vernier calipers, measure the tension portion diameter of the bolt.

**Standard diameter: 6.6 to 6.7 mm (0.260 to 0.264 in.)**

**Minimum diameter: 6.4 mm (0.252 in.)**

If the diameter is less than the minimum, replace the connecting rod bolt.

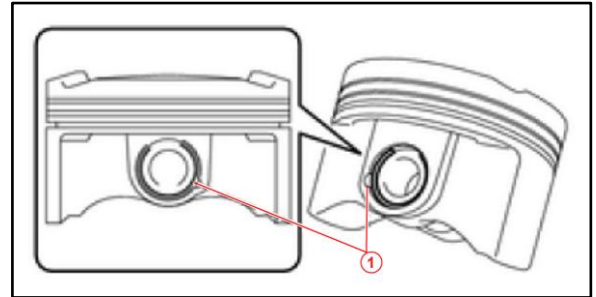
**Figure 14.**

- Using a screwdriver, install a NEW snap ring at one end of the piston pin hole.

Make sure that the end gap of the snap ring is NOT aligned with the pin hole cutout portion of the piston.

**1** Service Hole

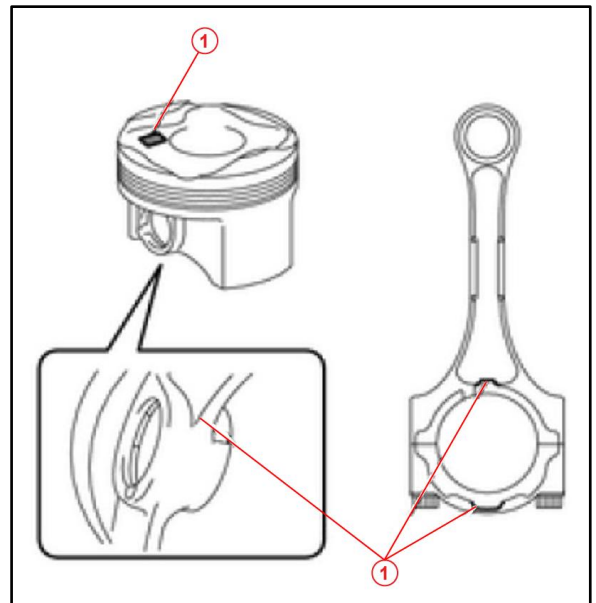
**Figure 15.**

- Gradually heat the piston to approximately 80° to 90°C (176° to 194°F).
- Align the front marks of the piston and connecting rod, insert the connecting rod into the piston, and then push in the piston pin with your thumb until the pin comes into contact with the snap ring.

The piston and pin are a matched set.

**1** Front Mark

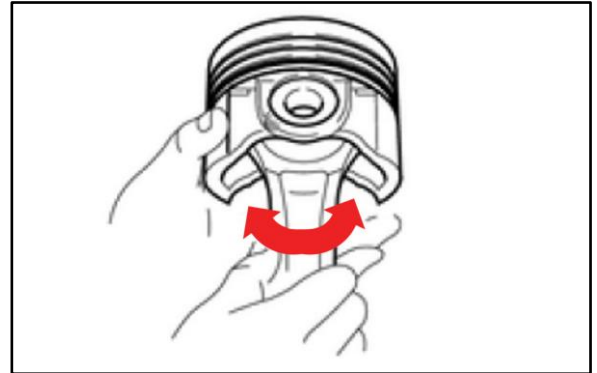
**Figure 16.**

11. Check the fitting condition between the piston and piston pin by trying to move the piston back and forth on the piston pin.

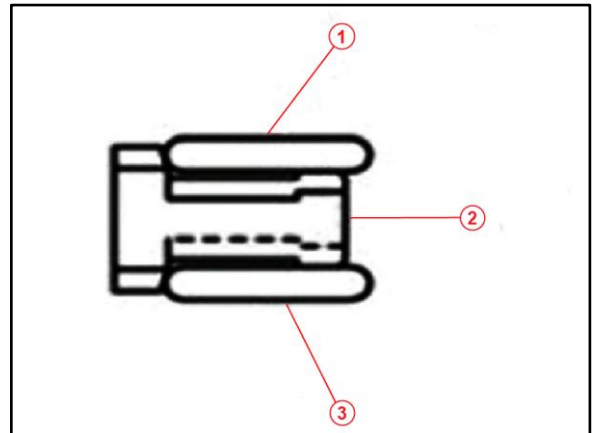
**Figure 17.**

12. Install the NEW Piston Rings Set.

3 piece oil control ring installation procedure is NOT included in the Repair Manual. Follow the steps below to install the piston rings and refer to the Repair Manual for ALL other reassembly steps.

<b>1</b>	Upper Oil Ring Side Rail
<b>2</b>	Oil Ring Expander
<b>3</b>	Lower Oil Ring Side Rail

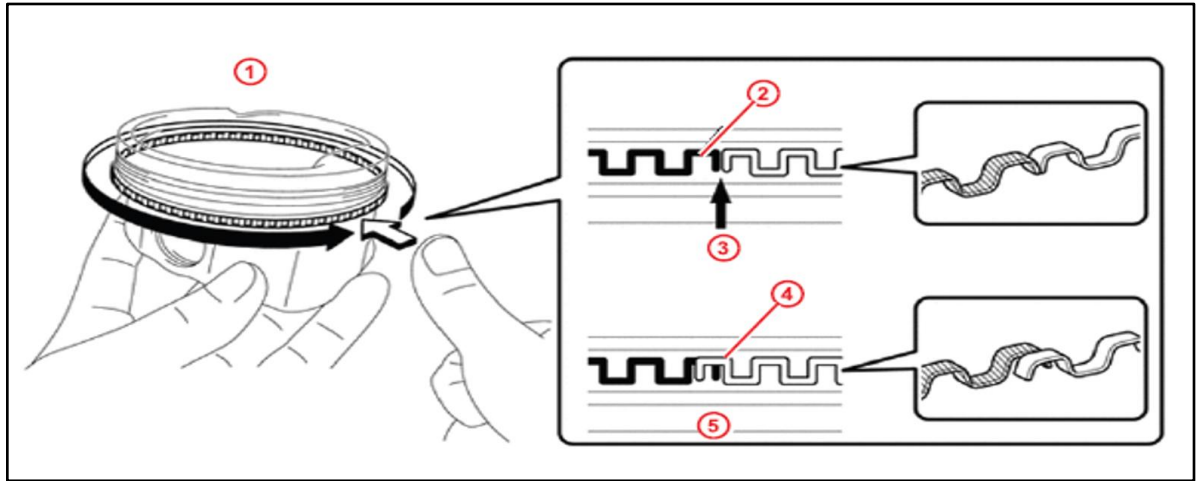
Figure 18.

- A. Install the oil ring expander and 2 oil ring side rails by hand.

When installing the oil expander ring, do NOT overlap the ends.

1	Push Oil Ring Expander Surface Into Piston With Thumb
2	Normal Condition
3	Align End of Ring

4	NG Condition
5	Do NOT Overlap

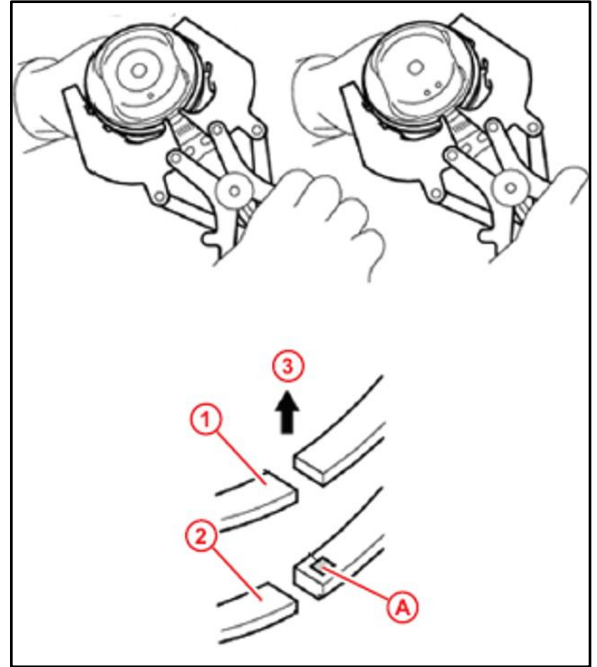
Figure 19.

- B. Using a piston ring expander, install the No. 1 compression ring and No. 2 compression ring with the code mark positioned as shown.

Install the No. 2 compression ring with the code mark facing upward.

A	Code Mark
1	No. 1 Compression Ring
2	No. 2 Compression Ring
3	Upward

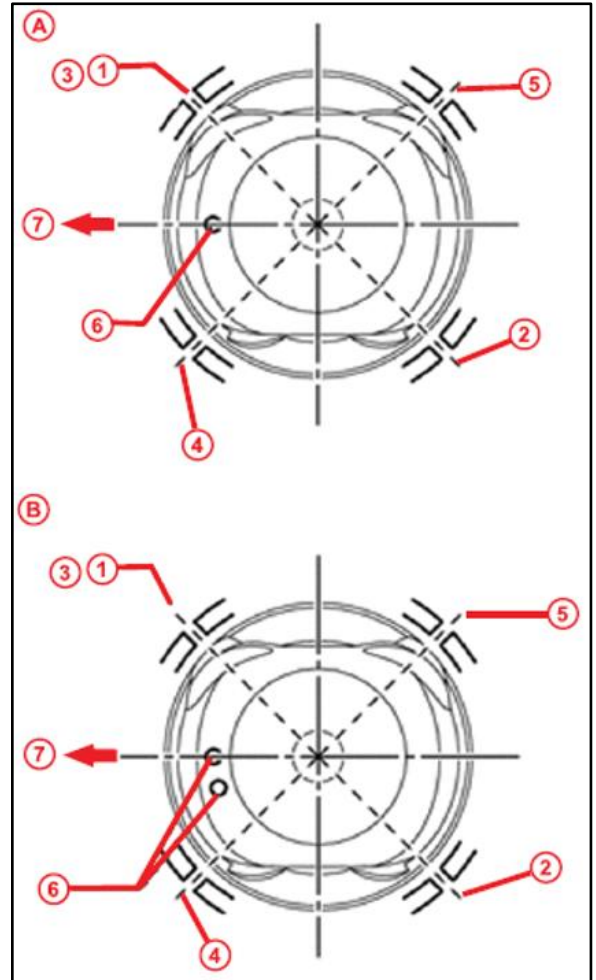
Figure 20.

- C. Position the piston rings so that the ends are as shown.

<b>A</b>	TMC Made
<b>B</b>	TMMK Made
<b>1</b>	No. 1 Compression Ring
<b>2</b>	No. 2 Compression Ring
<b>3</b>	Oil Ring Expander
<b>4</b>	Upper Side Rail – Oil Control Ring
<b>5</b>	Lower Side Rail – Oil Control Ring
<b>6</b>	Front Mark
<b>7</b>	Front Side
