Emissions Recall

Code: 23V5

Subject	3.0L TDI Engine – Emissions System Modification – Customer Only (Retail Sold) TDI Vehicles <u>USA ONLY</u>
Release Date	November 6, 2017
Affected Vehicles	U.S.A.: 2013-2015 MY Audi Q7 3.0L TDI Generation 2.1 <i>Check Campaigns/Actions screen in Elsa on the day of repair to verify that a VIN qualifies for repair under this action. Elsa is the <u>only</u> valid campaign inquiry & verification source.</i> <ul style="list-style-type: none">✓ Campaign status must show “open.”✓ If Elsa shows other open action(s), inform your customer so that the work can also be completed at the same time the vehicle is in the workshop for this campaign.
Problem Description	3.0L TDI vehicles were equipped with undisclosed Auxiliary Emission Control Devices which are not permitted by emissions regulations.
Corrective Action	Install updated engine control module (ECM) software, transmission control module (TCM) software and hardware to bring affected vehicles into regulatory compliance.

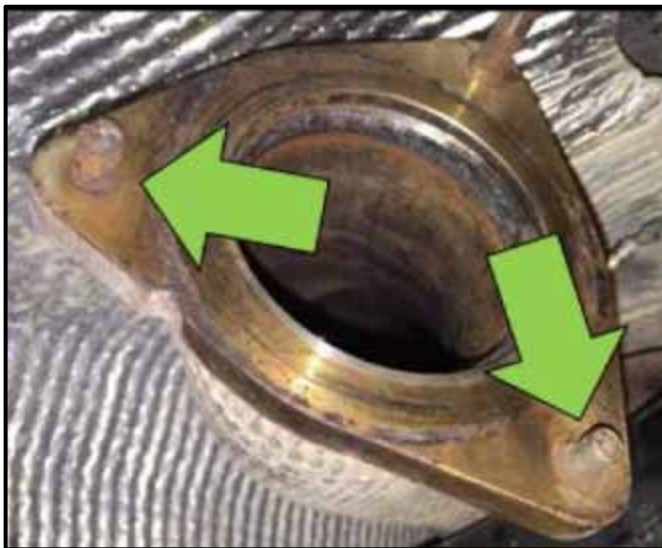
Due to corrosion, one or more of the mounting studs may break <arrows> when removing the SCR catalytic converter from the Diesel Particulate Filter (DPF) flange. Follow the steps below if one or more studs are broken or damaged.

- If stud replacement is necessary, use a clevis pin press, stud removal press, or other available screw type press tool to remove any necessary studs from the rear DPF flange.

DO NOT use a hammer and punch, heat, air hammer, or other method to remove the studs from the DPF. Consequential damage to the DPF or ancillary components will not be covered under this action due to damage from heat, impact, or vibration.

- If stud replacement is necessary, use a commercially available clevis pin press, such as an OTC 5057 (shown) or equivalent to press any broken or damaged studs out of the DPF flange.
 - It is advised if one stud breaks that all three studs are pressed out and replaced with the bolts/nuts included in the parts kit.
- Install the replacement bolts and corresponding nuts into the rear DPF flange.

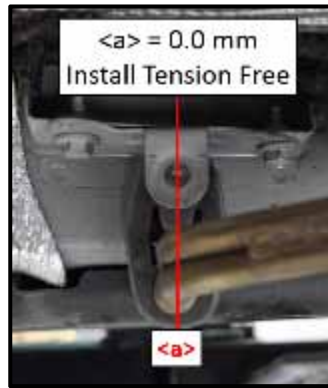
Figures <B and C>

Left and Right SCR hanging straps: $<a> = 0.00 \text{ mm}$, install without tension.

If necessary, loosen the bolts at the left and right SCR Cat hanging straps <B and C> and adjust the brackets until $<a> = 0.00 \text{ mm}$. The SCR Catalyst hanging straps are installed tension free.

- Tighten the two hanging strap bracket bolts to 60 Nm.
- Tighten the two hanging strap bracket bolts <C> to 23 Nm.
