Wind deflector net loose

Topic number	LI77.21-P-055302
Version	1
Design group	77.21 Panoramic roof
Date	02-04-2013
Validity	Model series 166 with panoramic roof (code 413)
Reason for change	
Reason for block

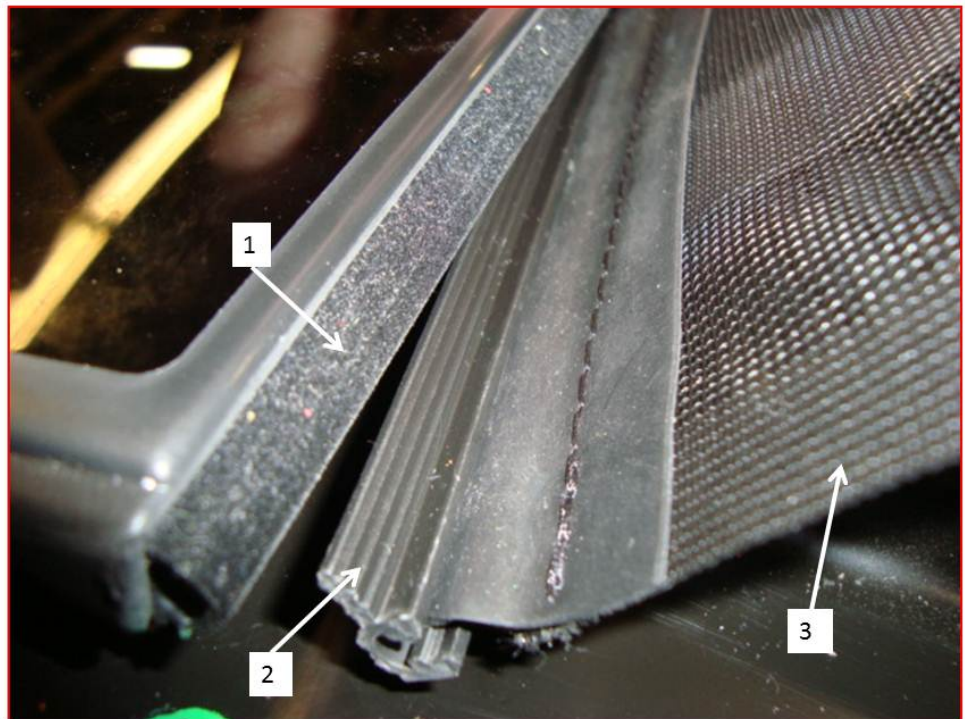
Bild BR166 ASD WAW
Netz lose.jpg:

Wind deflector net loose.

1. Profile rail (2) in PU channel in trim (1) may be incorrectly installed (automatically ribbed by the supplier since 01/12).
2. PU channel in trim (1), gap too large.
2. PU channel in trim (1), material can expand in the heat, the gap becomes larger and the profile rail (2) can loosen due to the tension of the net.
3. The profile rail (2) may have "barbs" on one side only (should be on both sides).

BR 166 ASD Windabweiser Netz lose

Do not replace the wind deflector with net (3), but insert the profile rail (2) into the PU channel (1) by gluing the profile rail (2) on the left and right outside.

Use commercially available instant adhesive Loctite 495.

Clean Point: The profile rail is glued in series production (supplier) since 07/12.
