09030 Version 9

## Warranty Extension: MIL Comes On With DTCs P0301 thru P0304

| Year | Model | Trim | VIN Range |
|---|---|---|---|
| 2009–13 | Pilot | ALL | Check the iN VIN Status for Eligibility |

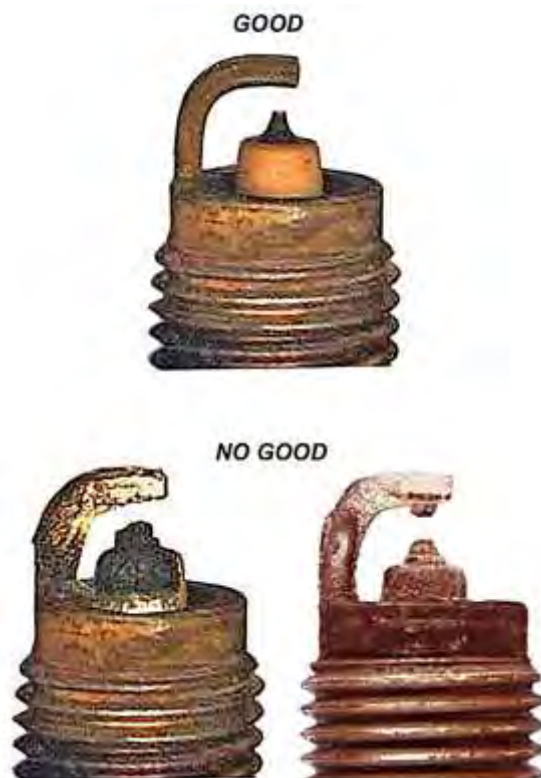
2. Remove and check the spark plug(s) on the affected cylinders (example: if P0301 is stored, check the spark plug on cylinder No. 1).

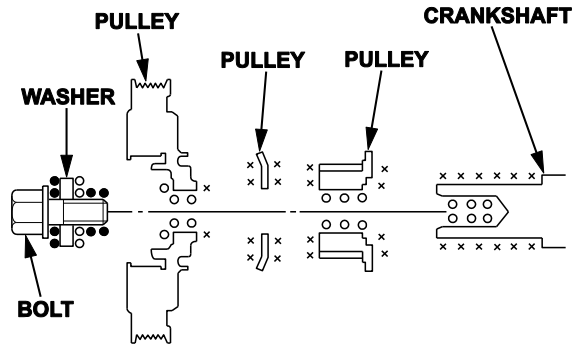
15. Depending on the diagnosis, remove the appropriate WU-TWC support bracket bolts.
16. Remove the EGR lower pipe nuts.
17. Remove the crankshaft pulley bolt but not the pulley.

NOTE: Make sure to apply new oil to the bolt flange and threads before reinstallation.

X : Remove any oil

O : Clean

● : Lubricate with new engine oil

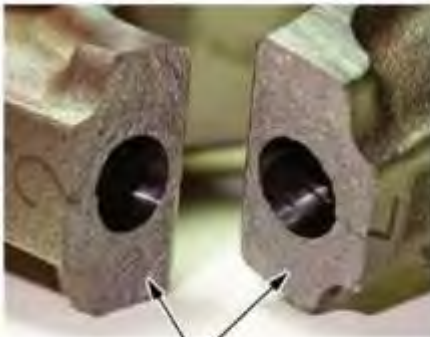
The uneven mating surfaces are uniquely matched and not interchangeable.

- Before removing the rod caps, use a grease pencil or suitable marking pen to mark each cap and its corresponding connecting rod with the cylinder number it came from.
- Do not confuse the existing marking on the side of the connecting rod and rod cap with a cylinder number. They are just manufacturing marks referring to the size of the big end of the rod.
- Installing a rod cap incorrectly will result in engine knock and/or engine failure. Remove and mark one rod assembly at a time to make sure it is assembled correctly.
- When torquing the rod cap bolts, refer to the service information for details.
- Click [HERE](#) to go to the *Tech2Tech*® video “Tips When Working with Fracture Rods”.

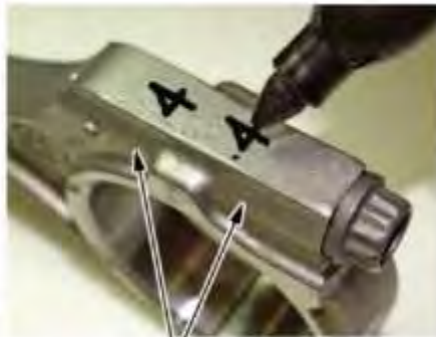
Mark the connecting rod and rod cap with the cylinder number.

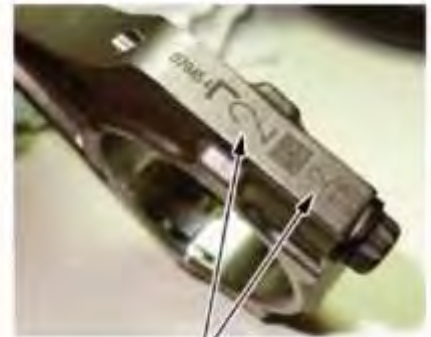
These are manufacturing marks, and do not indicate the cylinder number.

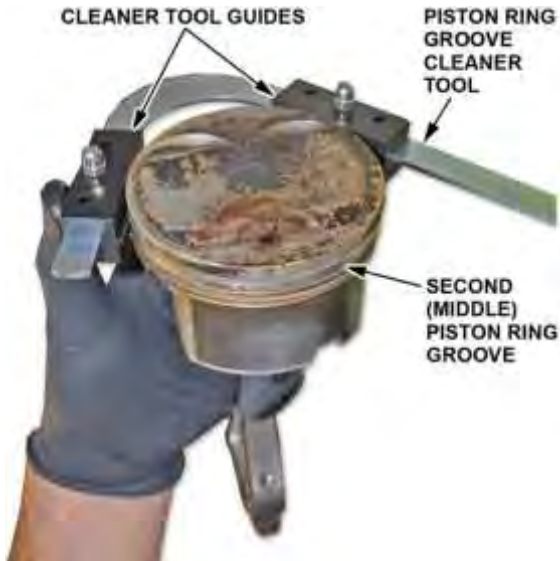
2. Spray the piston head and piston ring grooves thoroughly with Honda throttle plate cleaner.
3. While holding the piston upright in your left hand, take the piston ring groove cleaner tool in your right hand and line up the cleaner tool guides with the second (middle) piston ring groove.

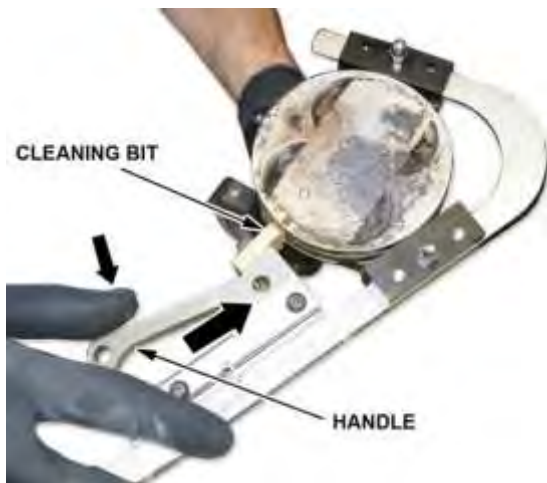
4. Press the handle on the piston ring groove cleaner tool and slide the cleaning bit onto the appropriate piston ring grooves.

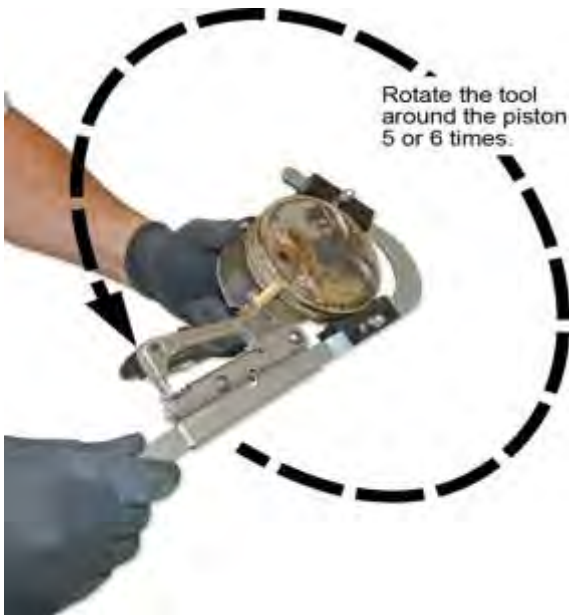
6. Hold the piston steady and rotate the tool counter-clockwise five to six times to remove any carbon deposits in the piston ring grooves. **Do not** rotate the tool clockwise.

NOTE: You can watch this procedure in the *Tech2Tech* segment "How to Clean Piston Ring Grooves".

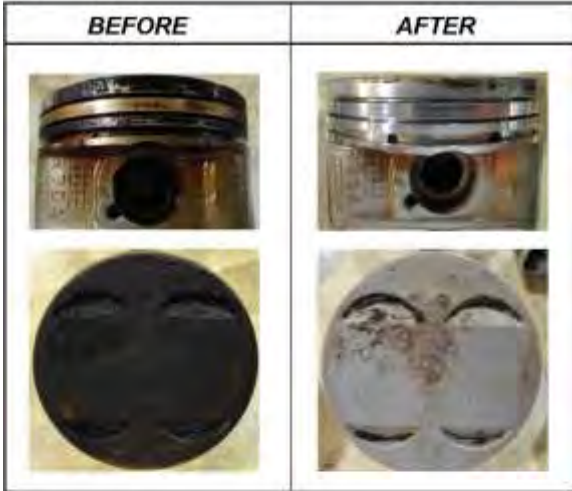
**54K PISTON**

NOTE: Below are some examples of before and after pictures. Depending on mileage and running conditions, the pistons will achieve different levels of cleanliness.
