Service Bulletin

Subject: Coolant Smell and/or Slight Leak at Radiator

Models: 2015 Cadillac Escalade Models
2015 Chevrolet Silverado, Suburban, Tahoe
2015 GMC Sierra, Sierra Denali, Yukon Models, Yukon Denali Models
Equipped with 4.3L, 5.3L or 6.2L Engine (RPOs LV1, LV3, L83 or L86)

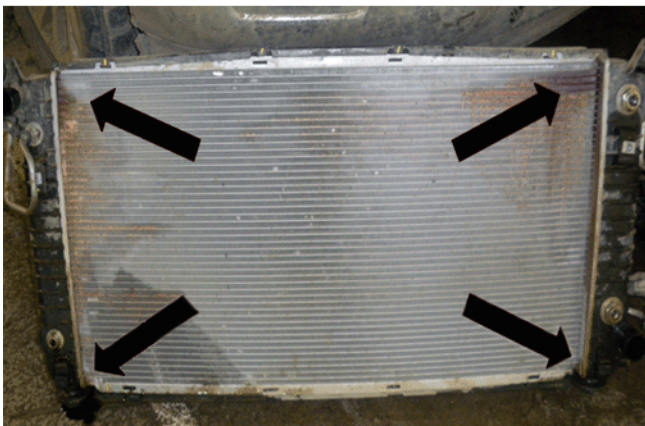
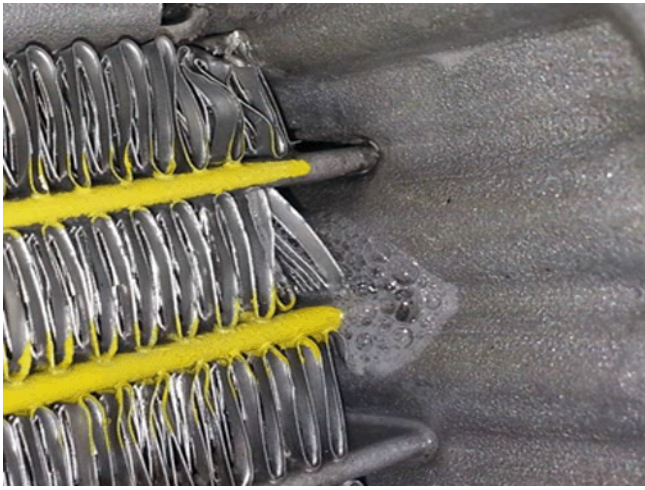
Technicians should start by inspecting the radiator for signs of leaks. Normally, signs of leaks can be found where the tubes attach to the headers.

This condition may be the result of excessive thermocycles within the cooling system caused by excessive cycling of the thermostat. These excessive thermocycles within the coolant system may cause the tubes to fatigue, crack and leak at the radiator headers. To correct this condition, a new thermostat has been designed that eliminates the thermostats excessive cycling.

If this condition is found, in addition to replacing the radiator, the engine coolant thermostat housing (w/thermostat) must also be replaced. Refer to *Engine Coolant Thermostat Housing Replacement* in SI, which is located in the Engine Heating and Cooling section.
