Spare Parts Requirements - Transfer Case/Transfer Case Control Unit: Note link between transfer case and control unit software (26/18)

Model Line: **Macan**

Model Year: **As of 2015 up to 2018**

Subject: **Transfer case and transfer case control unit** (all-wheel drive control unit)

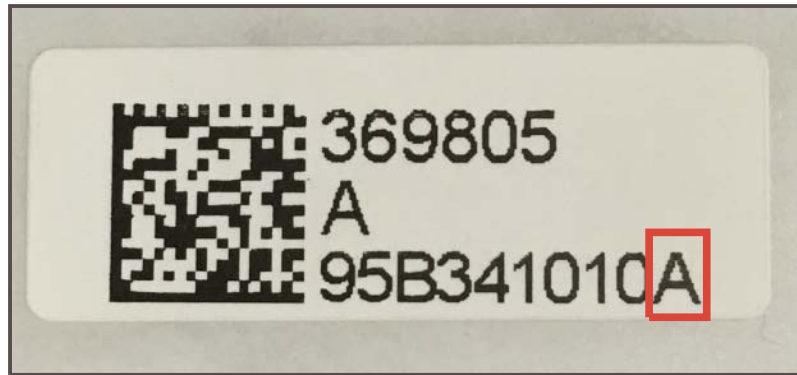
Sticker with part number

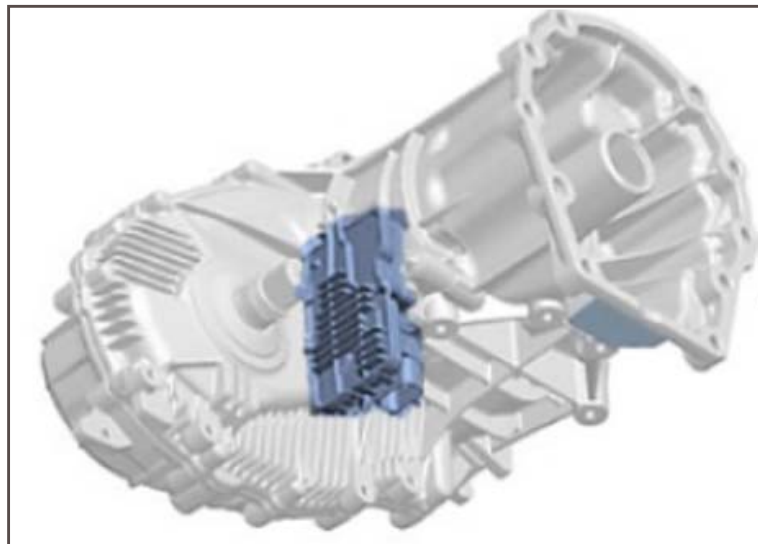
The relevant transfer case control unit is already fitted on a new transfer case. **PIWIS Tester 3** selects the correct data record and sets the PR number LU2 automatically.

Transfer case with control unit

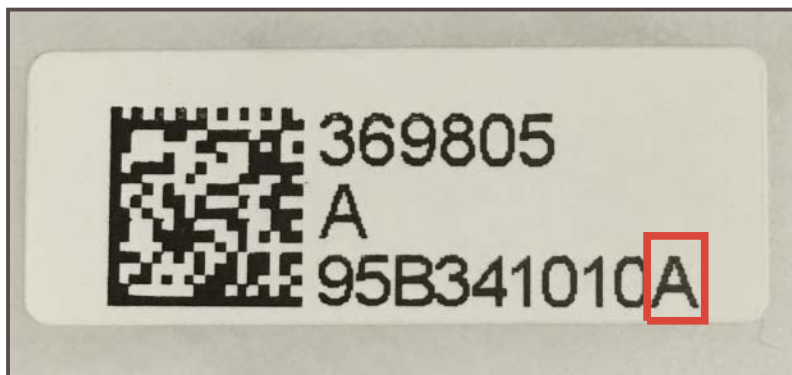
Part number on the new (replacement/reconditioned) transfer case (sticker with part number ⇒ *Sticker with part number*)

Sticker with part number

- a) **Part number** of the new **transfer case does not correspond to the new type** ⇒ **Part number ends with 010 and has no index** (no letter, e.g. "A")

- b) Part number of the new transfer case corresponds to the new type ⇒ **Part number has index letter ("A")**

⇒ **The transfer case on the new PDK must be replaced by a transfer case with the new part number (with index letter).**

⇒ **The transfer case can remain on the new PDK and can be installed in the vehicle.**
