Service Bulletin

Subject: Diagnostic Tip for Coolant Leak at Oil Cooler Inlet Pipe O-Ring After Service Engine Replacement

Models: 2001-2010 Chevrolet Silverado
2003-2010 Chevrolet Kodiak
2006-2010 Chevrolet Express
2001-2010 GMC Sierra
2003-2010 GMC TopKick
2006-2010 GMC Savana
Equipped with Duramax Diesel Engine (RPOs LB7, LLY, LBZ or LMM)

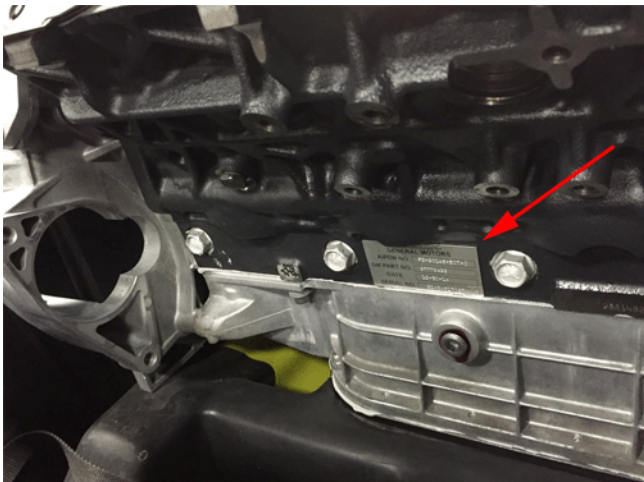
The following engine serial numbers are affected. The serial number can be found on the bottom right side of the block. Refer to the picture below.

Inspect the oil cooler inlet pipe and replace the O-ring if any leaks are found.
