May 25, 2018

Warranty Extension: Customer Support Program For Front Passenger's Airbag Inflator for 2003-07 Accord and 2003 Odyssey (Expires October 31, 2022)

AFFECTED VEHICLES

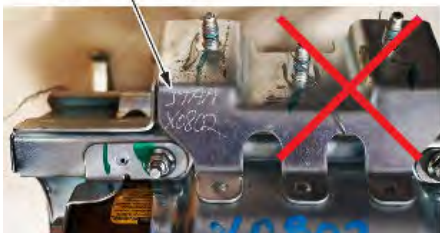
- If there are any unusual markings, like an incorrect label or a model year written in marker, the airbag module and inflator may not be the correct airbag module and/or inflator for the vehicle or it may be a counterfeit part. For more information about counterfeit airbags, you can refer to safercar.gov, enter keywords **MANAGING COUNTERFEIT**, and select **Recommended Dealer Guidance for Managing Counterfeit Air Bags** from the list. **If you suspect that the airbag module or inflator is counterfeit, do not continue this procedure.** Contact your DPSM for assistance.

HAND ENGRAVING

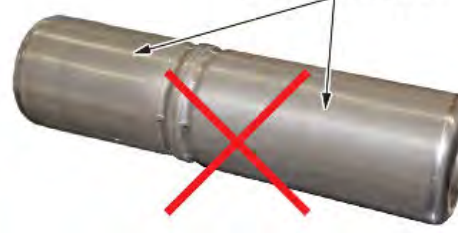
NO LABELS ON INFLATOR

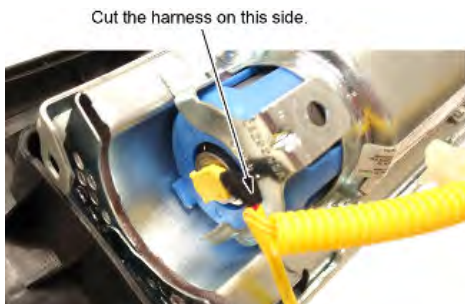
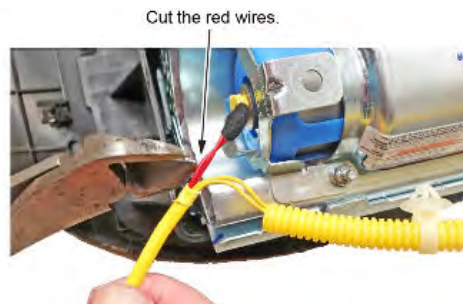
- 3.1. Cut the red wires about 2 inches from the inflator.

There may be some protective tube covering the wires that needs to be cut away to access the wires.

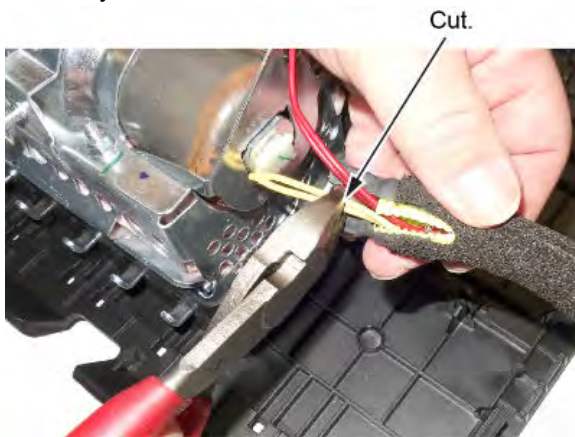
3.4. Cut the yellow wires about 2 inches from the inflator.
