NUMBER: 08-107-14

Radio Loss Of Audio Signal Or Static Interference On FM Stations

2015 (LA) Dodge Challenger

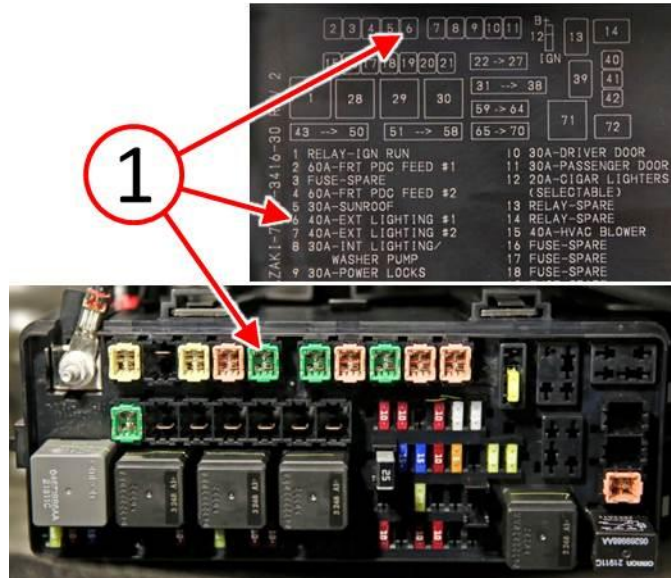
Fig. 1 Fuse 6

7. Turn the headlamp switch to the off position.
8. Using the radio SCAN button, tune to the next receivable FM station frequency band.
9. Repeat [Step #5](#) and [Step #6](#) until you reach the end of the FM station frequency band (Ex. 107.9 FM).
 - a. If the sound is clear and unchanged while cycling the park lamps off/on throughout the entire FM frequency band, this Bulletin does not apply. Further diagnosis is required.
 - b. If radio reception is poor (radio static) or no audio output (audio is muted) with the parking lamps on continue to [Step #10](#).
10. Disconnect the rear inner combination tail stop backup lamp by removing fuse 6 from the power distribution center located in the trunk, as shown in ([Fig. 1](#)).

1 - Fuse 6

11. With the radio tuned to an FM station frequency band experiencing static, turn the park lamps on (NOT the headlamps).
12. With fuse 6 removed, listen for noise (radio static) or no audio output (audio is muted). Cycle the park lamps off/on to determine if the noise or audio level changes.

- a. If the sound remains clear and unchanged while cycling the park lamps off/on, continue to [Step #13](#).
 - b. If noise or audio level changes while cycling the park lamps off/on, this Bulletin does not apply. Install fuse 6 and clear any diagnostic trouble codes that may have set due to fuse 6 being disconnected. Further diagnosis is required.

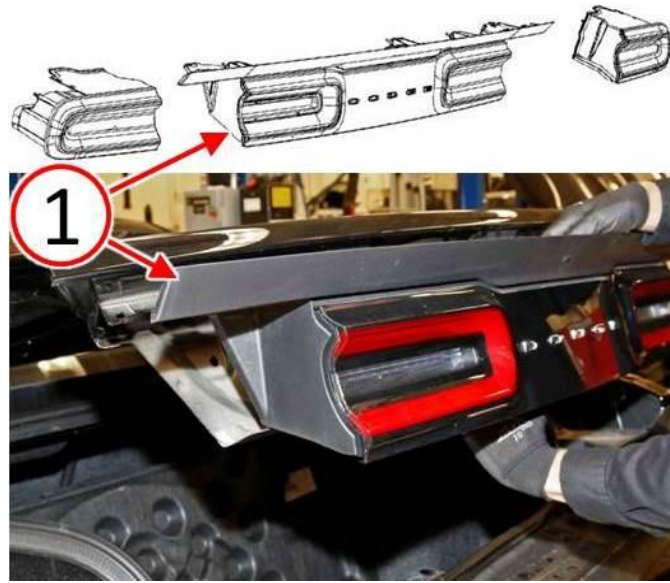
Fig. 2 Replace Inner Combination Tail Stop Backup Lamp

1 - Inner Combination Tail Stop Backup Lamp

13. Replace the inner combination tail stop backup lamp. Refer to the detailed service procedures available in DealerCONNECT> TechCONNECT under: Service Info> 08 - Electrical> 8L - Lamps and Lighting> Lamps/Lighting - Exterior> LAMP, Rear inner combination> Removal/Installation.
