JTB00544NAS1

**TECHNICAL
BULLETIN**

Front/Rear Door Primary Seal Lower Edge Loose/Adrift

MODEL:	MODEL YEAR:	VIN:	ASSEMBLY PLANT:
XF (X260)	2016 Onwards	Y00001 Onwards	Castle Bromwich

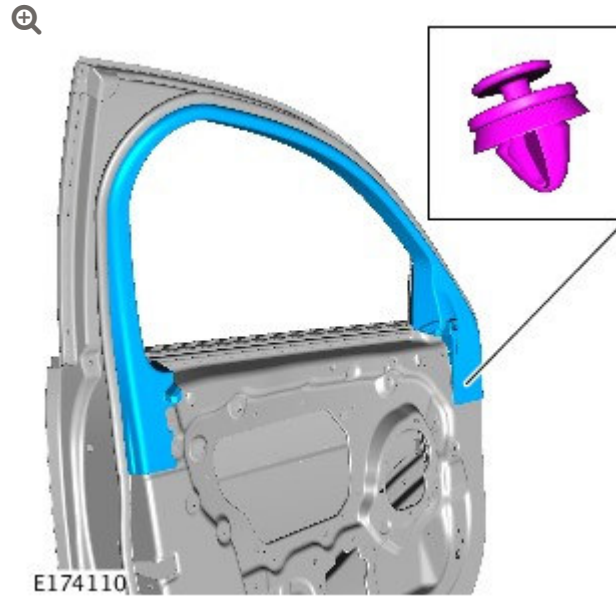
3

Front left door shown; others similar.

Remove the door frame interior finisher trim.

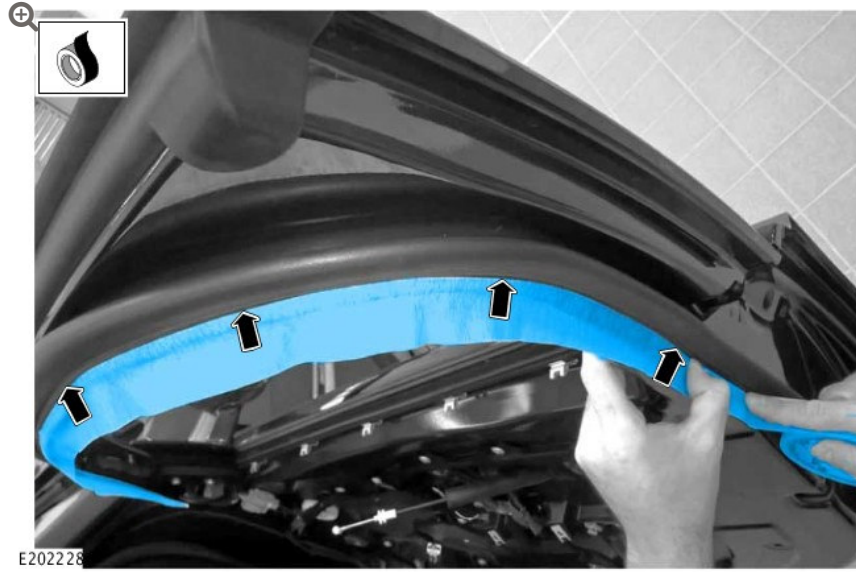
4

- The taped line must precisely follow the inner edge of the door primary seal.
- Front right door shown; others similar.

Using a suitable tape, mark the position of the inside edge of the door primary seal following its profile around the whole door.

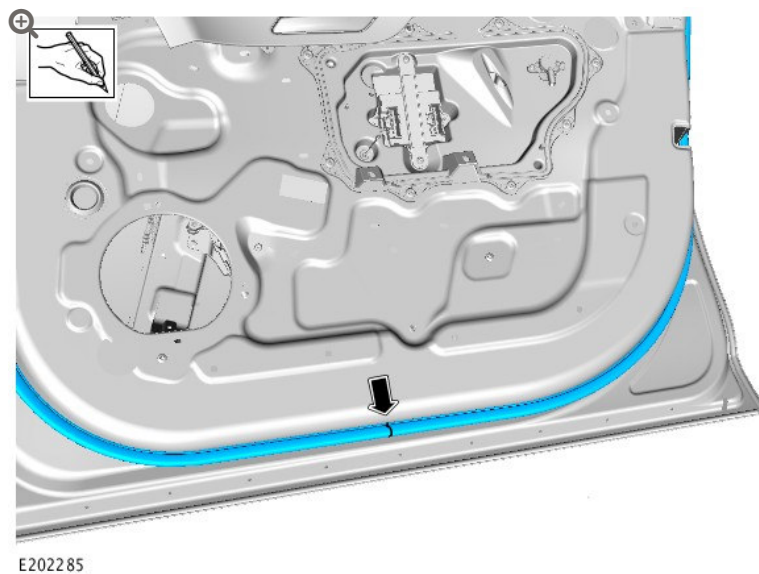
5

Front right door shown; others similar.

On the lower edge of the door, mark the center position where the two ends of the door primary seal join on the tape already applied.

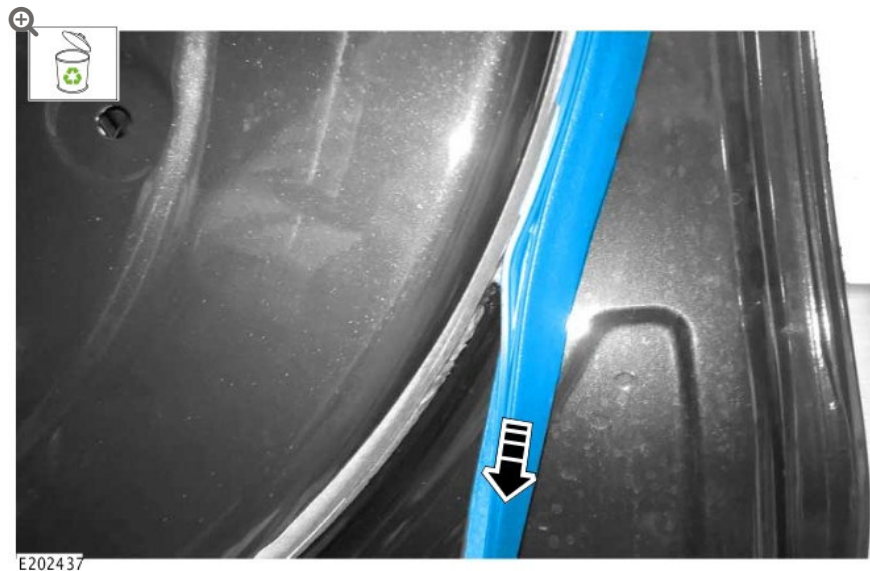
6

- Take note of the profile orientation of the door primary seal before removal.
- Remove the door seal at 30 degrees to the plane in which it is fitted whilst keeping it under tension to reduce the amount of adhesive left behind.
- Front right door shown; others similar.

Remove and discard the door primary seal.

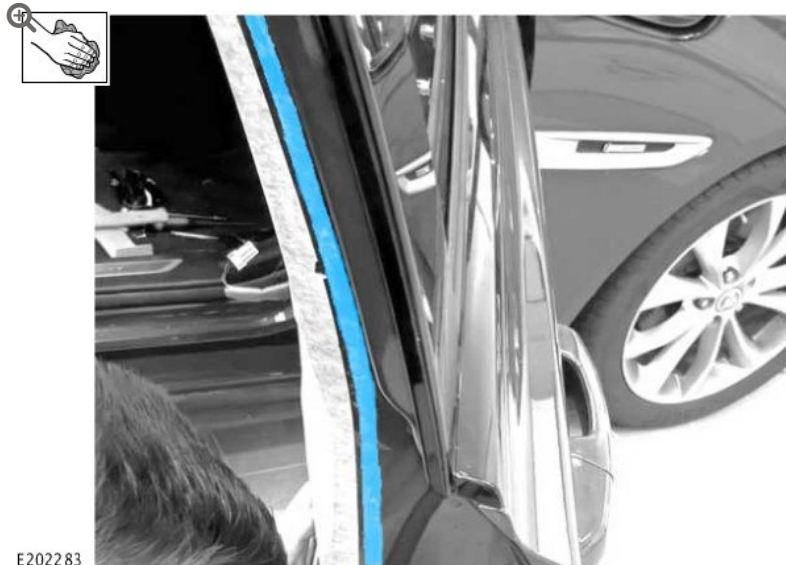
7

- Take care not to move or damage the taped line around the door.

- Front right door shown; others similar.

Clean and remove any remaining door seal adhesive from the edge of the door.

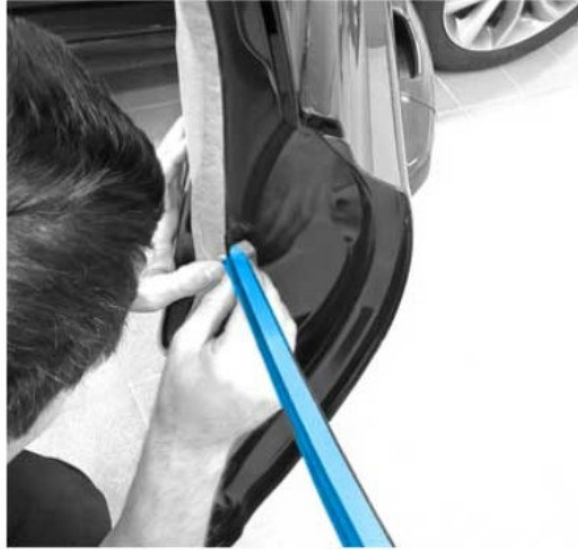
E202295

- Make sure the replacement door primary seal is installed in the same profile orientation as the original.
- Make sure to exactly follow the marked line when installing the new door primary seal.
- Front right door shown; others similar.

Starting with one end of the new door primary seal, start installing the seal against the outside of the taped line at the point previously marked on the lower edge of the door.

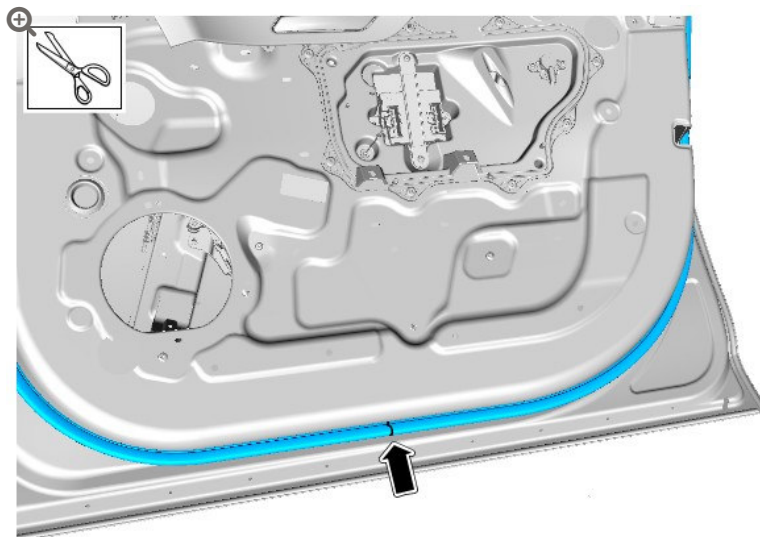
E202287

Front right door shown; others similar.

Using a suitable tool, trim the excess length off the newly installed door primary seal so that it meets the other end of the seal on the lower edge of the door.

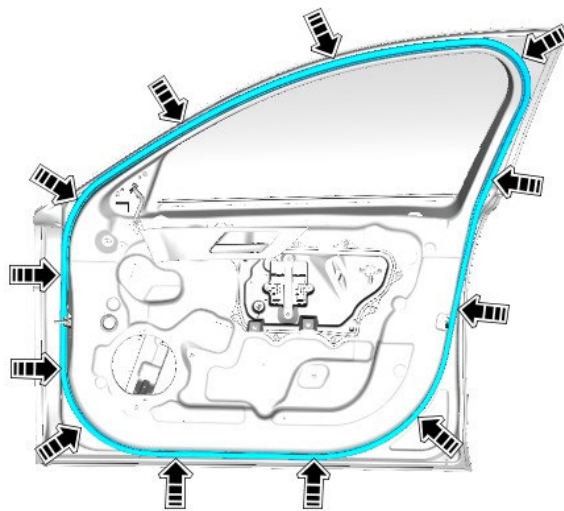
E202438

Front right door shown; others similar.

After installing the replacement door primary seal, apply pressure to the seal around the full circumference using a roller or similar to ensure the adhesive bonds to the door.

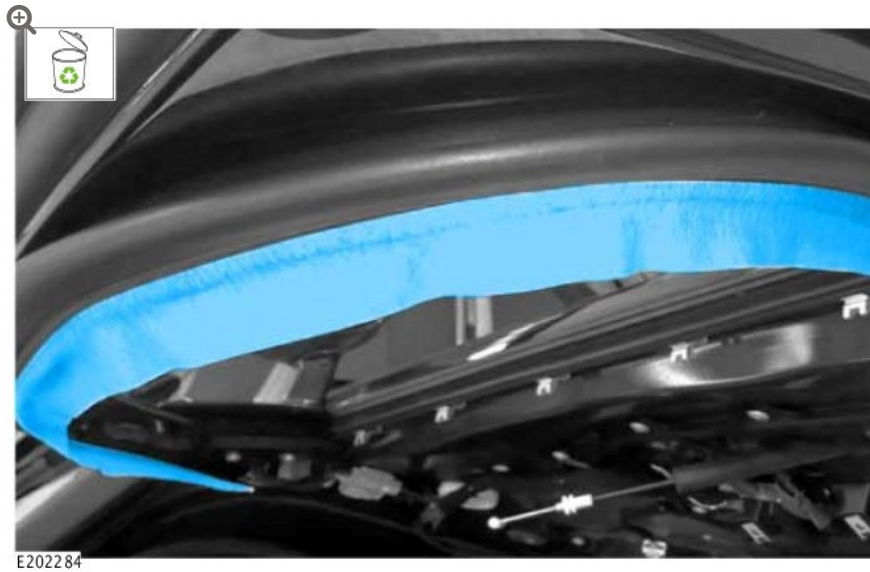
11

Front right door shown; others similar.

Remove the tape around the door seal.

- Clean and remove any remaining adhesive.

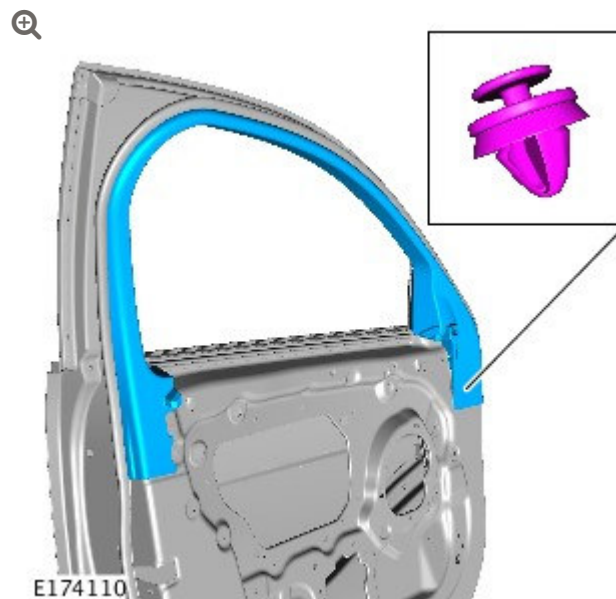
12

Front left door shown; others similar.

Install the door frame interior finisher trim.
